**Comments of the Natural Resources Defense Council (NRDC) on the  
*Draft 2011 Integrated Energy Policy Report (IEPR)***

Docket Number 11-IEP-1A  
2011 IEPR  
December 23, 2011

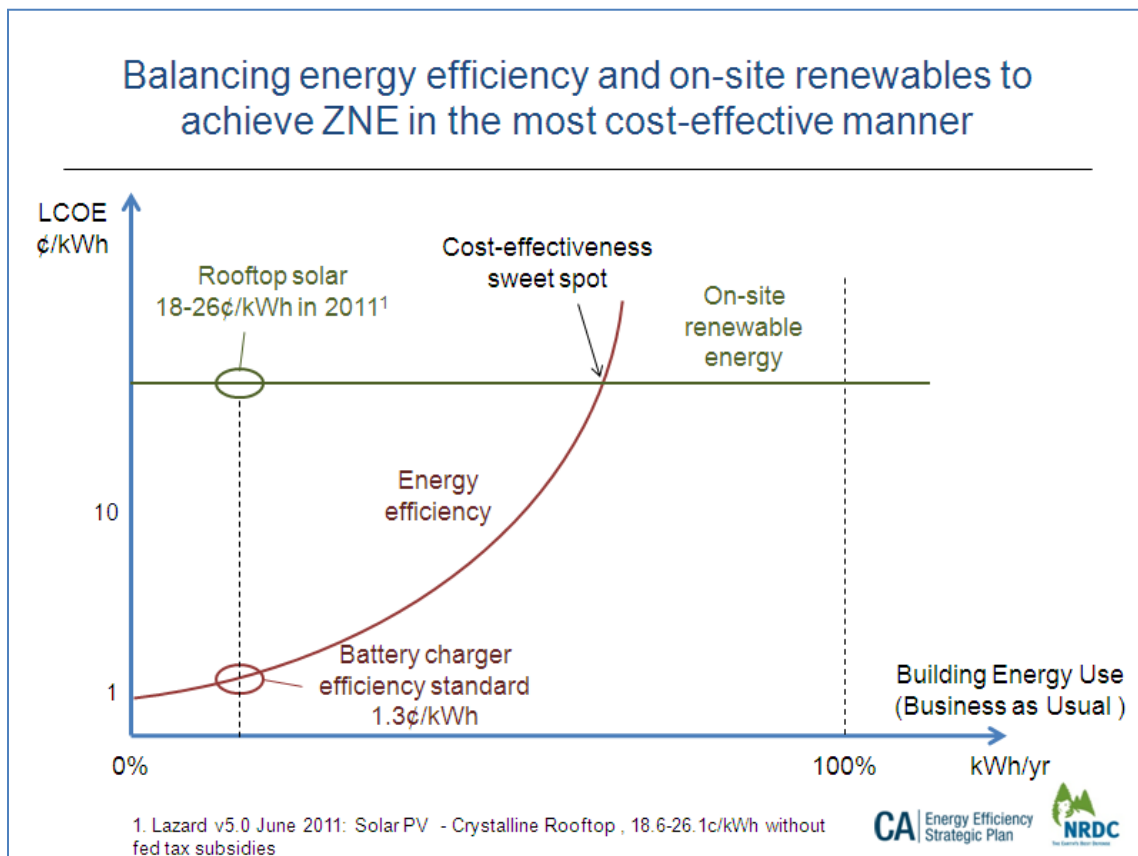
The figure below illustrates the sweet spot for cost effectiveness as the intersection of the energy efficiency and on-site renewable energy cost curves:

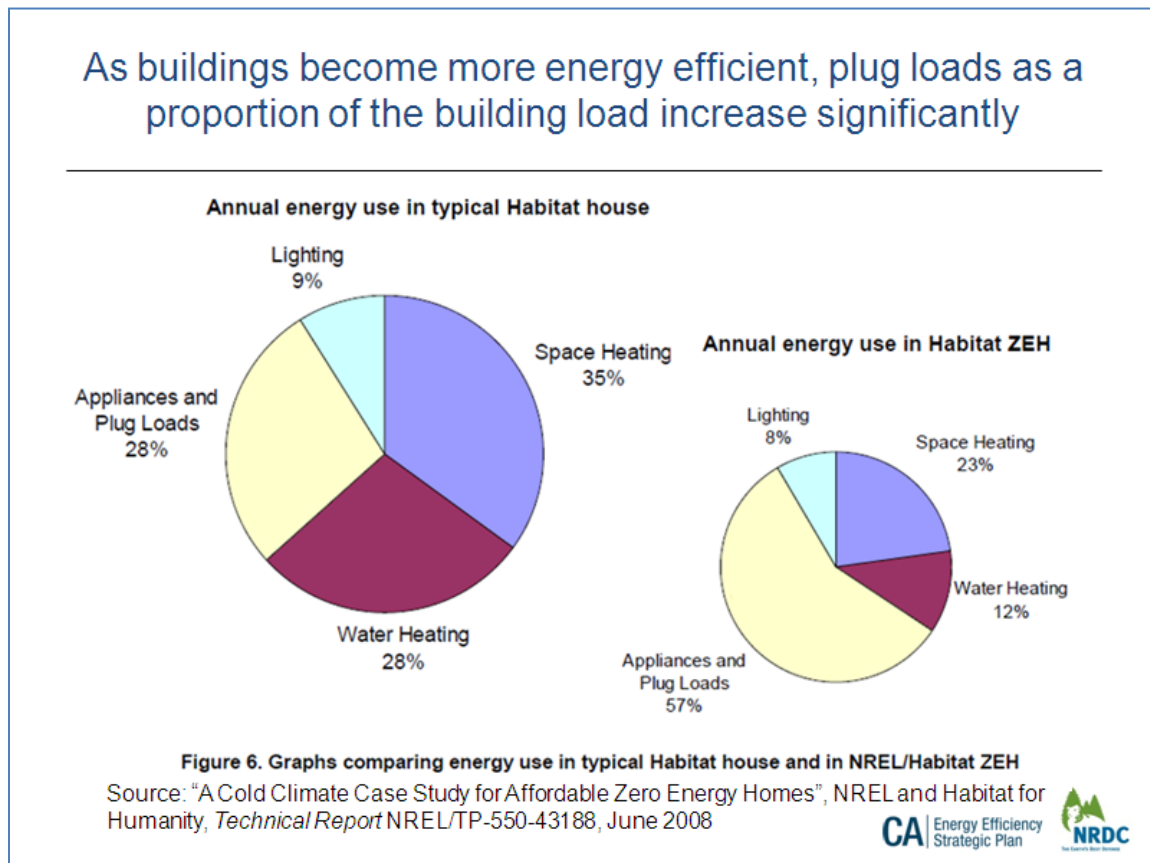
EIA projects that plug load energy use will almost double by 2030, while other traditional building loads are projected to remain approximately stable. As buildings become more energy efficient, plug loads are projected to increase from 28% of home energy use today to 57% per the figure below:

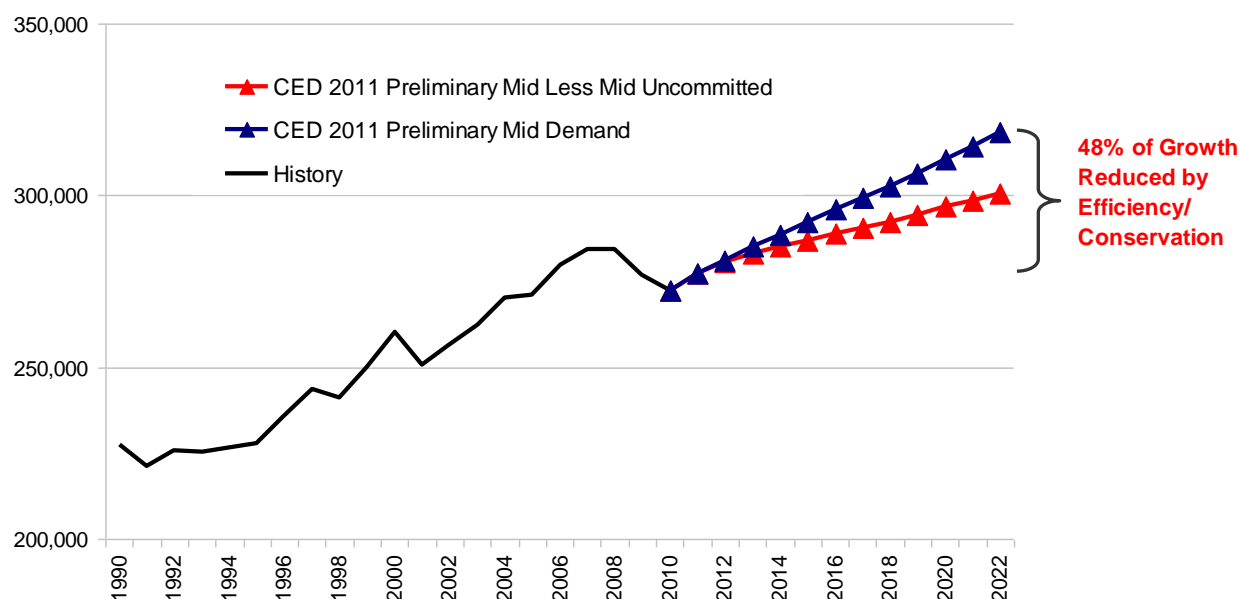
Figure 1: CEC Projected Energy Demand Growth With and Without Energy Efficiency<sup>19</sup>

Excluding the savings from projected efficiency programs and policies not only counteracts state policy, but it creates an inaccurate forecast as the savings from efficiency are reasonably likely to occur (as seen through the inclusion of efficiency in the IOU procurement plans), which is the criterion for determining what should be included in the forecast. Excluding future efficiency savings causes the forecasted growth to be off by 48%. That is, energy growth from 2012-2022 is expected to be **about half** of what is presented in the statewide electricity consumption forecast, after accounting for future energy efficiency.<sup>18</sup>

[http://www.energy.ca.gov/2011\\_energypolicy/documents/2011-08-30\\_workshop/mid-case/01\\_Mid\\_Statewide\\_Demand\\_Preliminary\\_Forecast\\_Forms.xls](http://www.energy.ca.gov/2011_energypolicy/documents/2011-08-30_workshop/mid-case/01_Mid_Statewide_Demand_Preliminary_Forecast_Forms.xls). Incremental uncommitted efficiency is expected to reduce that by 17,828 GWh in the Mid Case. *Preliminary Forecast*, Table A-8, Energy Efficiency/Conservation Consumption Savings (GWh), Residential and Non-residential Mid Demand Scenario. Available at: [http://www.energy.ca.gov/2011\\_energypolicy/documents/2011-08-30\\_workshop/mid-case/10\\_Mid\\_Electricity\\_Efficiency\\_Conservation\\_Savings\\_by\\_Planning\\_Area\\_and\\_Sector.xls](http://www.energy.ca.gov/2011_energypolicy/documents/2011-08-30_workshop/mid-case/10_Mid_Electricity_Efficiency_Conservation_Savings_by_Planning_Area_and_Sector.xls). Energy growth would be 48% lower (17,828/37,260) if incremental uncommitted efficiency were included.

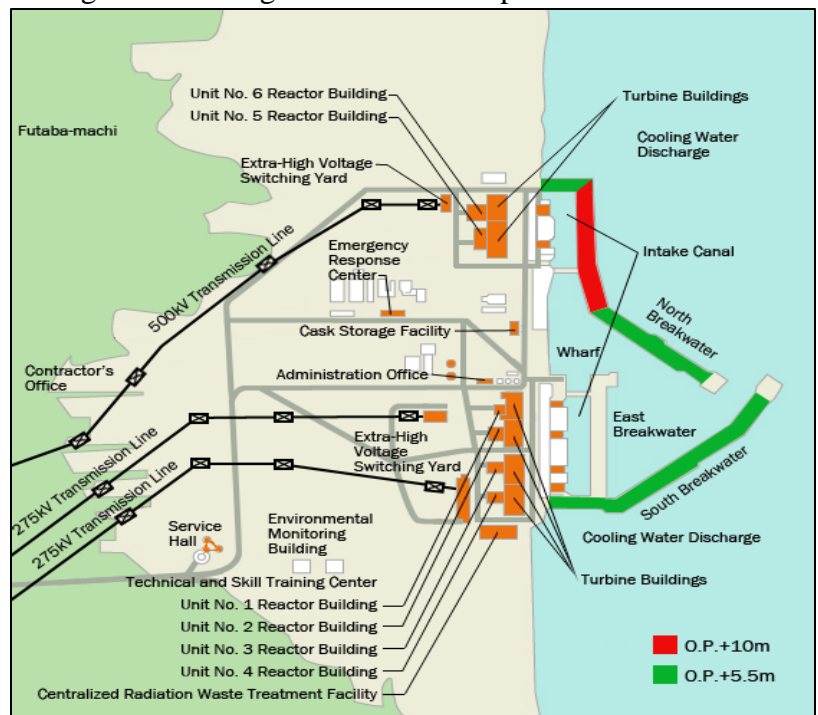
The units are designed such that units 1 and 2, 3 and 4, and 5 and 6 share common facilities and structures, such as a shared control room and turbine building. The station also has a shared spent fuel pool and dry cask storage facility. The shared spent fuel pool is located on the inland side (west) of Unit 4. The dry cask storage facility is located between units 1 and 5 along the coast.

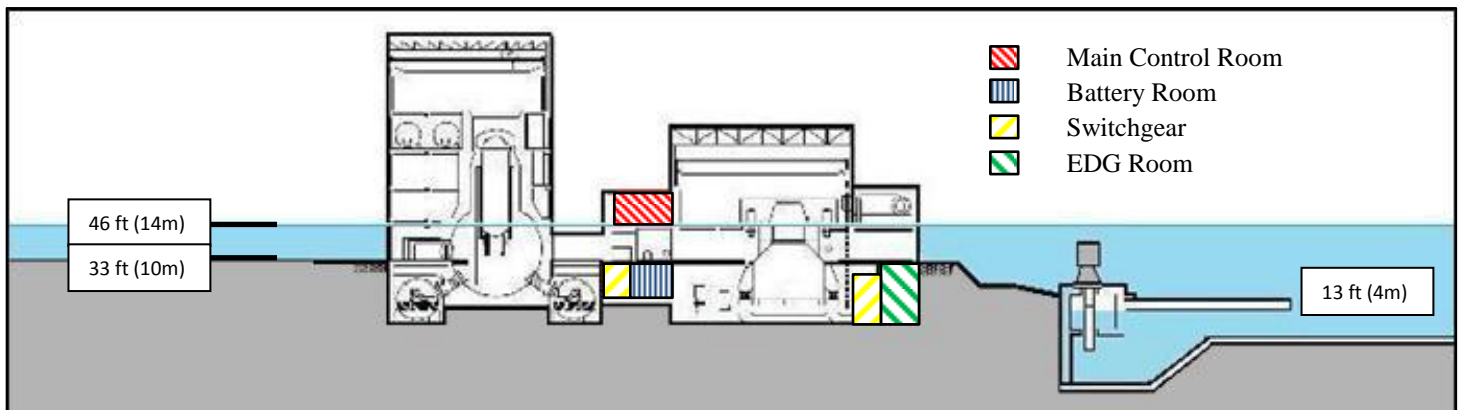
Figure 3.3-1 General Elevations and Inundation Level

The tsunami inundated the area surrounding units 1–4 to a depth of 13 to 16 feet above grade (4 to 5 meters), causing extensive damage to site buildings and flooding of the turbine and reactor buildings. Intake structures at all six units were unavailable because the tsunamis and debris heavily damaged the pumps, strainers, and equipment, and the flooding caused electrical faults. The damage resulted in a loss of the ultimate heat sink for all units. The diesel generators operated for a short time; but by 1541, the combination of a loss of cooling water, flooding of electrical switchgear, and flooding of some of the diesel generator rooms (located in the basement of the turbine buildings and not designed to withstand flooding) caused a loss of all AC power on site for units 1–5. (Refer to Figure 7.4-7.)

Figure 3.3-1 shows the general elevations (typical for units 1–4) and the approximate inundation level. The grade level of units 1–4 is 32.8 feet (10 meters) and is 42.7 feet (13 meters) at units 5 and 6 above mean sea level (commonly referred to as OP, for the level in the Onahama Port). The intake structures were at an elevation of 13.1 feet (4 meters) for all units.

Figure 3.3-1 shows the general elevations (typical for units 1–4) and the approximate inundation level. The grade level of units 1–4 is 32.8 feet (10 meters) and is 42.7 feet (13 meters) at units 5 and 6 above mean sea level (commonly referred to as OP, for the level in the Onahama Port). The intake structures were at an elevation of 13.1 feet (4 meters) for all units.

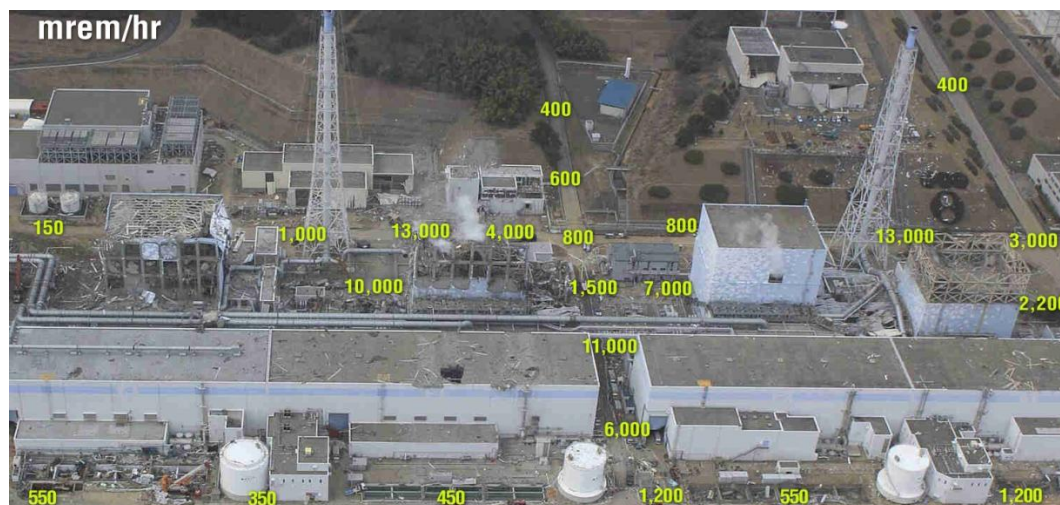
Figure 5.3-1 Site Dose Rates

On March 22 and 23, surveys of the airborne radioactivity and dose rates around the site began to be collected and documented. The dose rates are documented on Figure 5.3-1. Localized dose rates as high as 1,000 rem/hr (10 Sv/hr) were later discovered.

On March 22 and 23, surveys of the airborne radioactivity and dose rates around the site began to be collected and documented. The dose rates are documented on Figure 5.3-1. Localized dose rates as high as 1,000 rem/hr (10 Sv/hr) were later discovered.

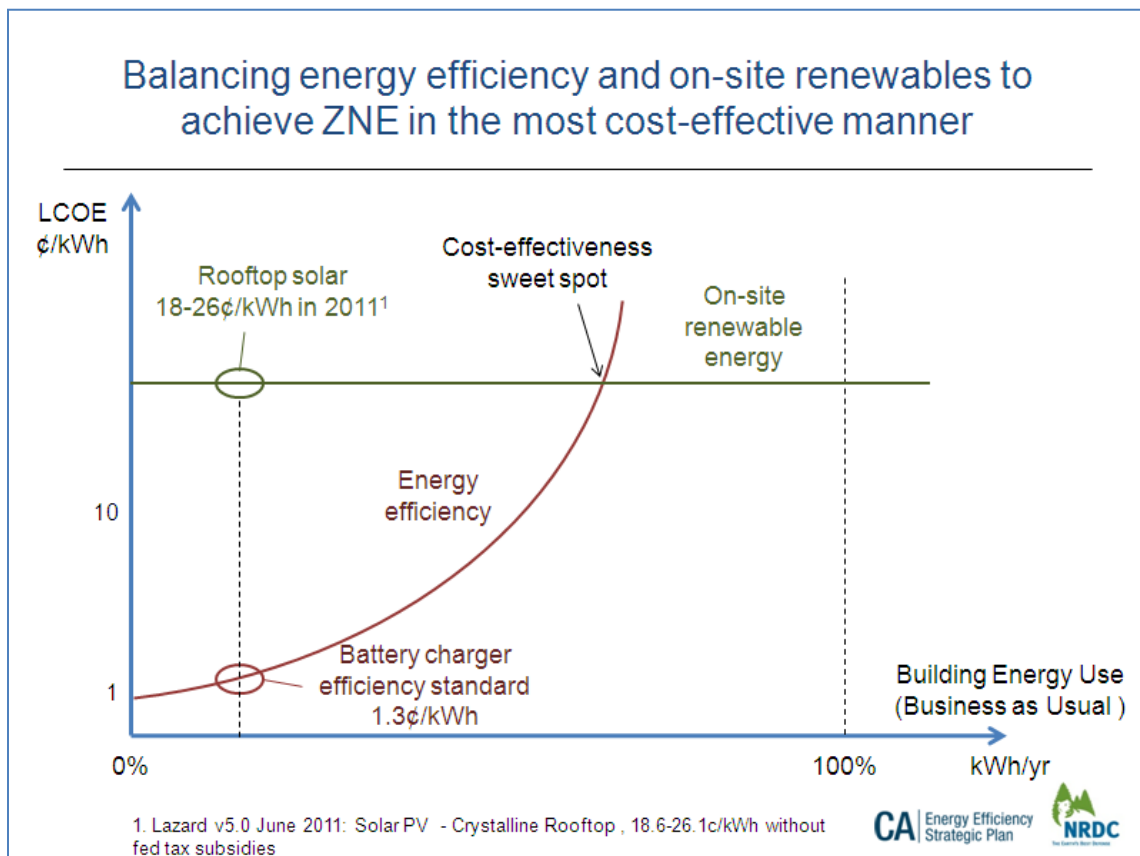
The figure below illustrates the sweet spot for cost effectiveness as the intersection of the energy efficiency and on-site renewable energy cost curves:
