<b>Docket Number:</b>	09-AFC-07C
<b>Project Title:</b>	Palen Solar Power Project - Compliance
<b>TN #:</b>	201977
<b>Document Title:</b>	Supplemental Opposition to Motion to Reopen Evidentiary Record and Scheduling Order
<b>Description:</b>	N/A
<b>Filer:</b>	Lisa Belenky
<b>Organization:</b>	Center for Biological Diversity
<b>Submitter Role:</b>	Intervenor
<b>Submission Date:</b>	4/7/2014 4:15:04 PM
<b>Docketed Date:</b>	4/7/2014

APPLICATION FOR CERTIFICATION  
FOR THE PALEN SOLAR POWER  
PROJECT

**CENTER FOR BIOLOGICAL DIVERSITY  
SUPPLEMENT TO OPPOSITION TO MOTION TO REOPEN EVIDENTIARY  
RECORD AND SCHEDULING ORDER**

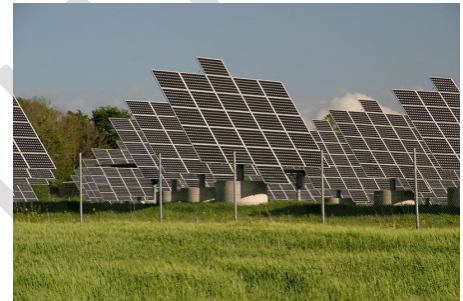
1) **Photovoltaic systems** directly convert the sun's light into electricity. The perceived threat to birds is associated with the presence of water ponds which attract birds and from traumatic impact with the photovoltaic cells. An example of this type of solar power plant is Desert Sunlight Solar Farm (AKA First Solar).

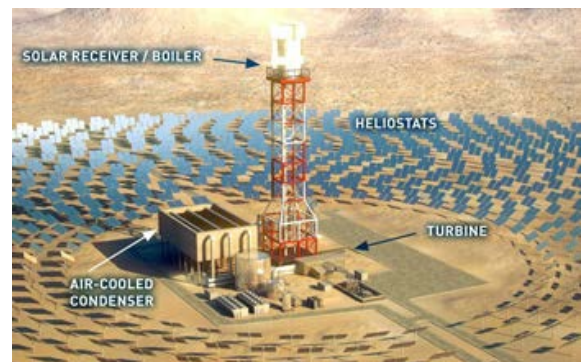
3) **Solar power towers** use thousands of mirrors to reflect the solar energy to a tower, where water in a boiler is converted to steam, generating the electricity. The perceived threat to birds is associated traumatic impact with the mirrors and the danger associated with the heat produced by the mirrors. An example of this type of solar power plant is Ivanpah Solar Electric Generating System.

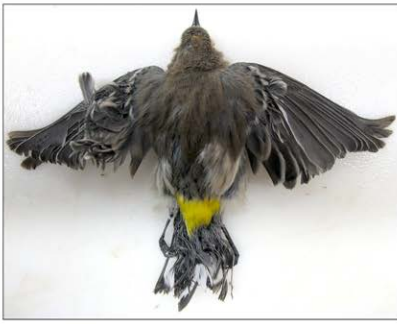
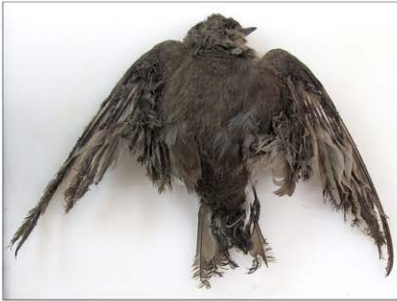
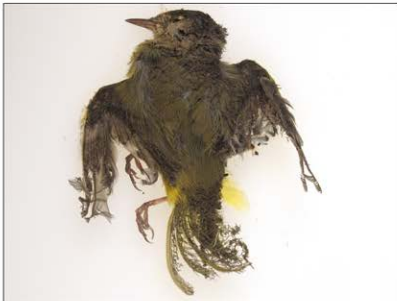
Birds with feather burns were graded based on the extent of the lesions. Grade 1 birds had curling of less than 50% of the flight feathers. Grade 2 birds had curling of 50% or more of the flight feathers. Grade 3 birds had curling and visible charring of contour feathers (Figure 1).

Figure 1: Three grades of flux injury based on extent and severity of burning. Grade 1 (top); Yellow-rumped Warbler with less than 50% of the flight feathers affected (note sparing of the yellow rump feathers). Grade 2 (middle); Northern Rough-winged Swallow initially found alive but unable to fly, with greater than 50% of the flight feathers affected. Grade 3 (bottom); MacGillivray's Warbler with charring of feathers around the head, neck, wings and tail.

Eight birds were assigned a feather damage Grade of 1 with curling of less than 50% of the flight feathers. Six of these had other evidence of acute trauma (75%). Five birds were Grade 2, including three birds that were found alive and died shortly afterwards. Of these birds, 2 (the birds found dead) also had evidence of acute trauma. Twenty-eight birds were Grade 3; with charring of body feathers. Of these birds, 21/28

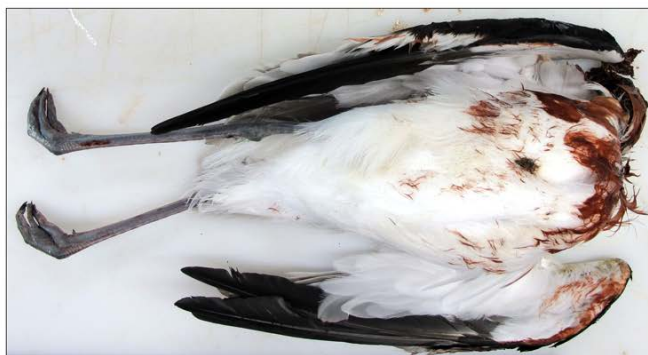
Blunt force impact trauma was determined to have been the cause of death for 19 Desert Sunlight birds including two Western Grebes (*Aechmophorus occidentalis*) and one each of 16 other species. Impact (blunt force) trauma is diagnosed by the presence of fractures and internal and/or external contusions. In particular, bruising around the legs, wings and chest are consistent with crash-landings while fractures of the head and/or neck are consistent with high-velocity, frontal impact (such as may result from impacting a mirror).

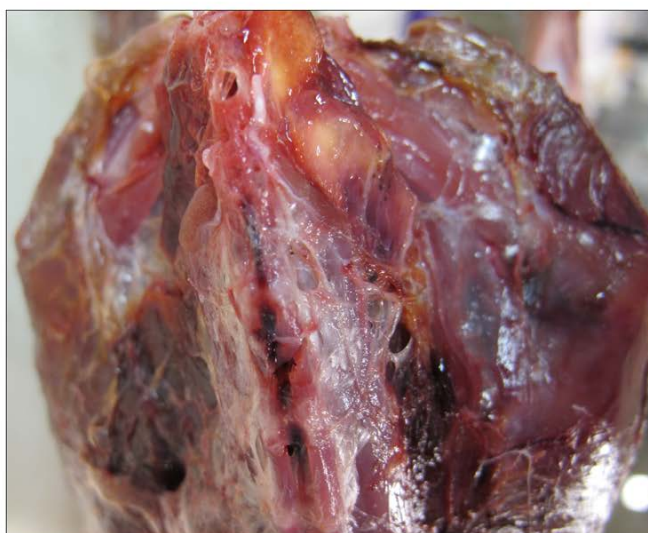
Figure 2: Predation trauma (top) resulting in traumatic amputation of the head and neck (American Avocet) and impact trauma (bottom) causing bruising of the keel ridge of the sternum (Brown Pelican).

Predation was the immediate cause of death for 15 birds. Lesions supporting the finding of predation included decapitation or missing parts of the body with associated hemorrhage (9/15), and lacerations of the skin and pectoral muscles. Eight of the predated birds from Desert Sunlight were

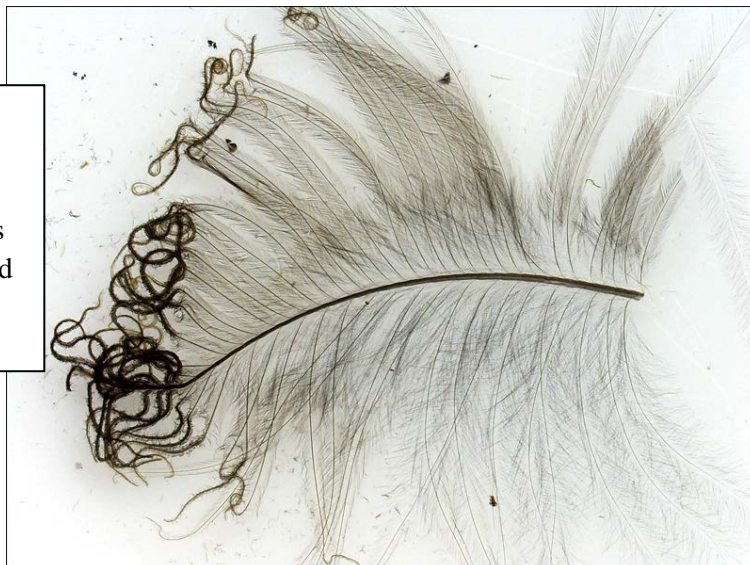
Figure 3: contour feather from the back of a House Finch with Grade 3 solar flux injury. The feather has curling and charring limited to the exposed tip.

Solar flux injury was identified as the cause of death in 47/141 birds. Solar flux burns manifested as feather curling, charring, melting and/or breakage and loss. Flight feathers of the tail and/or wings were invariably affected. Burns also tended to occur in one or more of the following areas; the sides of the body (axillae to pelvis), the dorsal coverts, the tops and/sides of the head and neck and the dorsal body wall (the back). Overlapping portions of feathers and light-colored feathers were often spared (Figures 3 and 4).

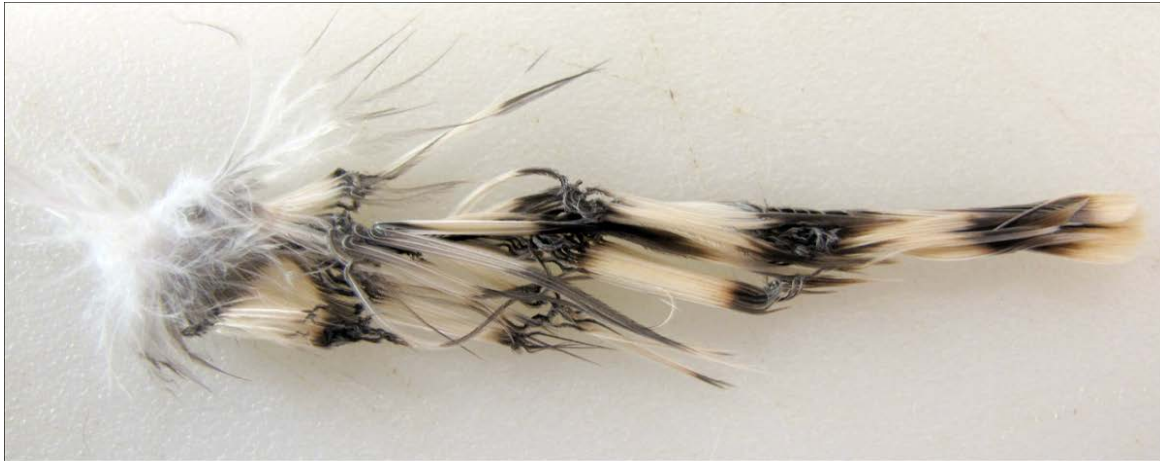
Figure 4: Feather from a Peregrine Falcon with Grade 2 solar flux injury. Note burning of dark feather bands with relative sparing of light bands.

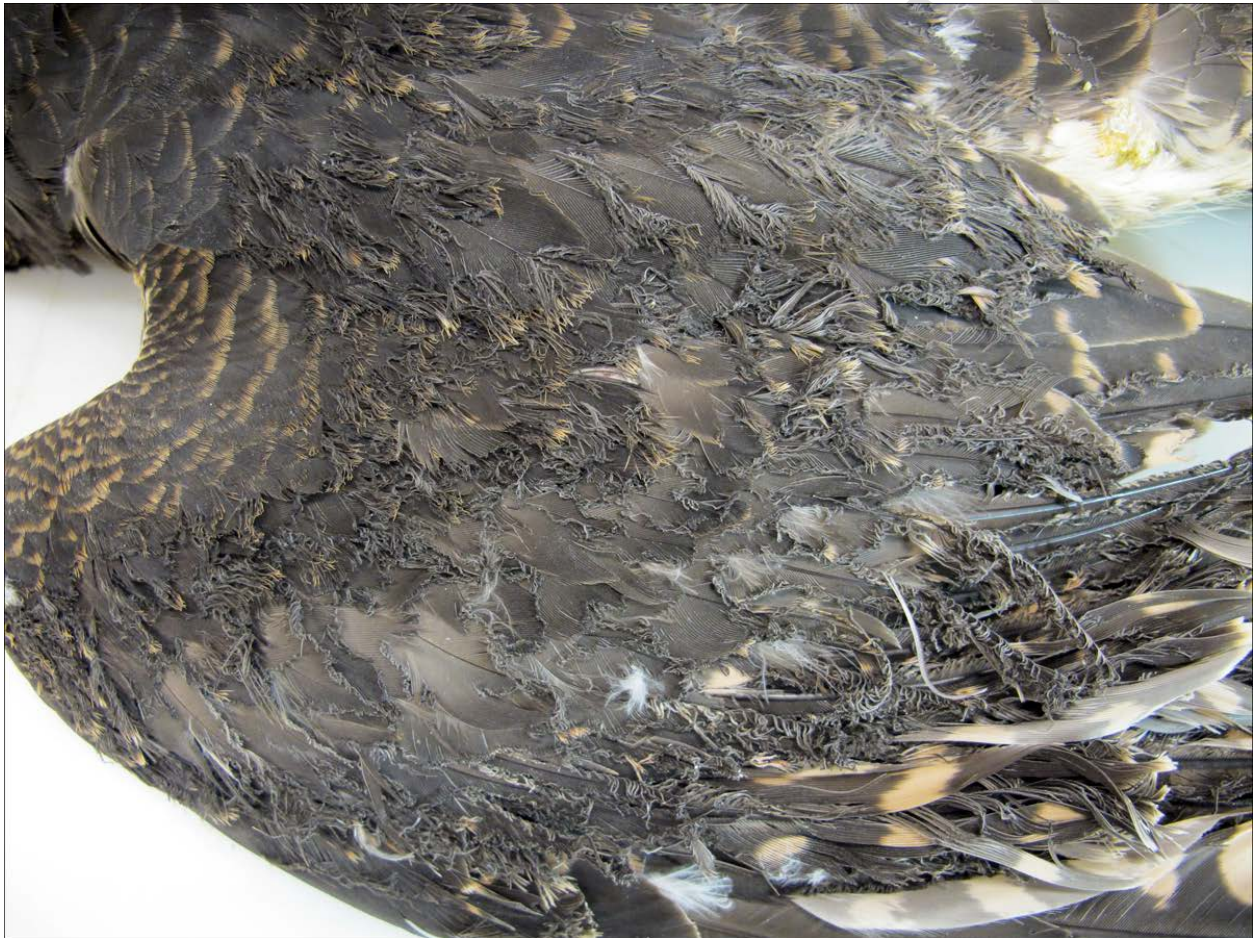
Figure 5: The dorsal aspect of the wing from a Peregrine Falcon (the same bird as shown in Figure 4) with Grade 2 lesions. Note extensive curling of feathers without visible charring. This bird was found alive, unable to fly, emaciated and died shortly thereafter. These findings demonstrate fatal loss of function due to solar flux exposure in the absence of skin or other soft tissue burns.

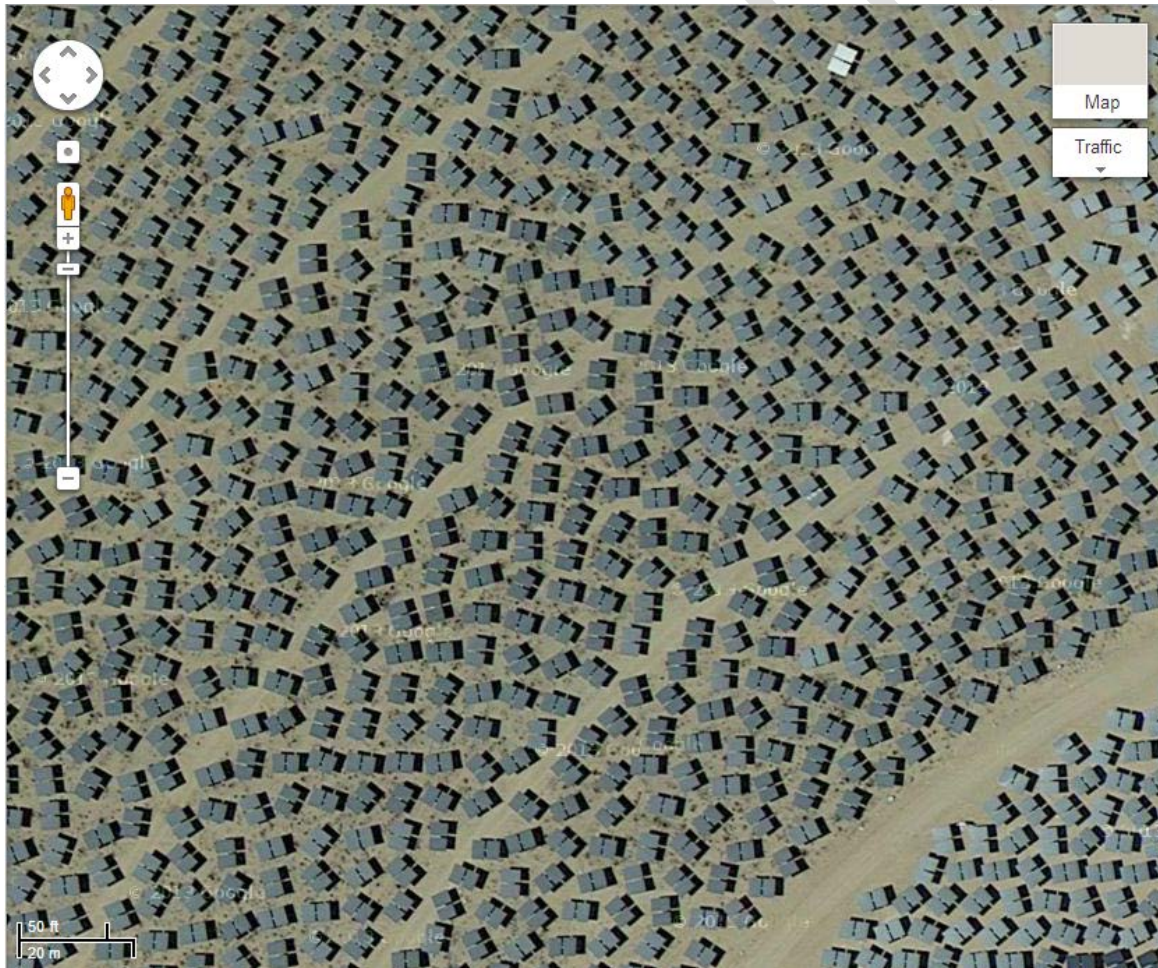
Figure 6: The Ivanpah Solar Electric Generating System as seen via satellite. The mirrored panels are 5 x 8 feet.

A desert environment punctuated by a large expanse of reflective, blue panels may be reminiscent of a large body of water. Birds for which the primary habitat is water, including coots, grebes, and cormorants, were over-represented in mortalities at the Desert Sunlight facility (44%) compared to Genesis (19%) and Ivanpah (10%). Several factors may inform these observations. First, the size and continuity of the panels differs between facilities. Mirrors at Ivanpah are individual, 4 x 8’ panels that appear from above as stippling in a desert background (Figure 6). Photovoltaic panels at Desert Sunlight are long banks of adjacent 27.72 x 47.25” panels (70 x 120 cm), providing a more continuous, sky/water appearance. Similarly, troughs at Genesis are banks of 5 x 5.5’ panels that are up to 49-65 meters long.

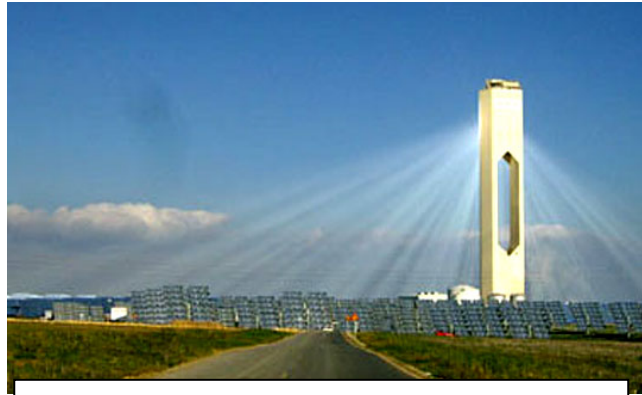
If all the solar heliostats are focused on the solar tower the beams multiply the strength of sunlight by 5000 times, and this generates temperatures at the solar tower in excess of 3600° Fahrenheit (> 1982° Celsius). Since steel melts at 2750° Fahrenheit (1510° Celsius), only a percentage of heliostats are focused on the solar receiver so that the optimal temperature at the tower is approximately 900° Fahrenheit (~482° Celsius) (“How do they do it” Wag TV for Discovery Channel, Season 3, Episode 15, “Design Airplane Parachutes, Create Solar Power, Make Sunglasses” Aired August 25, 2009).

Figure 8: Seville solar power facility (<http://inhabitat.com/sevilles-solar-power-tower>)

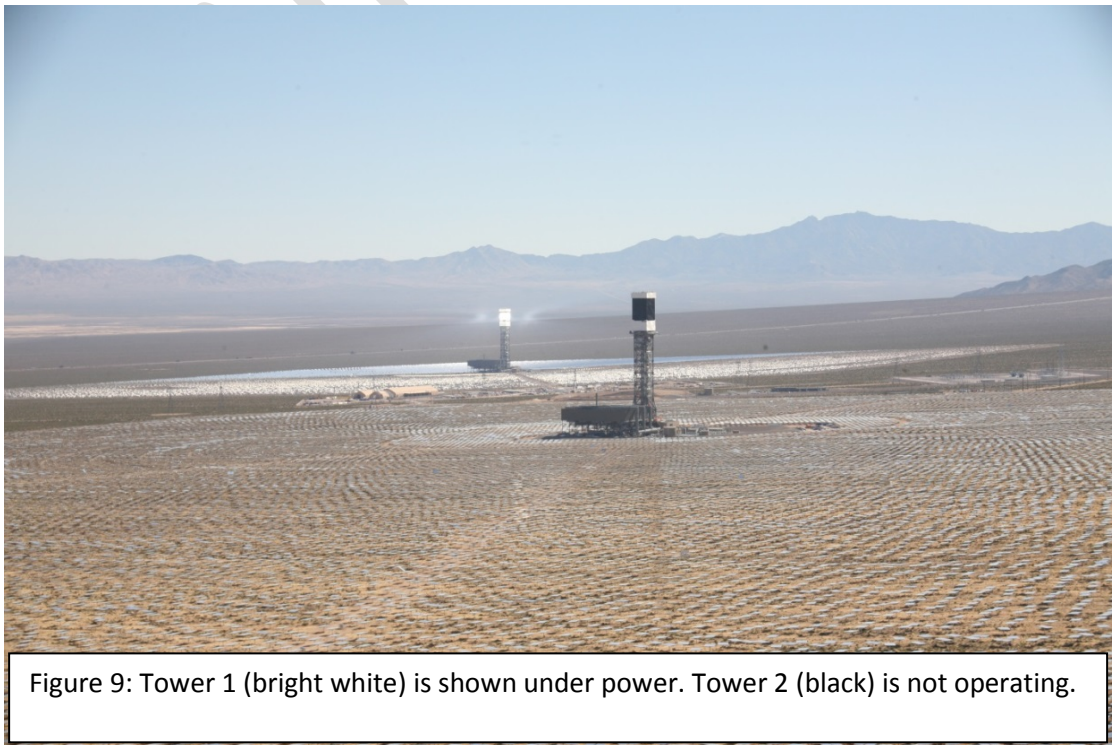
There is a phenomenon that occurs when the heliostats are focused on the tower and electricity is being generated. The phenomenon can be described as either a circle of clouds around the tower or, at times, a cloud formed on the side that is receiving the solar reflection. It appears as though the tower is creating clouds. Currently we propose two hypotheses of why this “cloud” is formed. The first hypothesis is simply the presumption that the high heat associated with towers is condensing the air, and forming the

Figure 9: Tower 1 (bright white) is shown under power. Tower 2 (black) is not operating.

clouds. The second hypothesis is that this phenomenon does not represent clouds at all rather it is a place in space where the heliostats that are not being used to generate heat are focused. Under this scenario, it is a place where the mirrors focus the excess energy not being used to generate electricity.

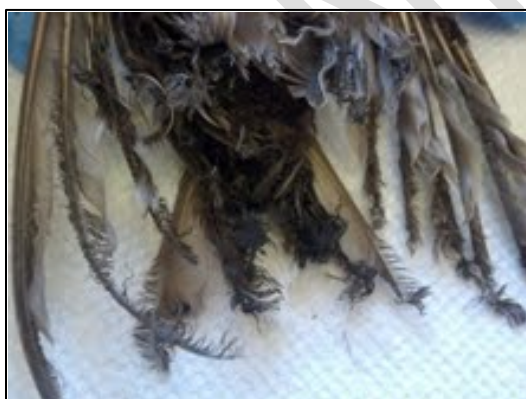
Many of the carcasses recovered from the Ivanpah Solar plant after the plant became operational showed singeing of feathers as shown in Figure 10.

Figure 10: Singed feathers from a Northern Rough-winged Swallow

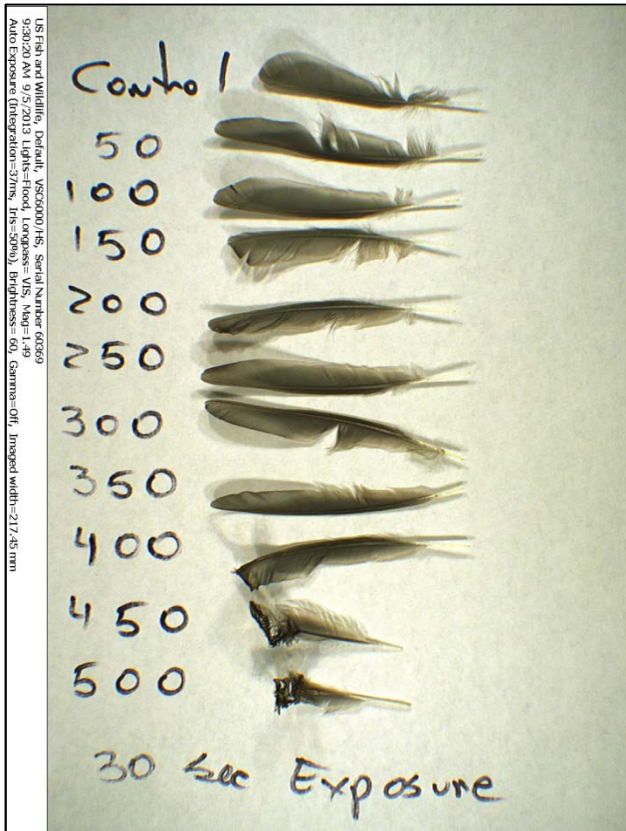
In order to investigate at what temperature feathers burn/singe, we exposed feathers to different air temperatures. Each feather was exposed to a stream of helium and air for 30 seconds. The results indicate that at 400° Celsius (752° Fahrenheit) after 30 seconds the feather begins to degrade. But at 450° and

Figure 11: Results of exposing feathers to different temperatures (in degrees Celsius)

500° Celsius (842° and 932° Fahrenheit respectively) the feathers singed as soon as they made contact with the superheated air (Figure 11). Therefore, when singed birds are found, it can be inferred that the temperatures in the solar flux at the time a bird flew through it was at least 400° Celsius (752° Fahrenheit). This inference is consistent with the desired operating temperature of a power tower solar boiler (482° Celsius).
