#### RE: AMENDED CARLSBAD ENERGY CENTER PROJECT, DOCKET NO. 07-AFC-06C, DEMOLITION OF ENCINA POWER STATION CONDITION OF CERTIFICATION, COM-6 JULY 2021, MONTHLY COMPLIANCE REPORT

## Amended Carlsbad Energy Center Project Encina Power Station Demolition (07-AFC-06C) California Energy Commission Monthly Compliance Report COM-6

## July 2021

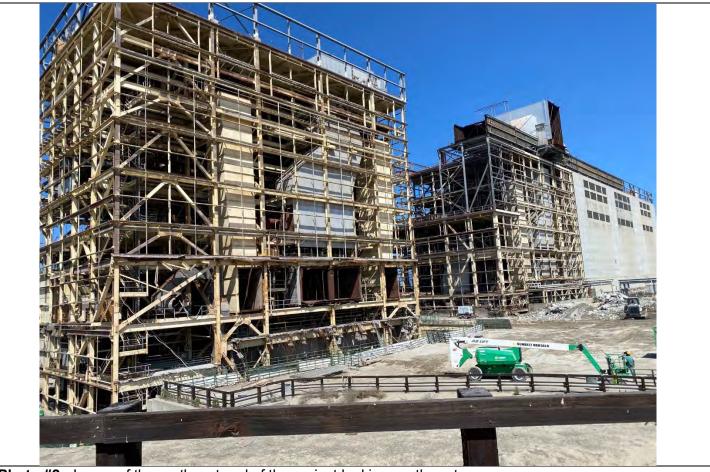
Photo #2: Image of the northeast end of the project looking southwest.

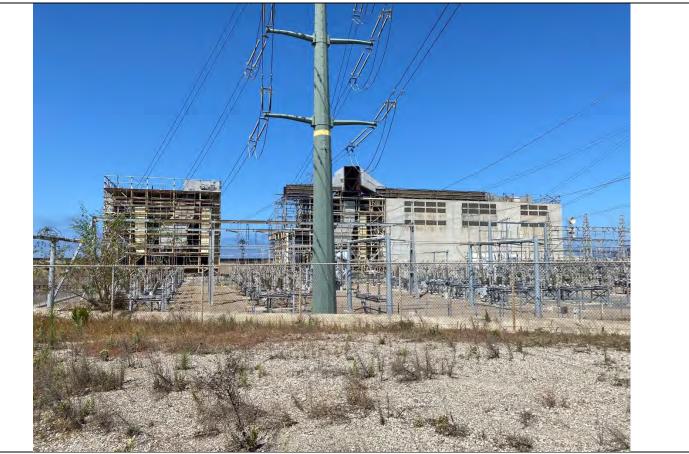
**Photo #4:** Image of the east side of the project looking west. From this angle it can be seen that Unit 5 (to the left) is now completely separated from the remaining portion of the building.

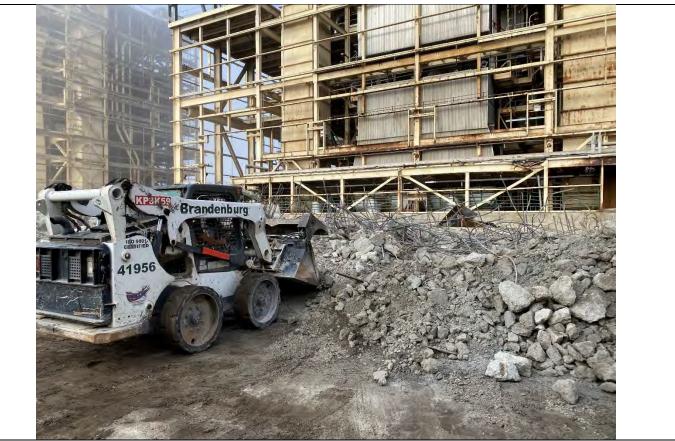
**Photo #5:** In designated areas debris has been piled and is loaded into dumpsters for removal. Areas around the piles appeared to be relatively clean.

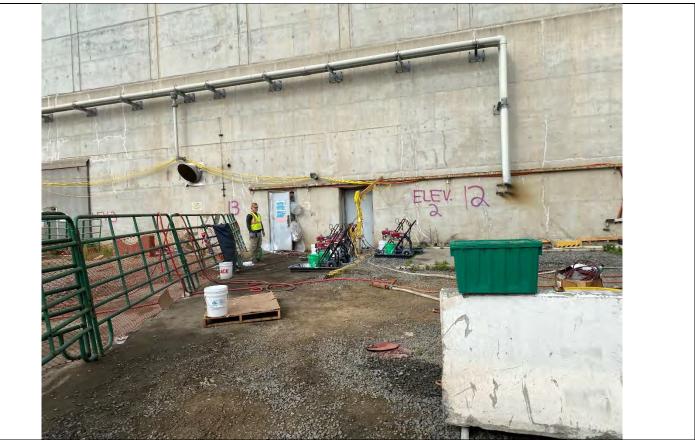
**Photo #7:** This is a view at the encapsulating entrance for Unit 3. This is where the buckets of materials that are used to encapsulate the surfaces after cleaning and prior to removal are stored.

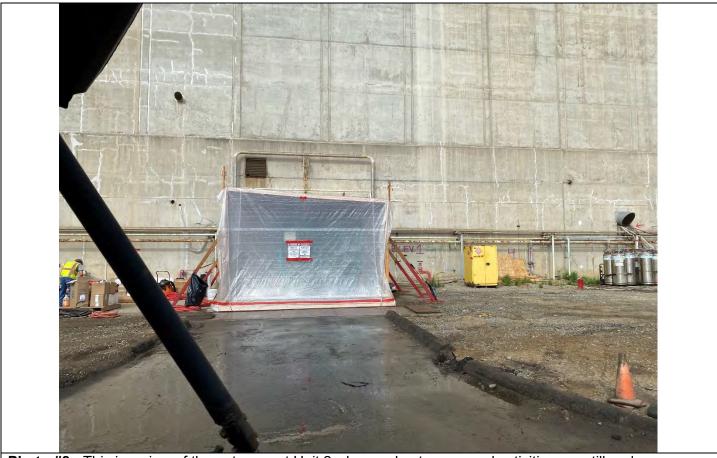
Photo #8: This is a view of the entrance at Unit 2 where asbestos removal activities are still underway.

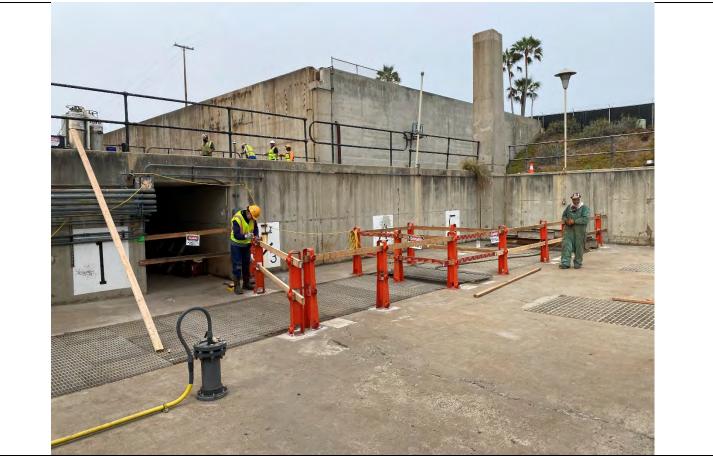
**Photo #9:** Guards are currently being placed and the grates will then be removed to allow access for the filling of the tunnels.

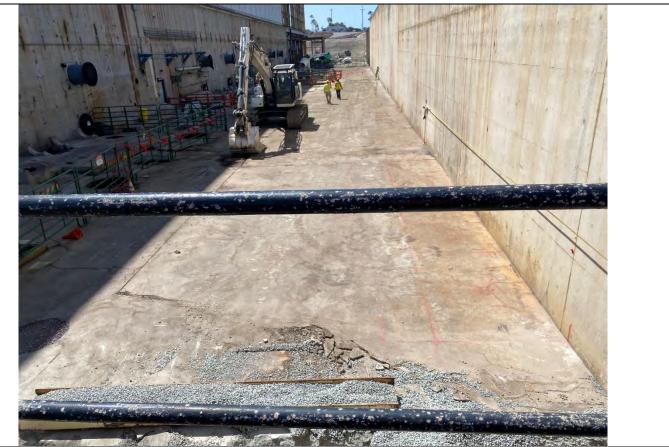
**Photo #10:** Here is a view of the tunnel lid. Holes will be punctured in the lid about every 10-feet to allow for the fill material to be placed within the tunnel.

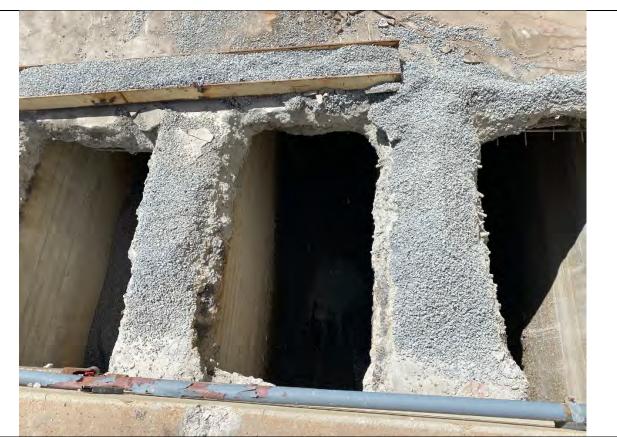
**Photo #11:** Here is a view of the openings in the tunnel lid and the <sup>3</sup>/<sub>4</sub>-inch crushed aggregate that has begun to be placed in the tunnel. The aggregate will be placed to within a foot or two of the lid and then a flowable fill will be placed for the upper portion.

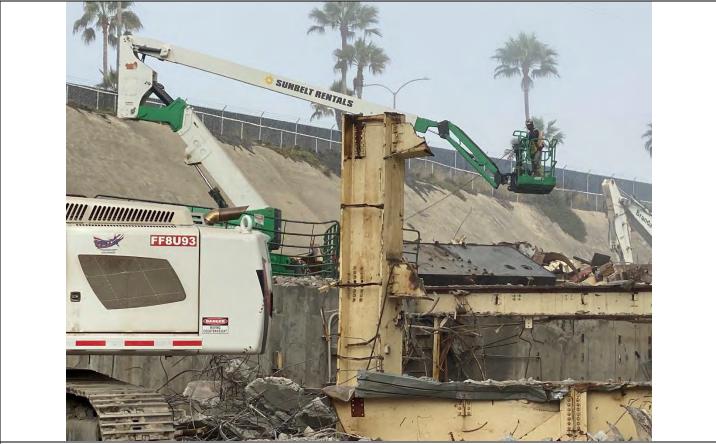
**Photo #12:** This photo shows a worker in a manlift that cut the larger sections of structural steel and then the larger equipment shown on the left pulls it and places it in the appropriate dumpster or pile.

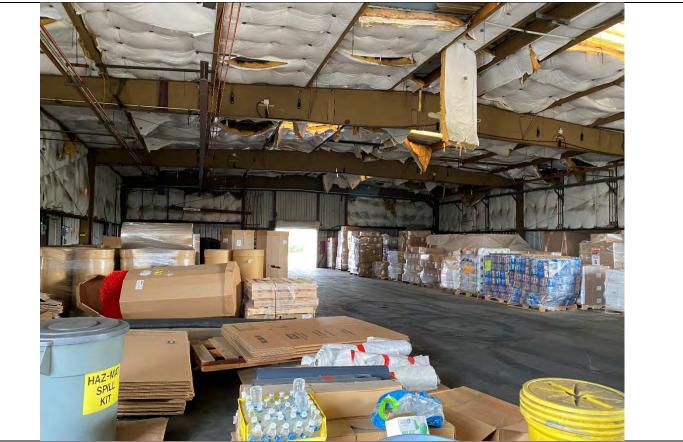
**Photo #13:** The warehouse that contains the general supplies is relatively organized and has maintained good housekeeping practices.

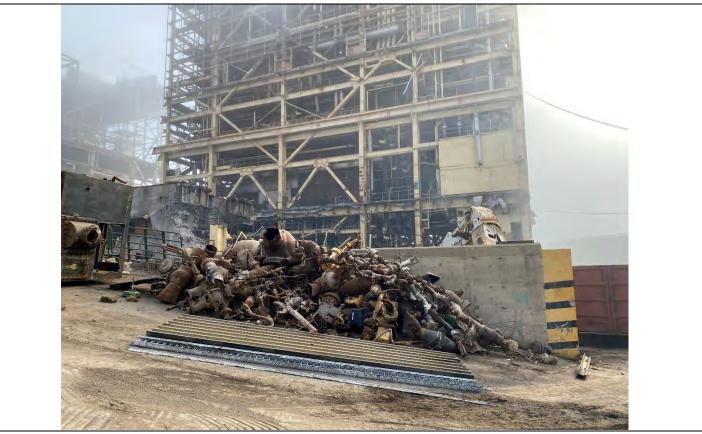
**Photo #14:** As shown in previous photos, this photo shows stockpiling if specific materials and shows how good housekeeping has been maintained around the piles.
