# **Quarterly Evaporation Pond Monitoring Report**

For July-September 2024

## **Mojave Solar Project**

09-AFC-5C

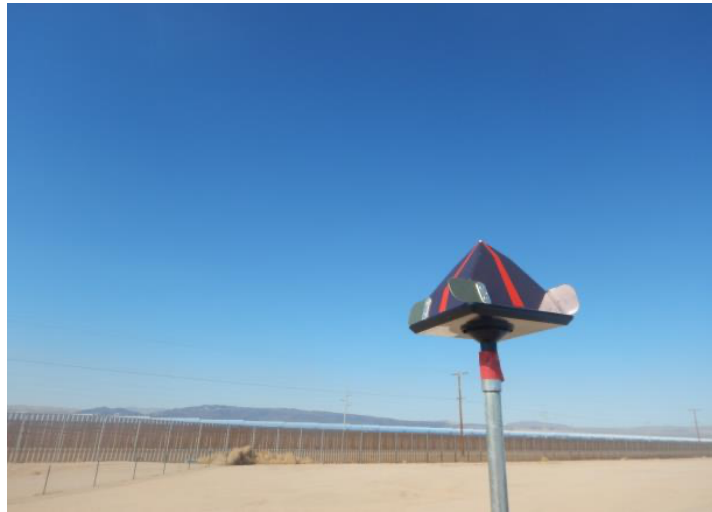
**Photo 1:** Eagle Eye deterrent

- **Visual Deterrents (Eagle Eyes):** The Eagle Eye unit uses a reflective pyramid that rotates to reflect sunlight, creating a menacing pattern with the moving beams of light. The ever-changing light spectrum reflected by the Eagle Eye disorients birds in flight by significantly limiting their vision, causing them to deviate in flight and go elsewhere. The systems are either wind-powered or use a 12-volt electric

battery to rotate the reflective pyramid. The battery may be charged by a small photovoltaic cell. It can be used to deter resident birds. Eight Eagle Eyes (4 red wind driven and 4 silver electrically driven) are installed around each pond perimeter (Figure 2) for total of 32 units installed at the four ponds.

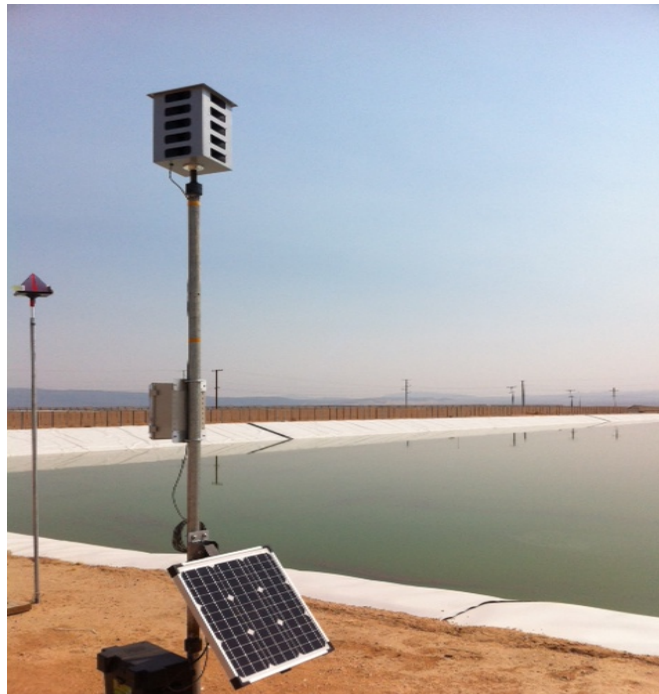
**Photo 2:** BirdGard deterrent

- **BirdGard:** This device uses digital recordings of species-specific distress and alarm calls, along with the sounds of a bird's natural predators are broadcast through high fidelity weather-resistant speakers to convince birds they are under attack and drive them away.

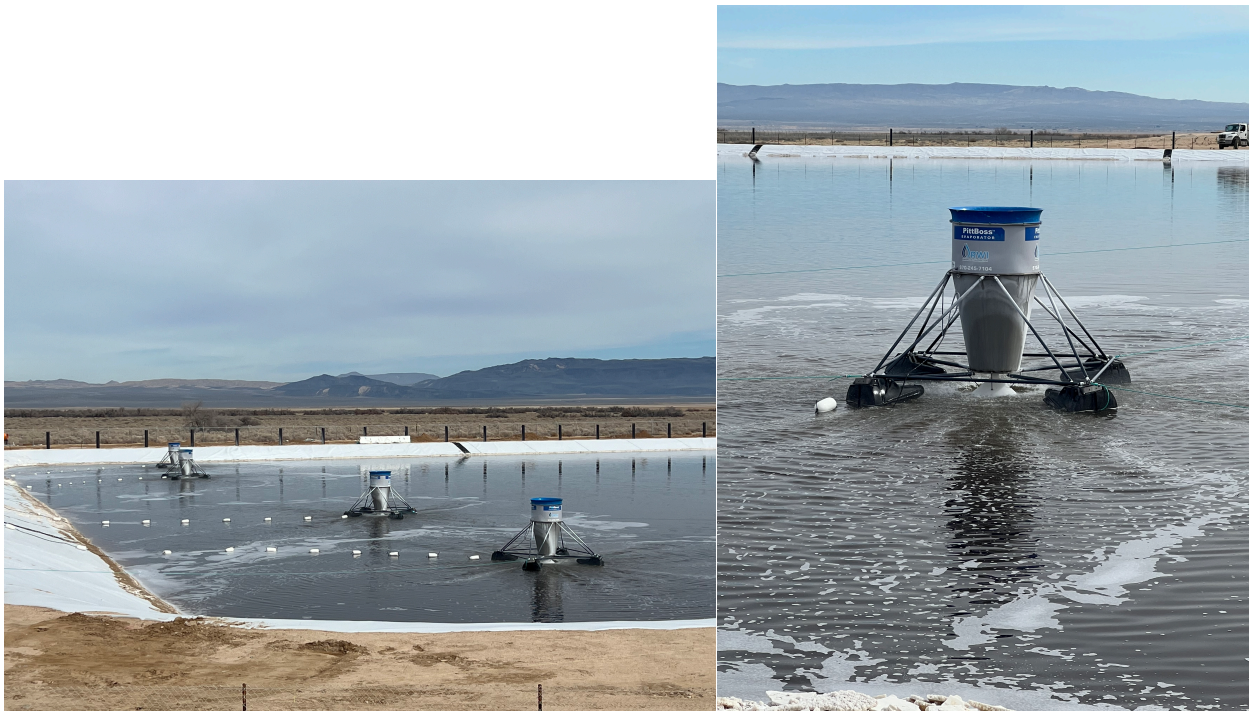
Subsequently, MSP communicated with CEC regarding the use of PittBoss Sprayer-less Evaporators to replace the existing evaporators when the ponds are netted. In a letter dated December 22, 2023, CEC approved the use of the PittBoss evaporators. In February 2024, MSC installed four PittBoss evaporators in the alpha east pond (see photos). After several months of operation, MSP ceased operation of the PittBoss evaporators on 8/16/24 due to low efficiency.

Photos 3&4: Location and close-up of PittBoss Sprayer-less Evaporators installed in the Alpha East Pond.

The CEC instructed MSP to monitor the effects that the evaporators have on birds. To date, birds have not been observed interacting with them and since the completion of netting over the ponds, this is no longer a concern.
