<b>Docket Number:</b>	09-AFC-07C			
Project Title:	Palen Solar Power Project - Compliance			
TN #:	200177			
<b>Document Title:</b>	Applicant Response to CEC Data Request 57- Part 5.3			
<b>Description:</b>	N/A			
Filer:	Tiffani Winter			
Organization:	Galati Blek, LLP			
<b>Submitter Role:</b>	Applicant's Representative			
ubmission Date:	8/13/2013 11:07:01 AM			
Docketed Date:	8/13/2013

## HISTORIC RESOURCES INVENTORY

\*Resource Name or # Desert Center Army Air Base

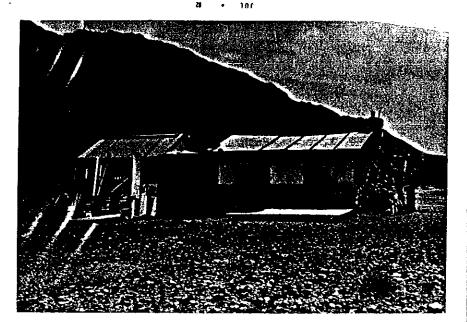
7b. Briefly describe the present physical description of the site or structure and describe any major alterations from its original condition: Structures on this property include a small cabin, a shed, the remains of a mill for ore processing, a water tank, a windmill, and a well.

The cabin is rectangular in plan with a gable roof, exposed rafters, a stone end chimney, a rock wall base with a wood frame structure and plywood siding over that, and mullioned casement and double-hung windows. A screened-in breezeway connects this cabin to a shed which has a corrugated sheet metal gable roof, plywood siding, and mullioned windows.

The mill site has wood foundations, ore chutes, and two-by-four buttress supports, and a large ore bin, all located on the side of an embankment next to the wash.

The water tank is about eight feet high, six feet in diameter, constructed of corrugated sheet metal.

The well is about four feet square, has a wooden platform next to it, and a metal frame, windmill tower, minus its propeller, over it, also located on the side of an embankment next to the wash.
