Docket Number:	06-AFC-09C
Project Title:	Colusa Generating Station - Compliance
TN #:	231056
Document Title:	Annual Compliance Report 2018
Description:	Annual compliance Report
Filer:	Anwar Ali
Organization:	PG&E
Submitter Role:	Applicant
Submission Date:	12/10/2019 12:58:48 PM
Docketed Date:	12/10/2019

**Subject: Colusa Generating Station (06-AFC-9)
Condition of Certification COM-7 (BIO-2; HAZ-1; Noise-8; Soil and Water 2, 7, 8, 9;
TLSN-3; VIS-1, 3; Waste-5 – Annual Operating Report**

Appendix A
Site Photo

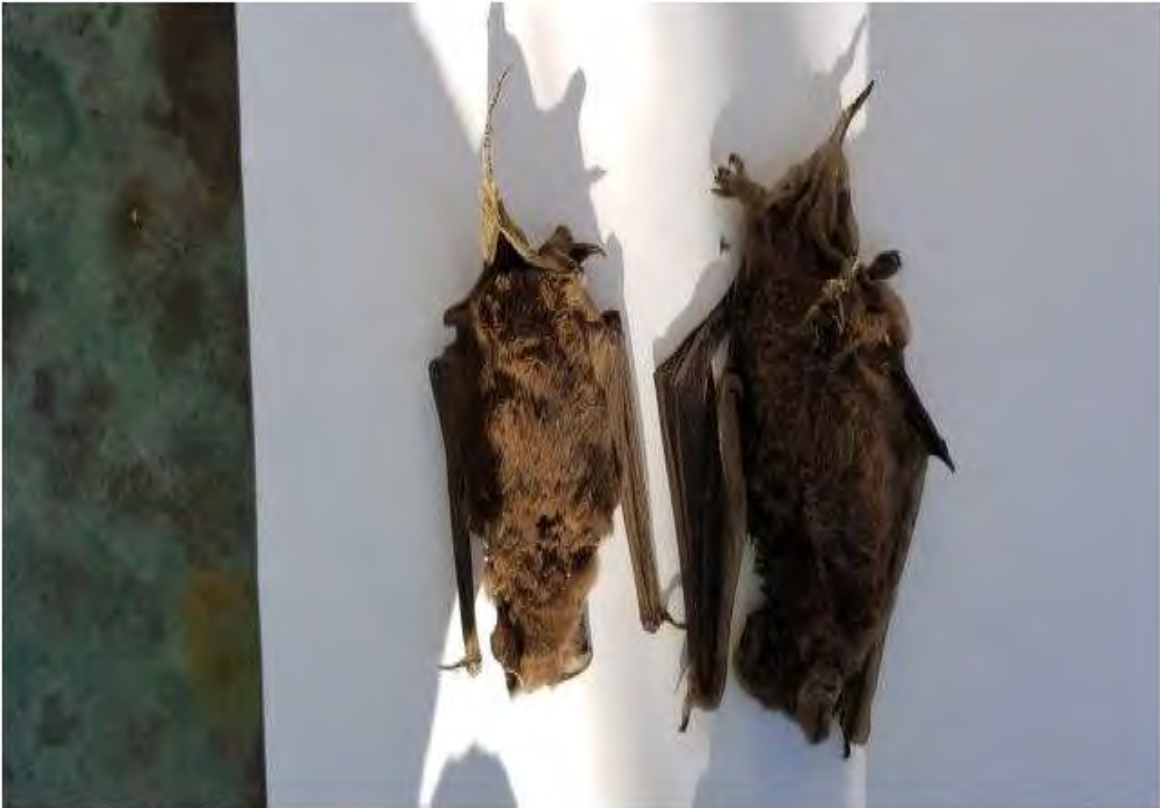
Photo 80, of 29 dead Myotis sp. bats observed under the ACC structure, 10/11/18.

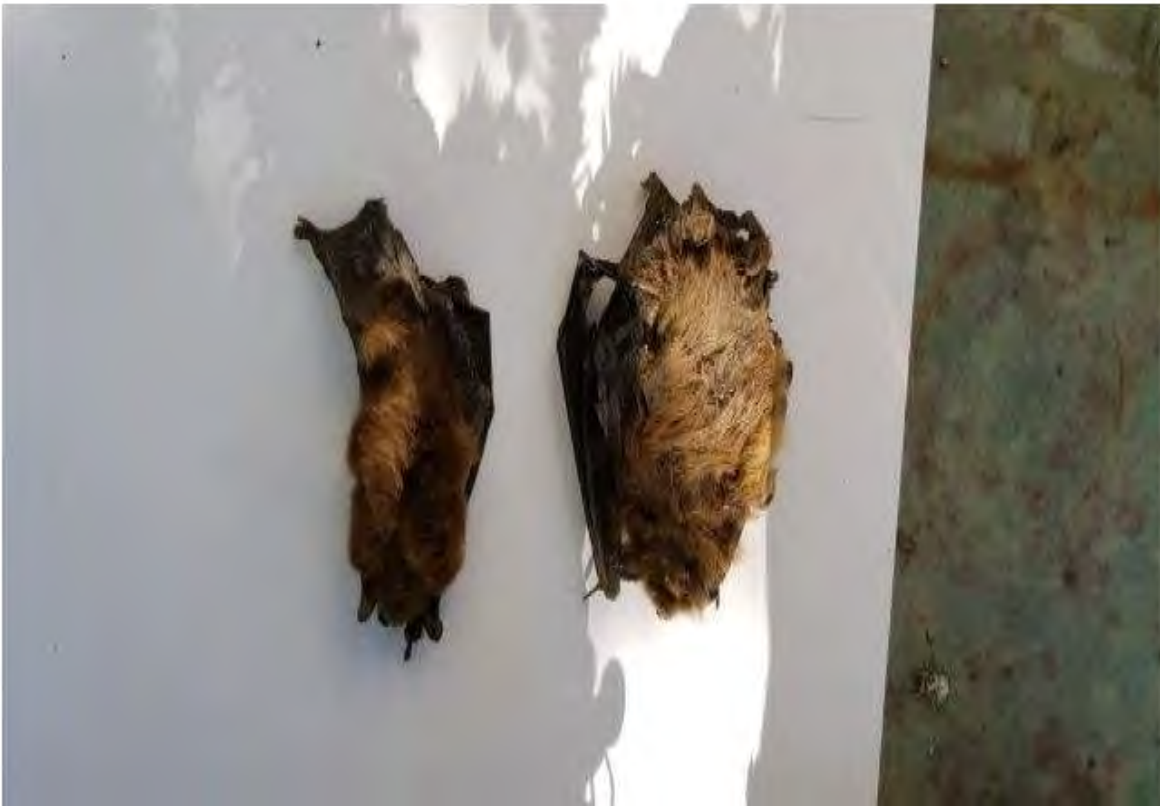
Photo 81, of 2 dead Mexican free-tail bats observed under the ACC structure, 10/11/18.

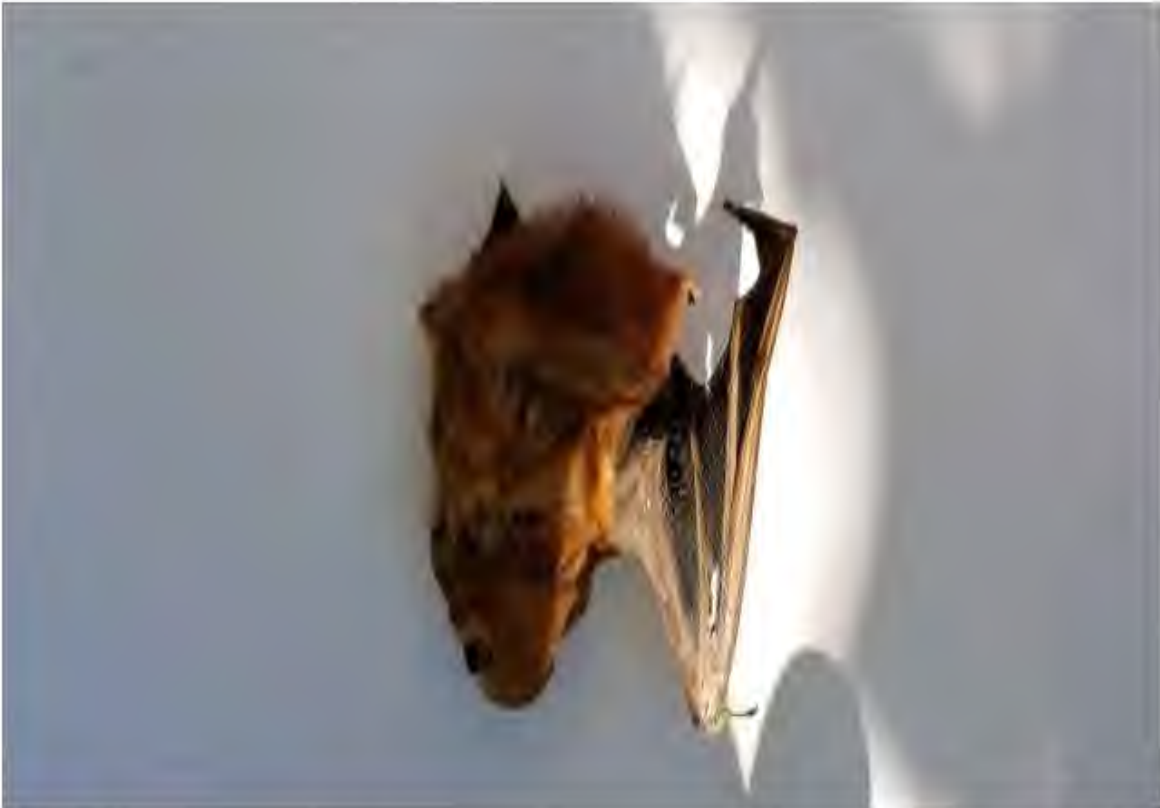
Photo 82, of 2 dead big brown bats observed under the ACC structure, 10/11/18.
