#### EL SEGUNDO ENERGY CENTER PROJECT, DOCKET NO. 00-AFC-14C, CONDITION OF CERTIFICATION COMPLIANCE-7, 2018 ANNUAL COMPLIANCE REPORT, DOCKET NO. 00-AFC-14C

#### RE: EL SEGUNDO ENERGY CENTER PROJECT, DOCKET NO. 00-AFC-14C, CONDITION OF CERTIFICATION COMPLIANCE-7, 2018 ANNUAL COMPLIANCE REPORT, DOCKET NO. 00-AFC-14C

Eighth Year Annual Report El Segundo Shoreline Monitoring Program At El Segundo, California

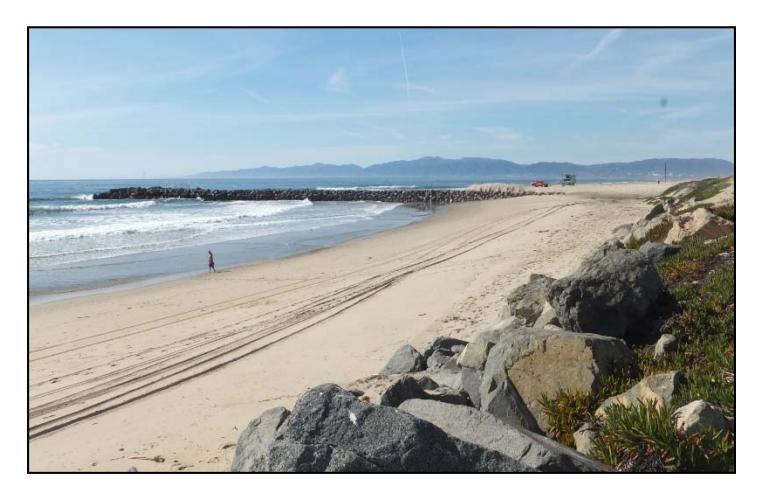
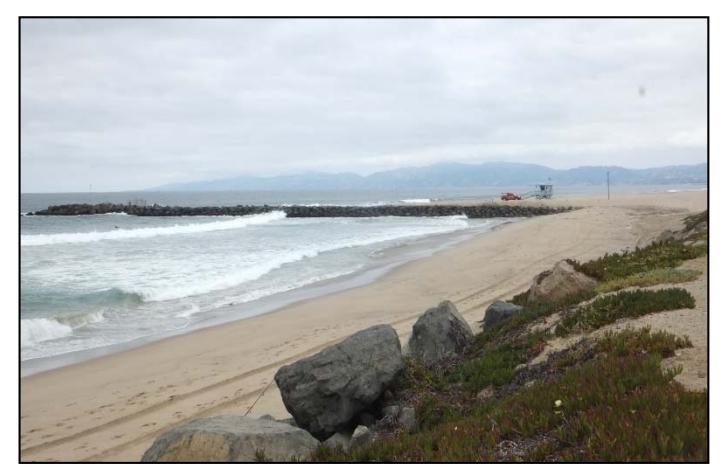
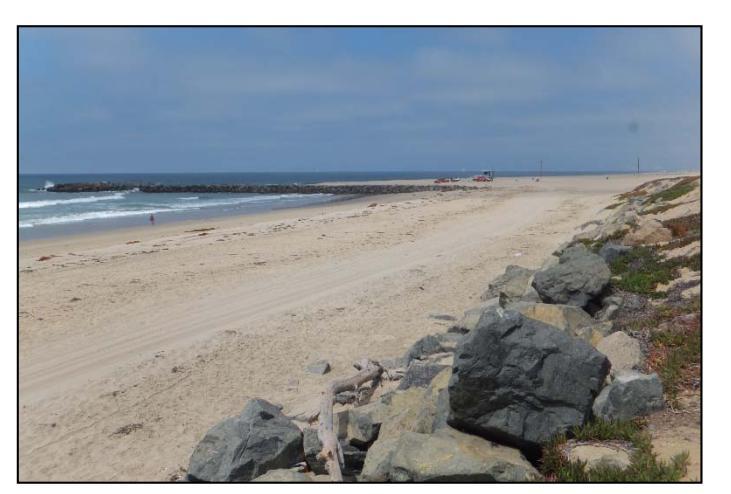
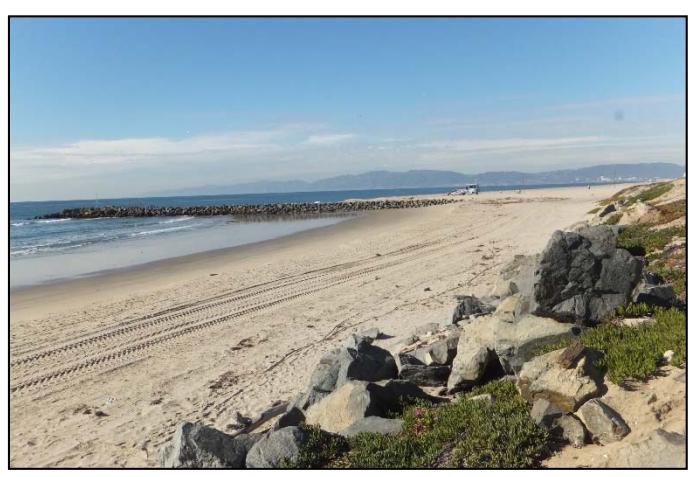
Ground Photos at Location A (Looking Upcoast)

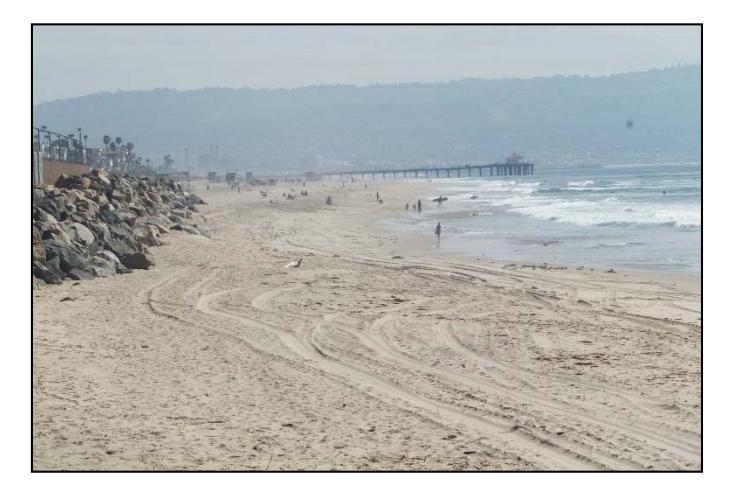
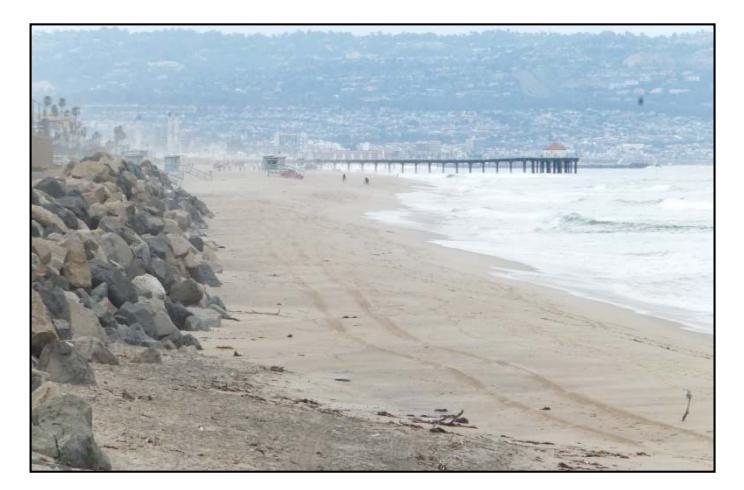
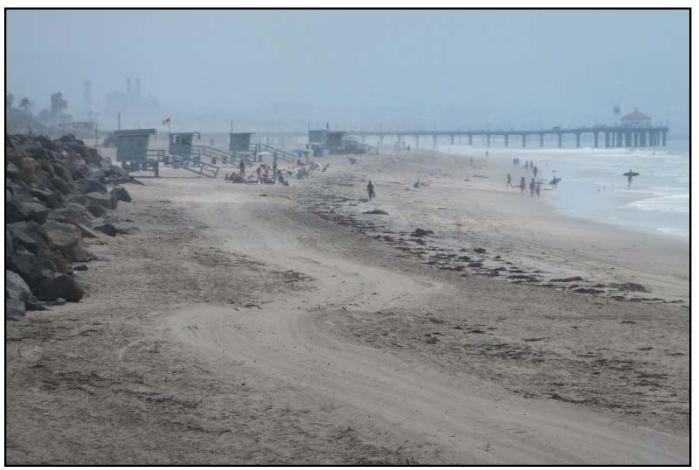
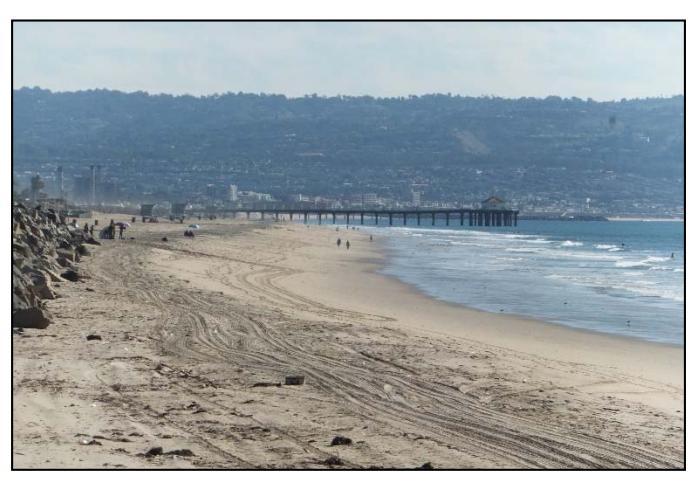
Ground Photos at Location A (Looking Downcoast)

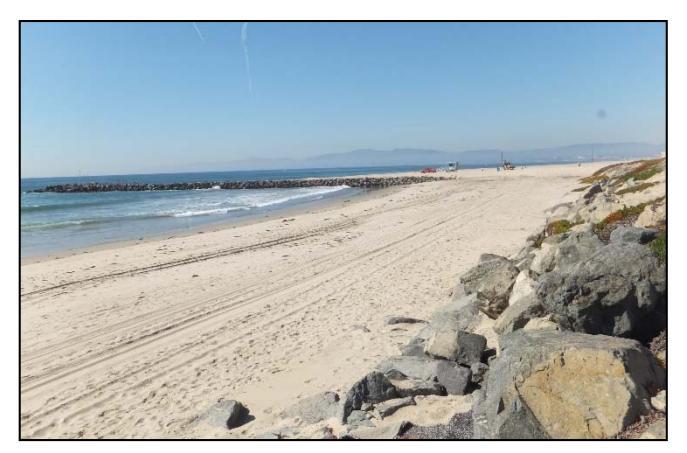
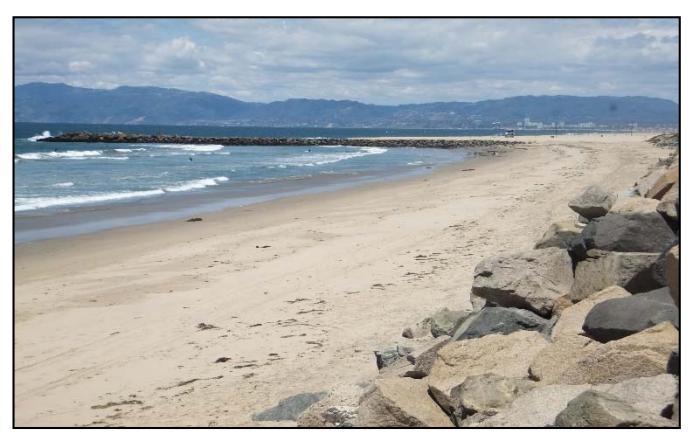
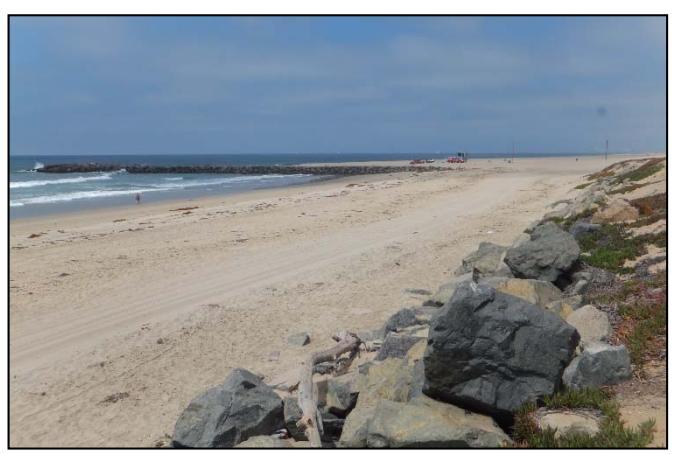
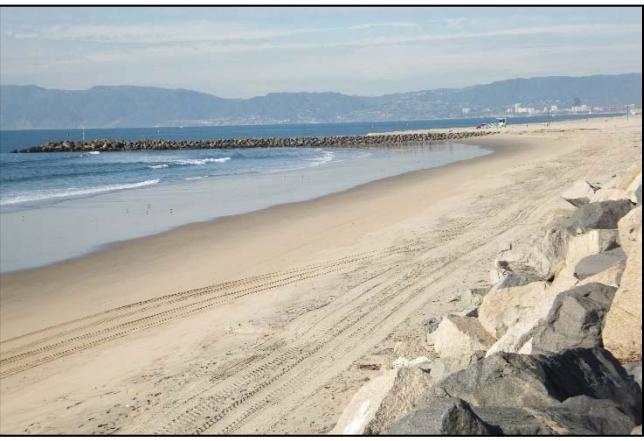
Ground Photos at Location B (Looking Upcoast)

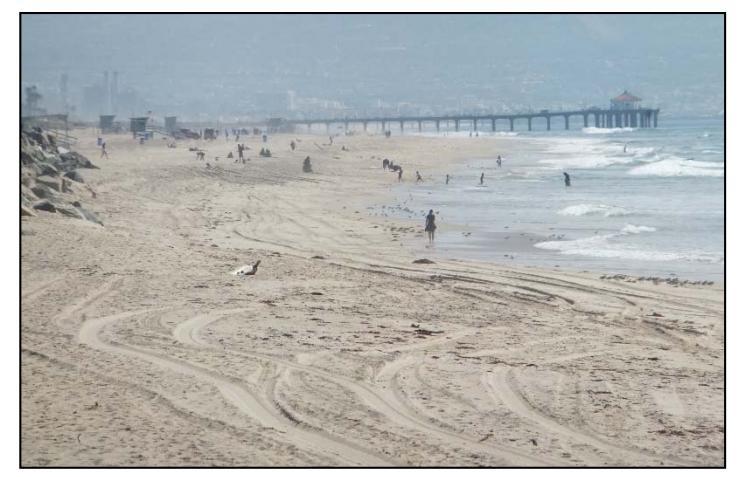
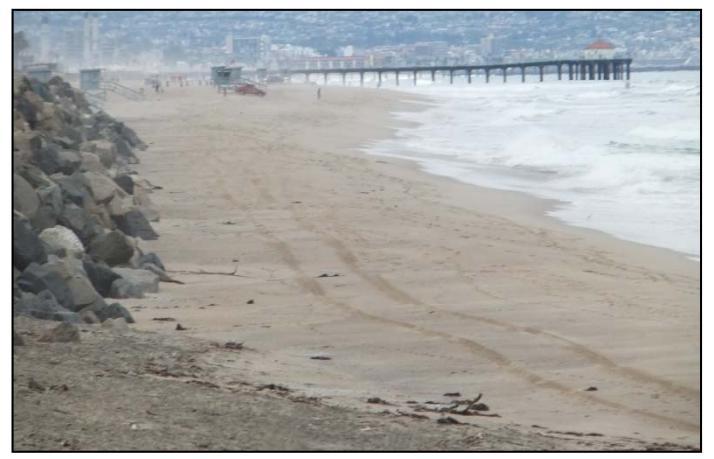
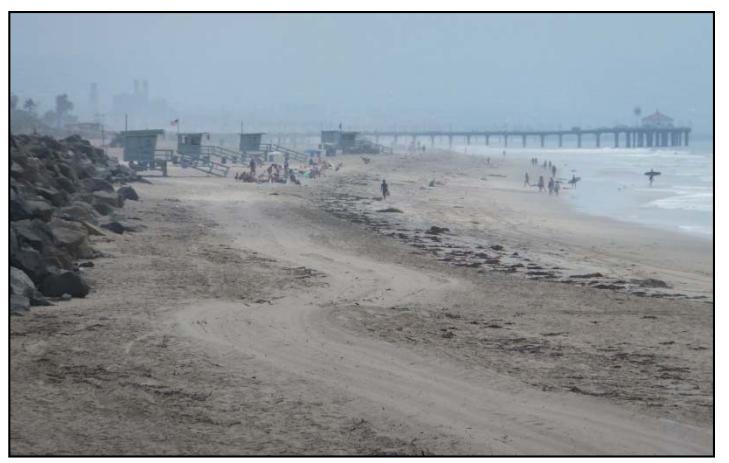
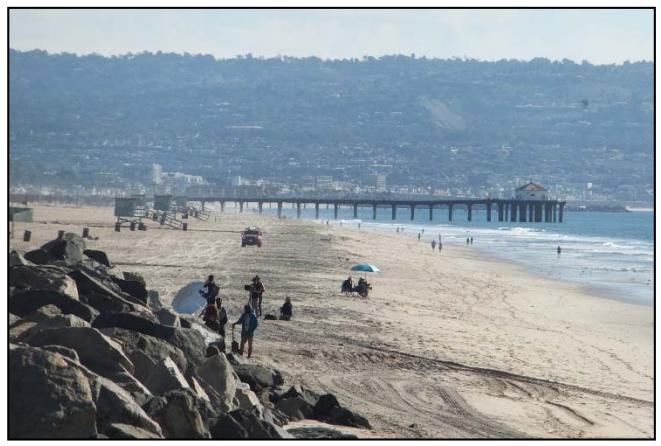
Ground Photos at Location B (Looking Downcoast)

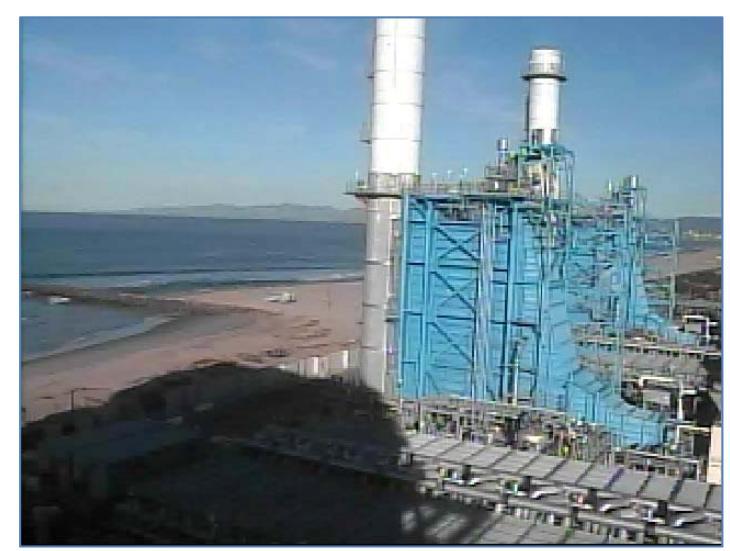
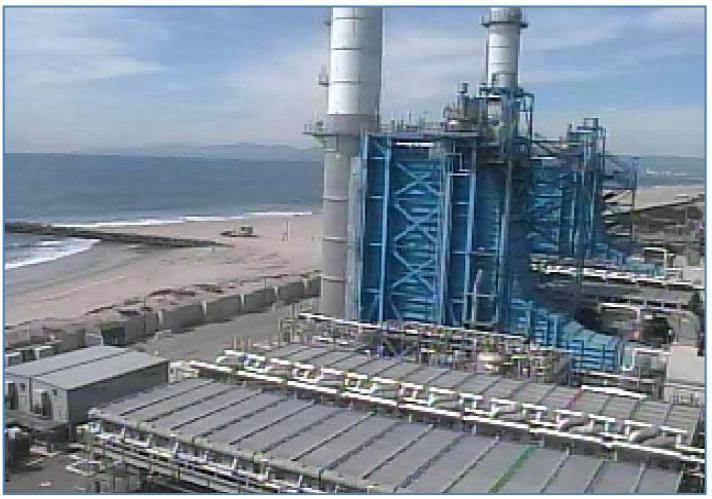
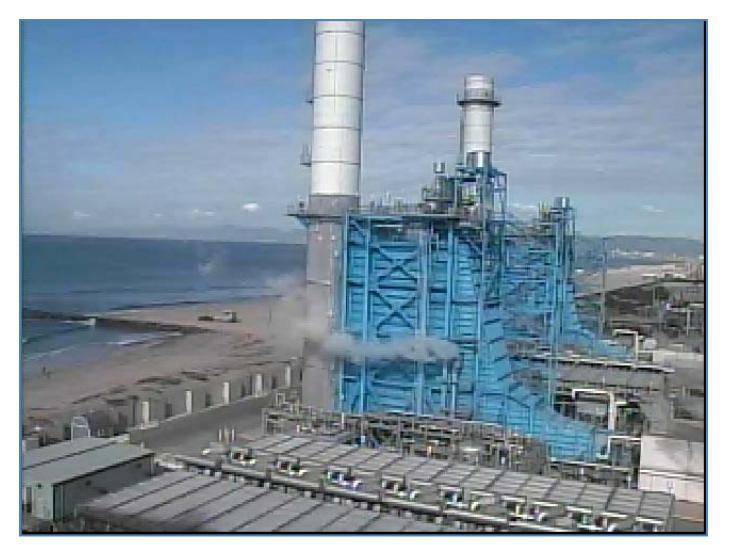
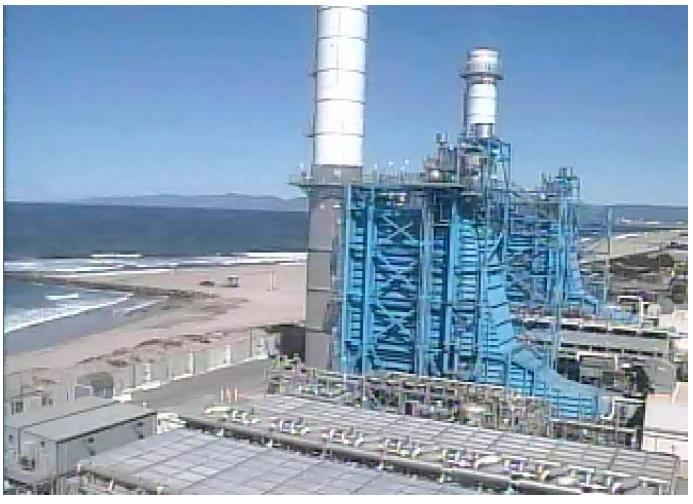
El Segundo Beach Conditions (Looking Upcoast)

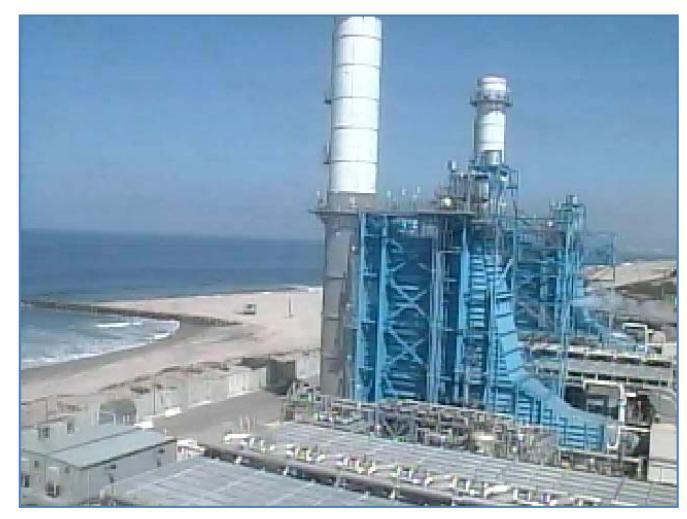
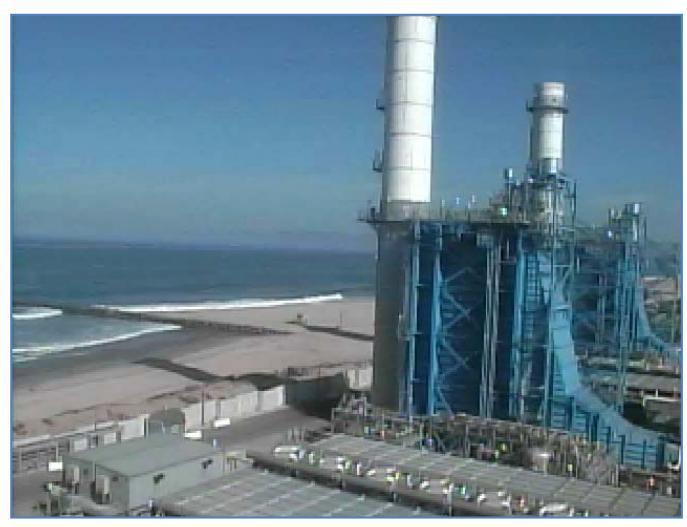
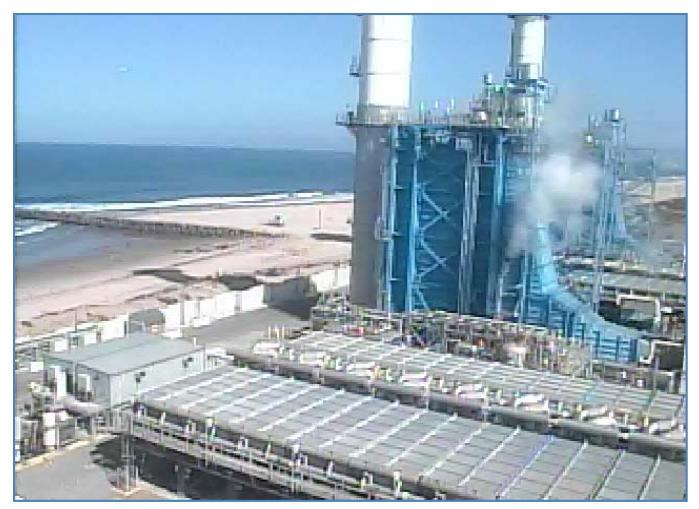
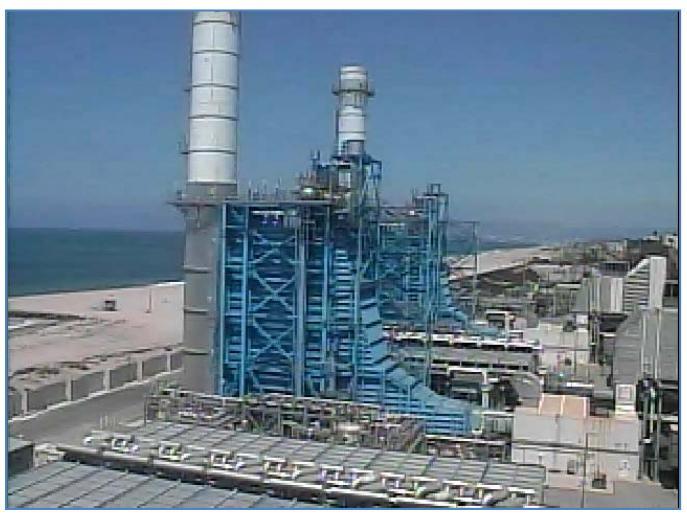
El Segundo Beach Conditions (Looking Upcoast)
