<b>DOCKETED</b>	
<b>Docket Number:</b>	87-AFC-01C
<b>Project Title:</b>	COMPLIANCE-Luz Solar Electric Generating System Cogeneration AFC (150 MW) Units III-VII.
<b>TN #:</b>	241138
<b>Document Title:</b>	Petition to Amend Boundary Change Appendix B Part I - SEGS III-VII
<b>Description:</b>	N/A
<b>Filer:</b>	Scott Galati
<b>Organization:</b>	DayZenLLC
<b>Submitter Role:</b>	Applicant Representative
<b>Submission Date:</b>	1/11/2022 2:18:22 AM
<b>Docketed Date:</b>	1/11/2022

## **APPENDIX B**

Monthly Compliance Reports and Biological Memorandum

Subject: SEGS III-VII Decommissioning (87-AFC-01C) Monthly Compliance Report for June 2021

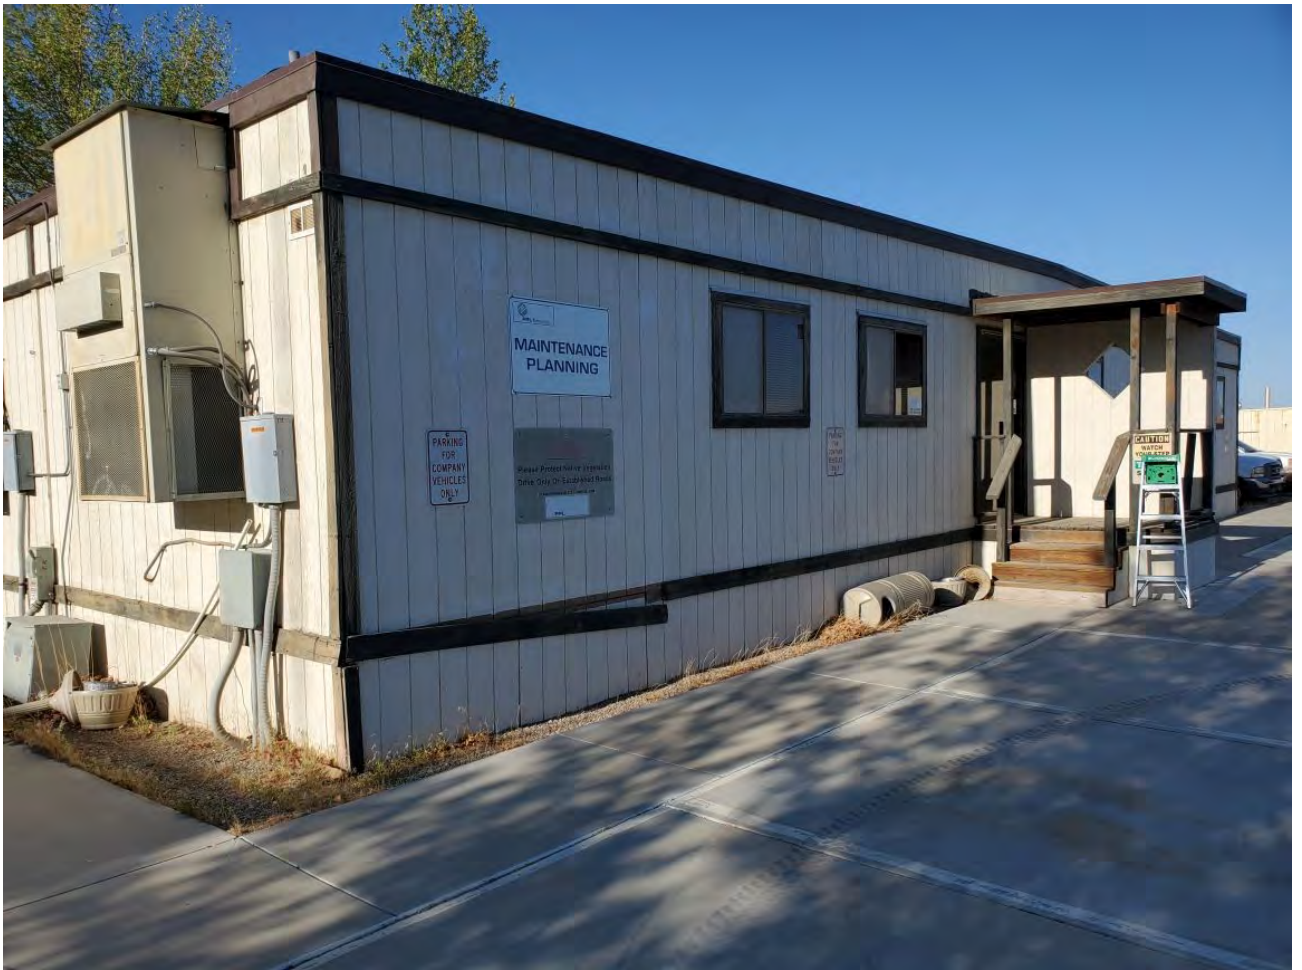
Photo 1: The Maintenance Planning trailer

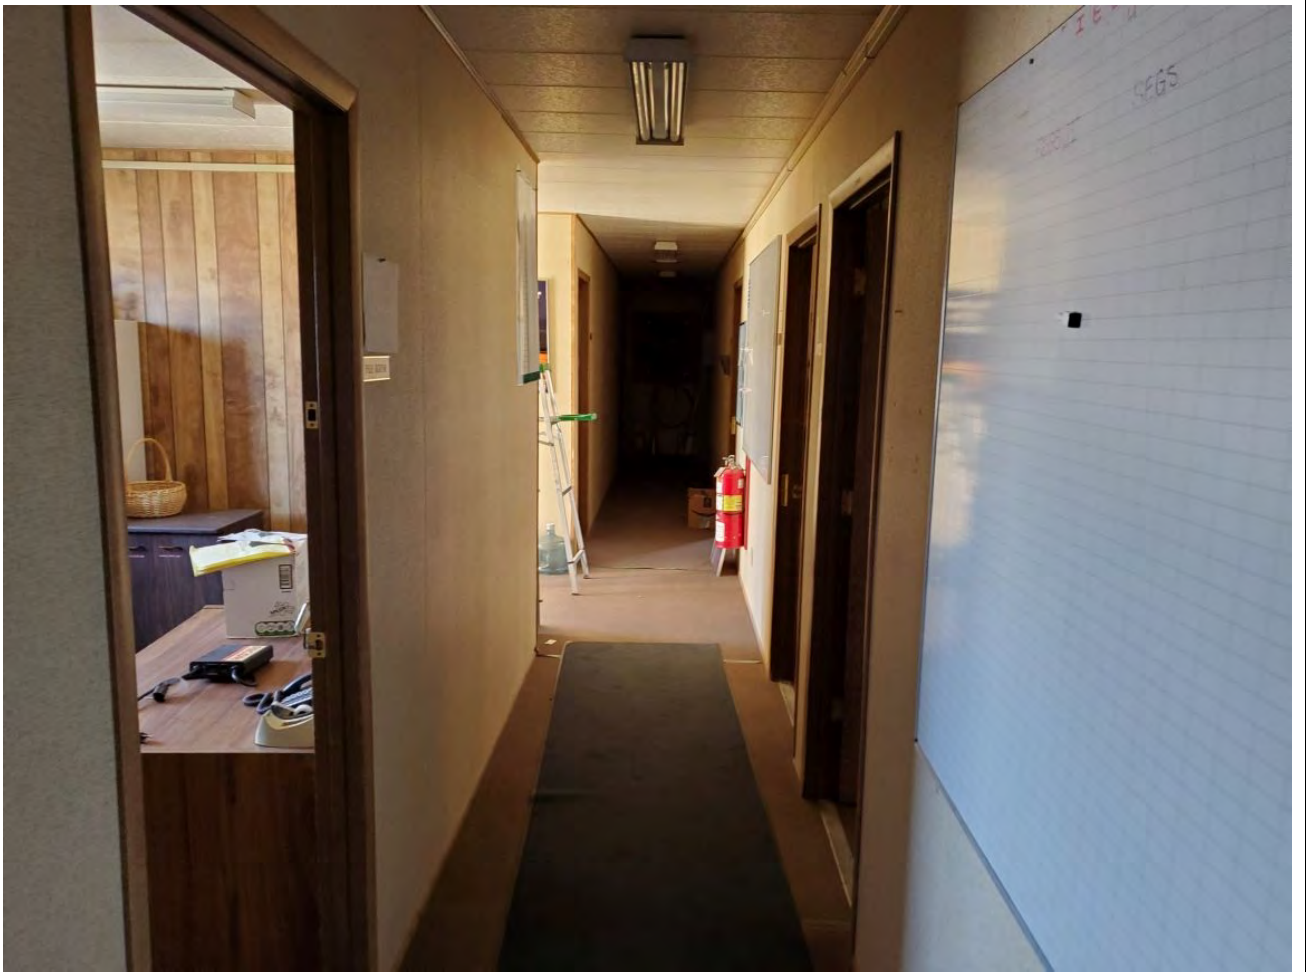
Photo 2: Inside the Maintenance Planning trailer

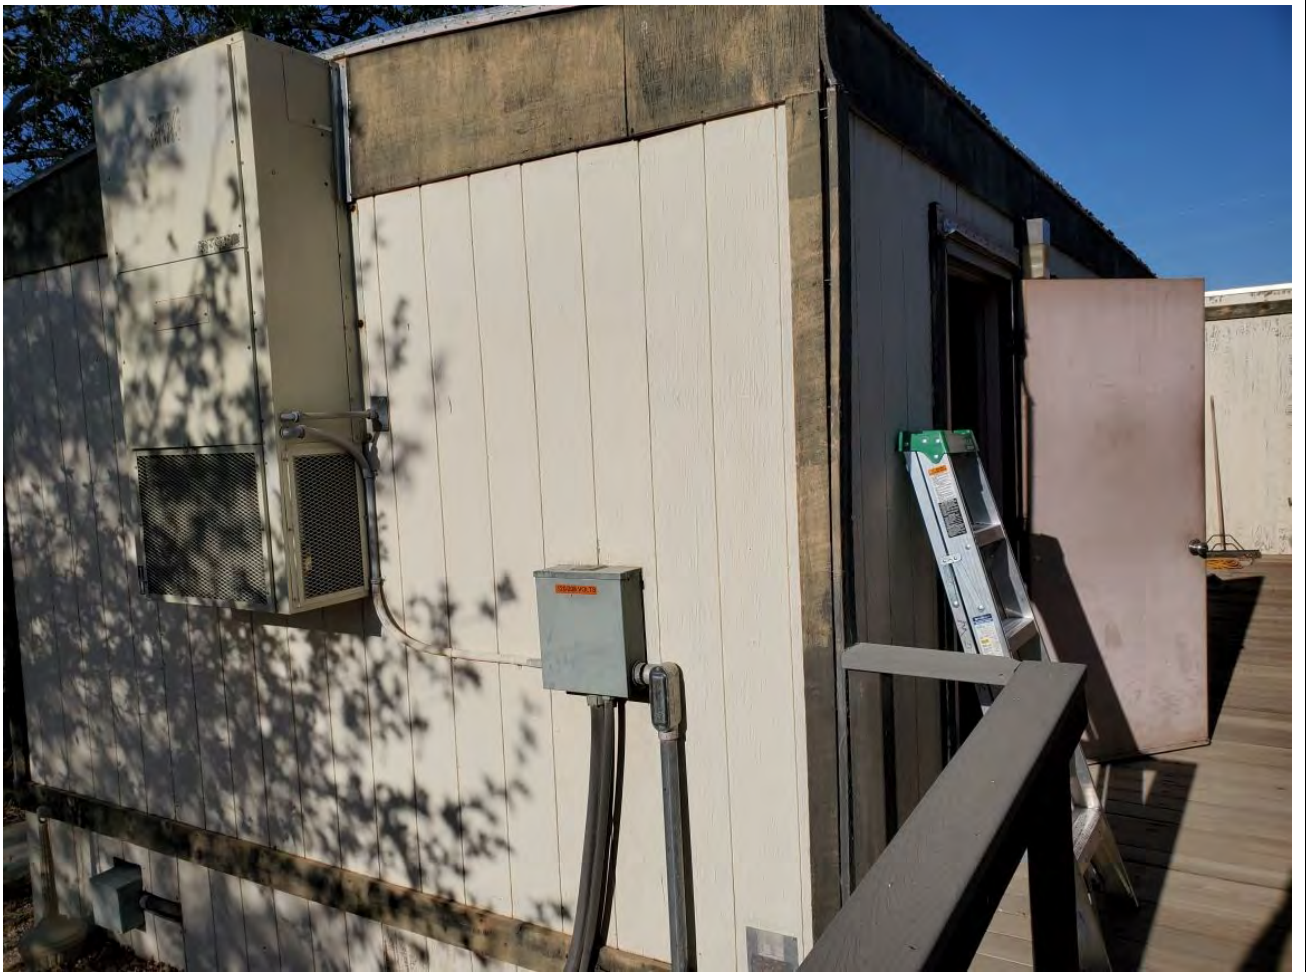
Photo 3: The Training Room trailer

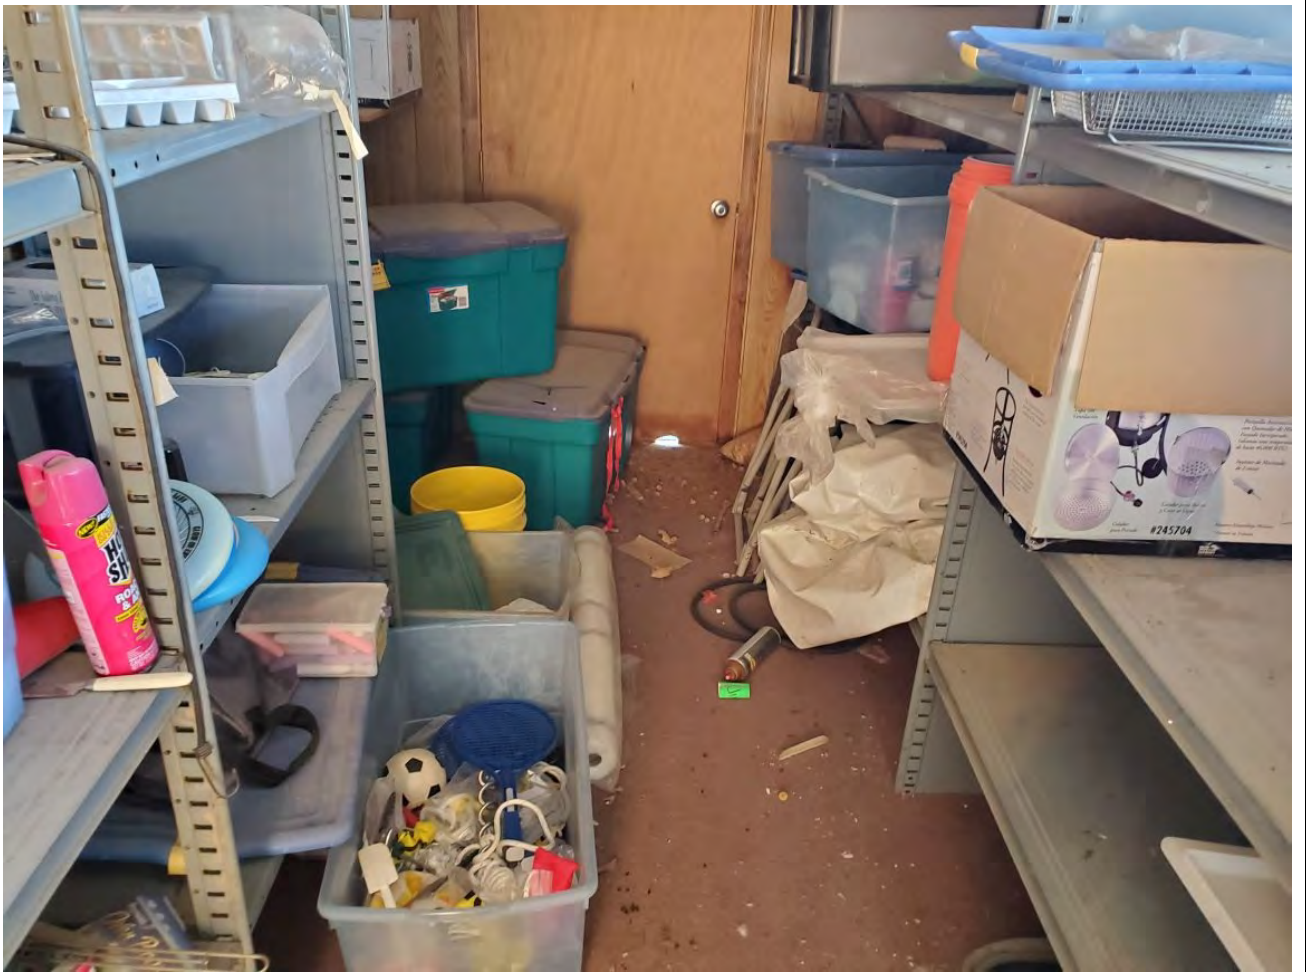
Photo 4: Inside the Trailing Room trailer

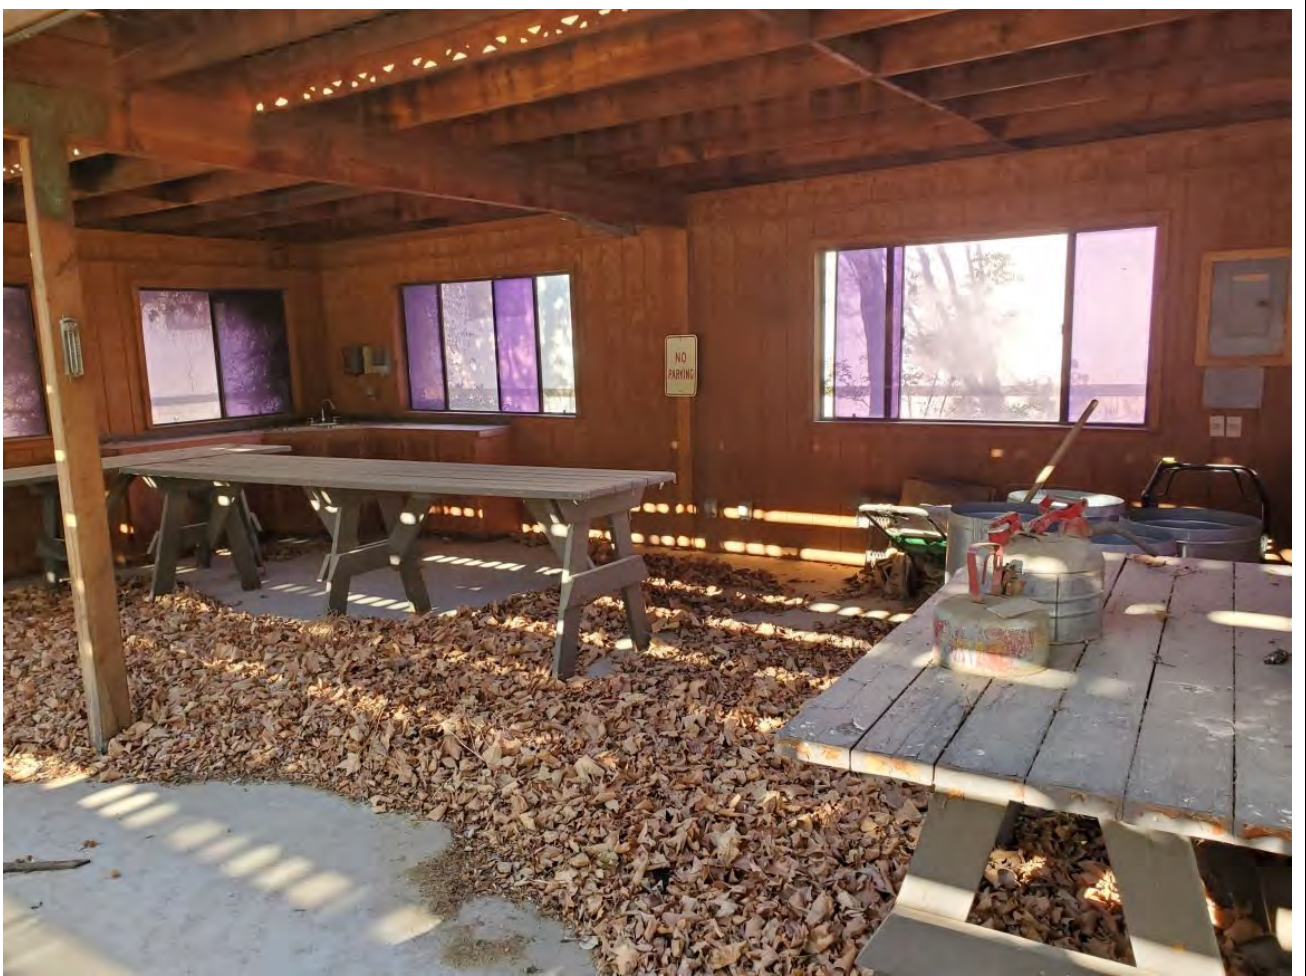
Photo 5: The lunch area

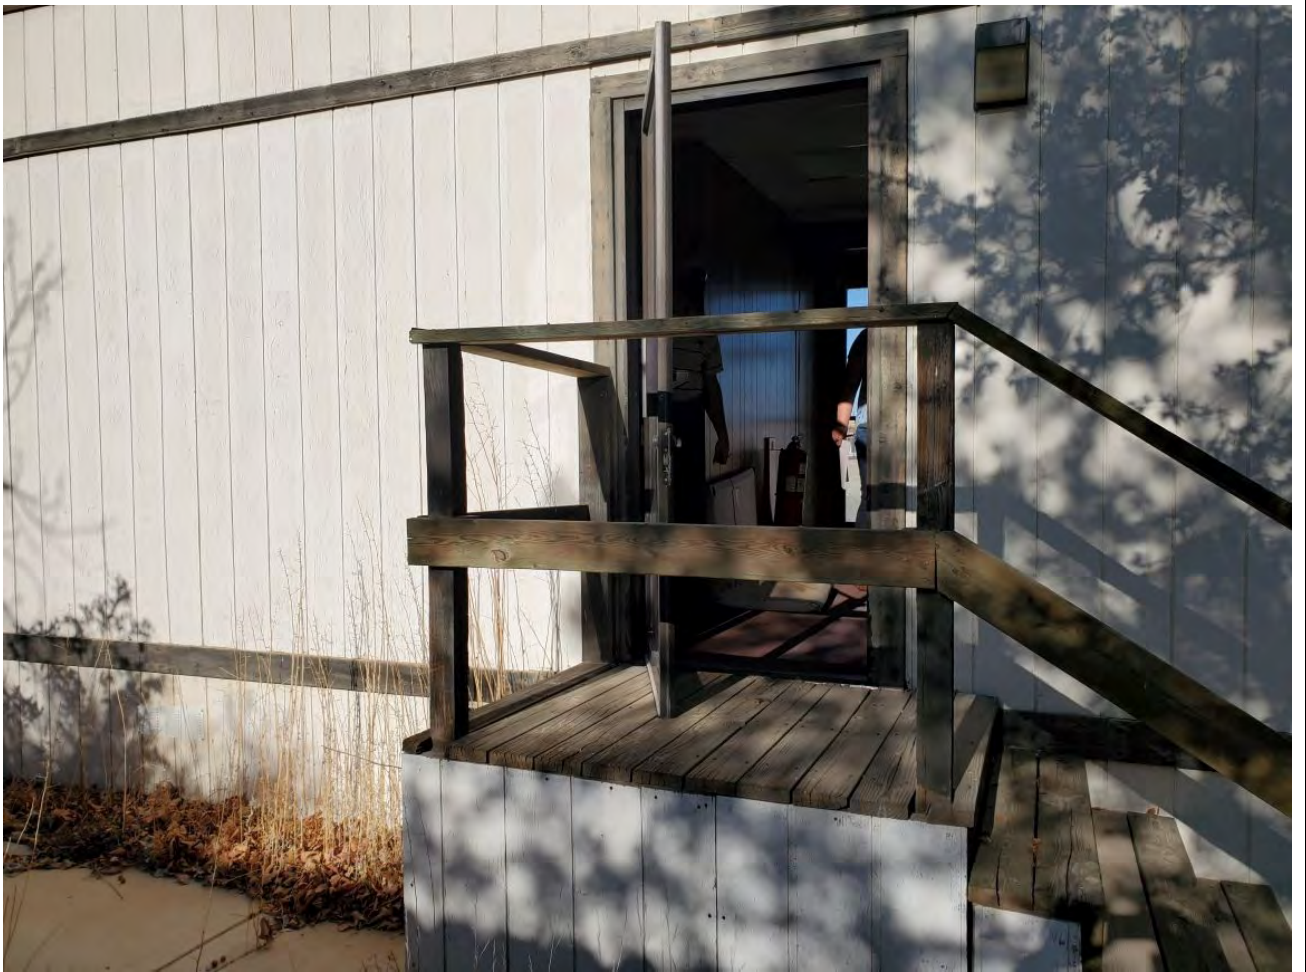
Photo 6: The Documentation trailer

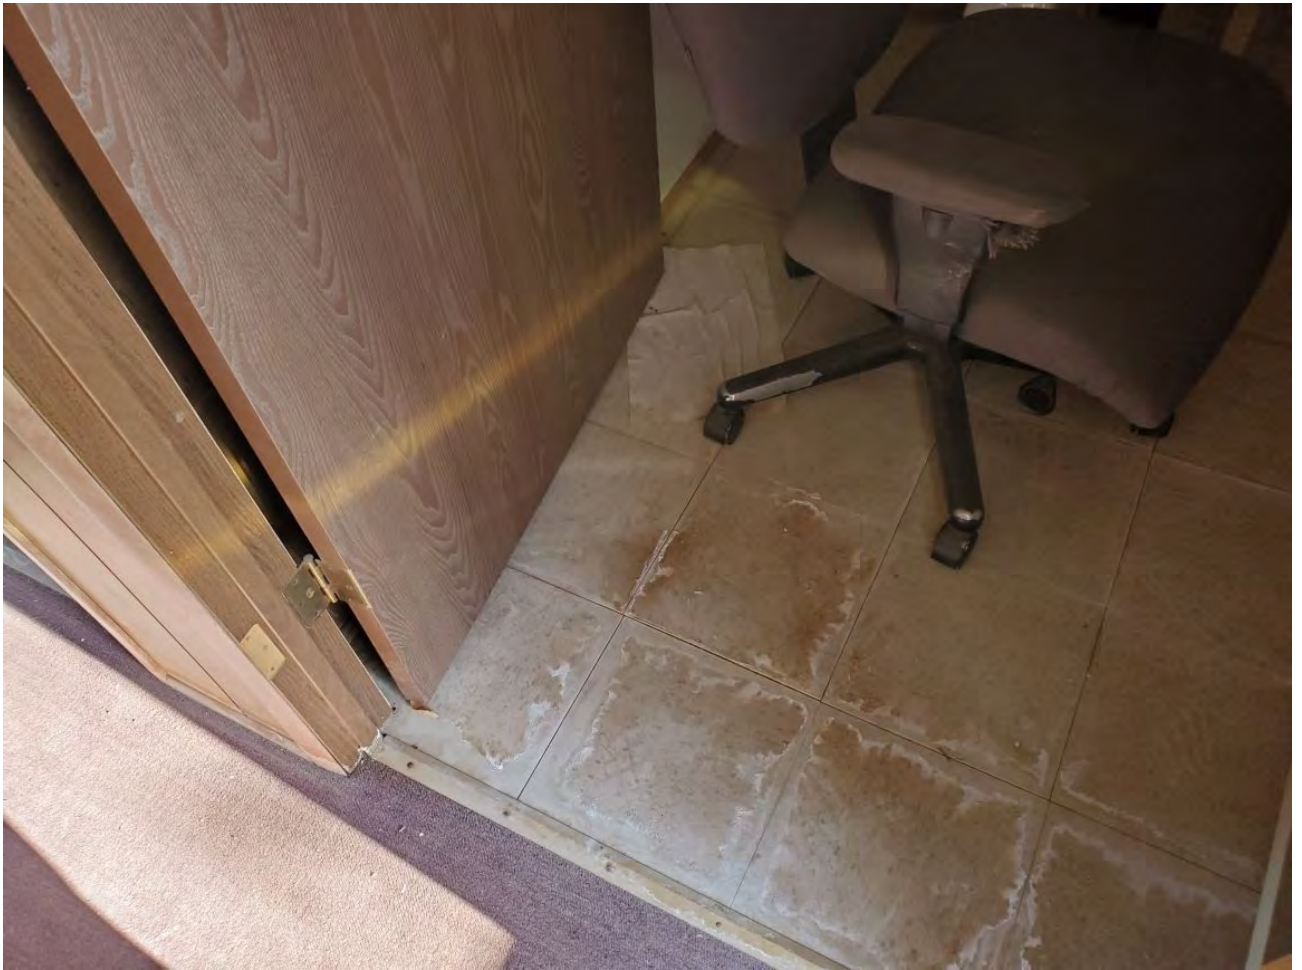
Photo 7: The 12 x 12 vinyl floor tile in the Documentation trailer

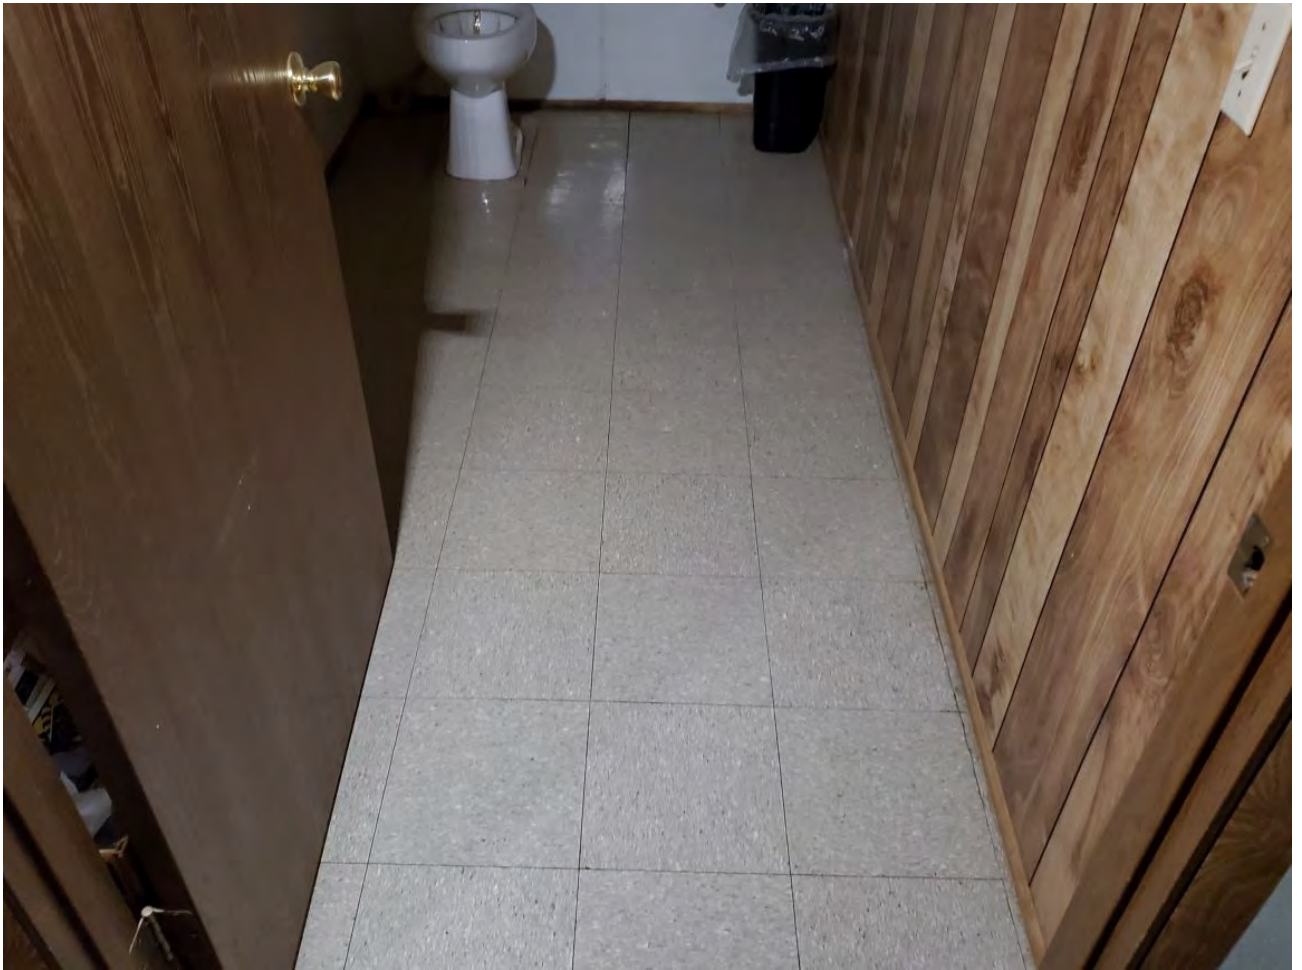
Photo 8: The 12 x 12 vinyl floor tile in the Technical Services trailer

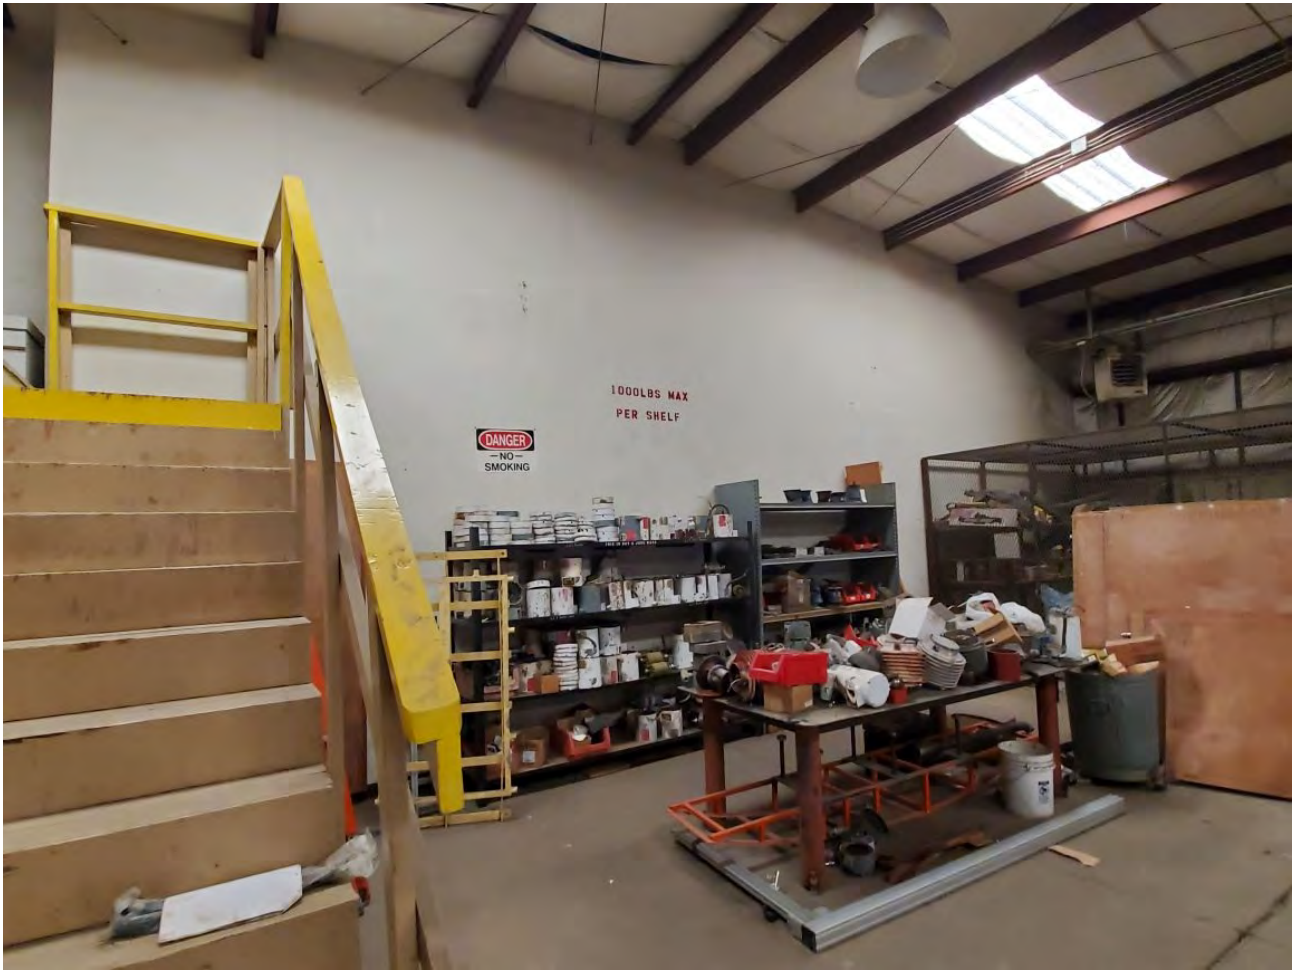
Photo 11: Inside the Maintenance and Auto Shop

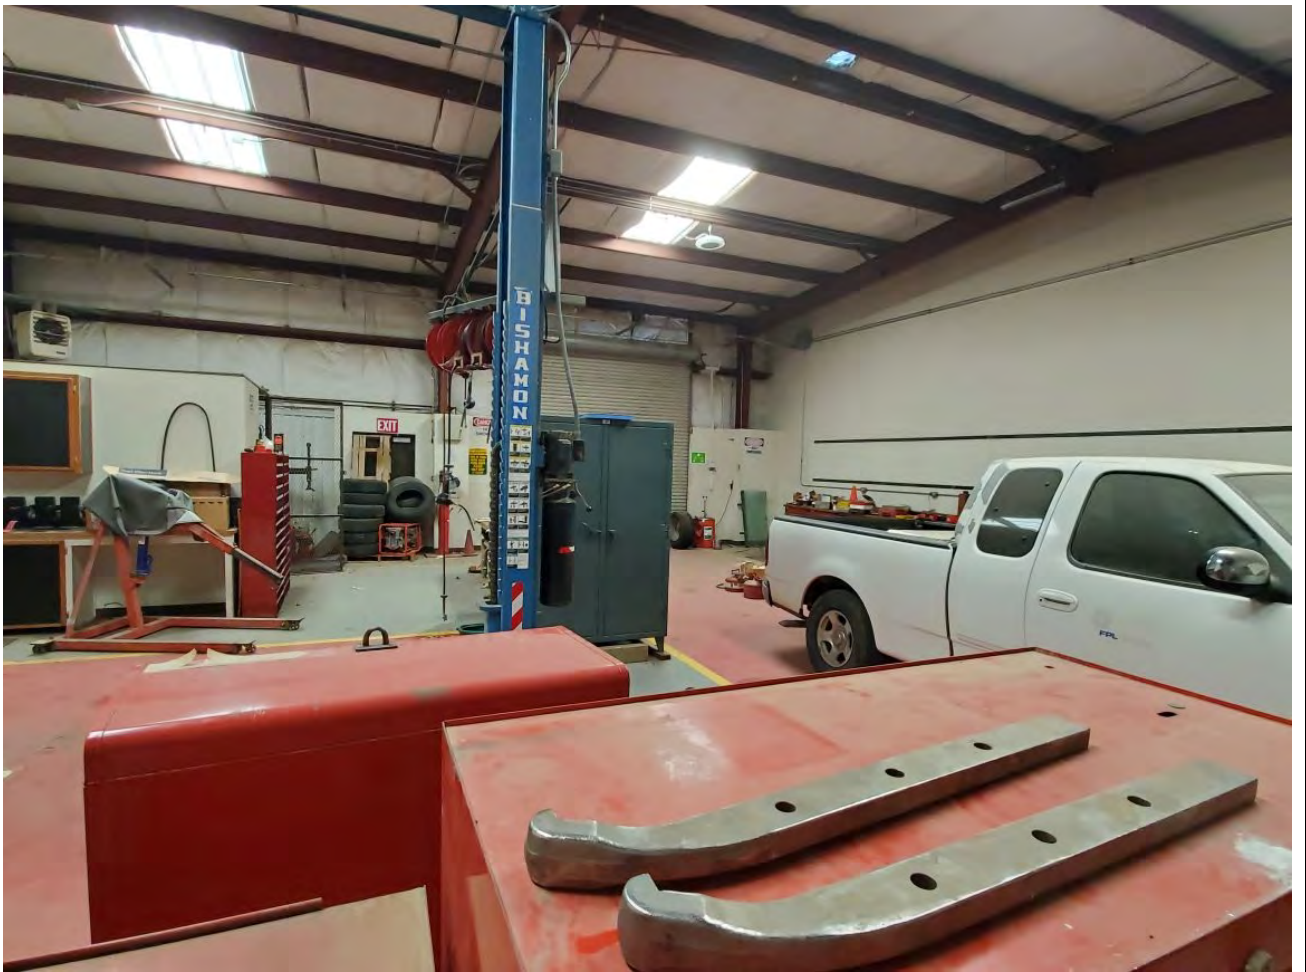
Photo 12: The Auto Shop area

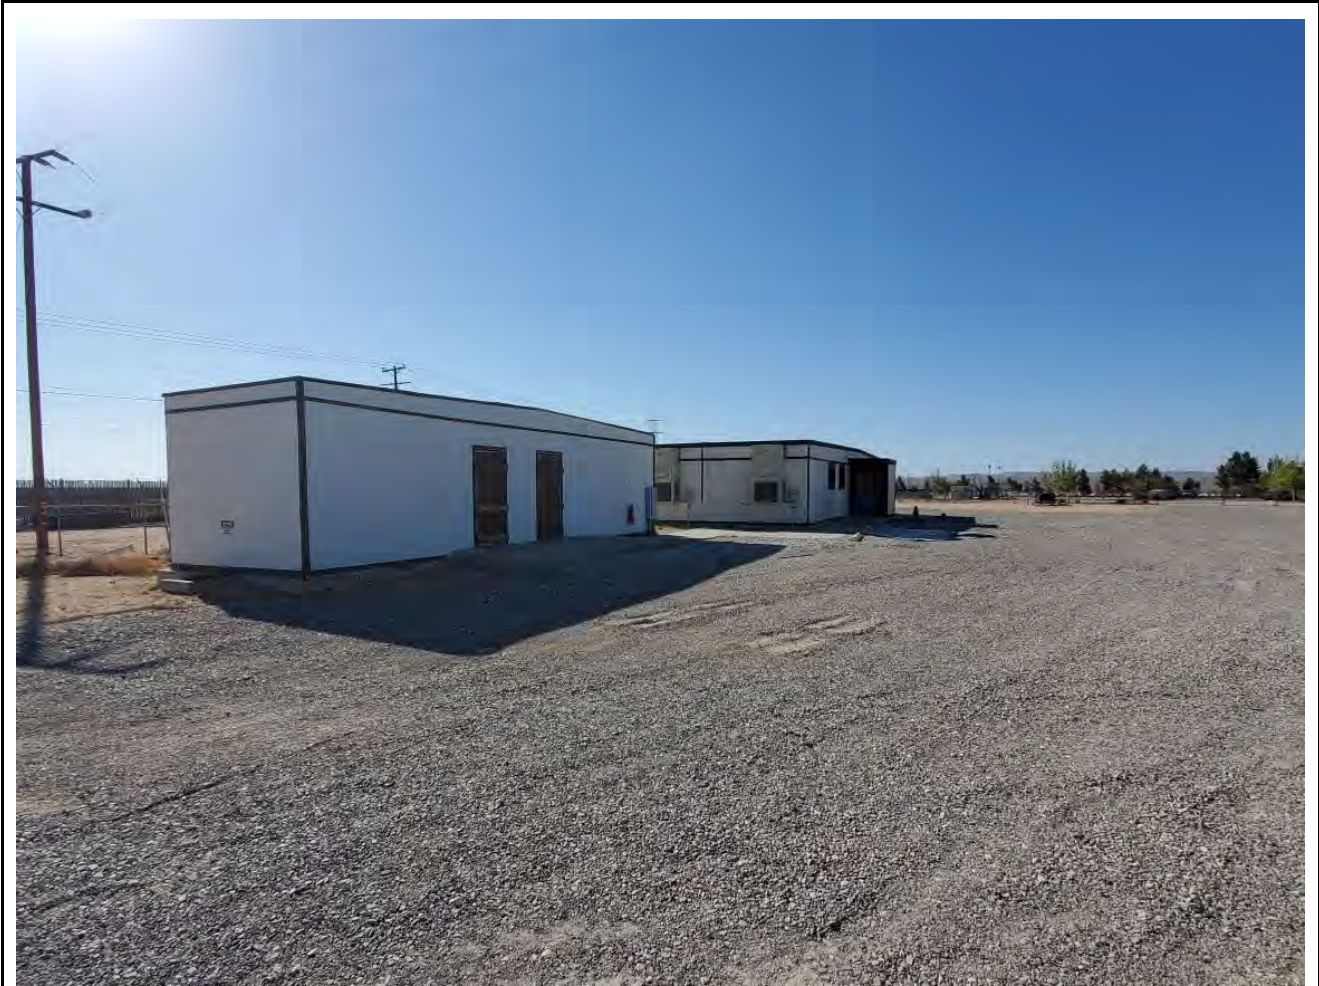
Photo 13: The abandoned restroom building (nearest) and the SF Office

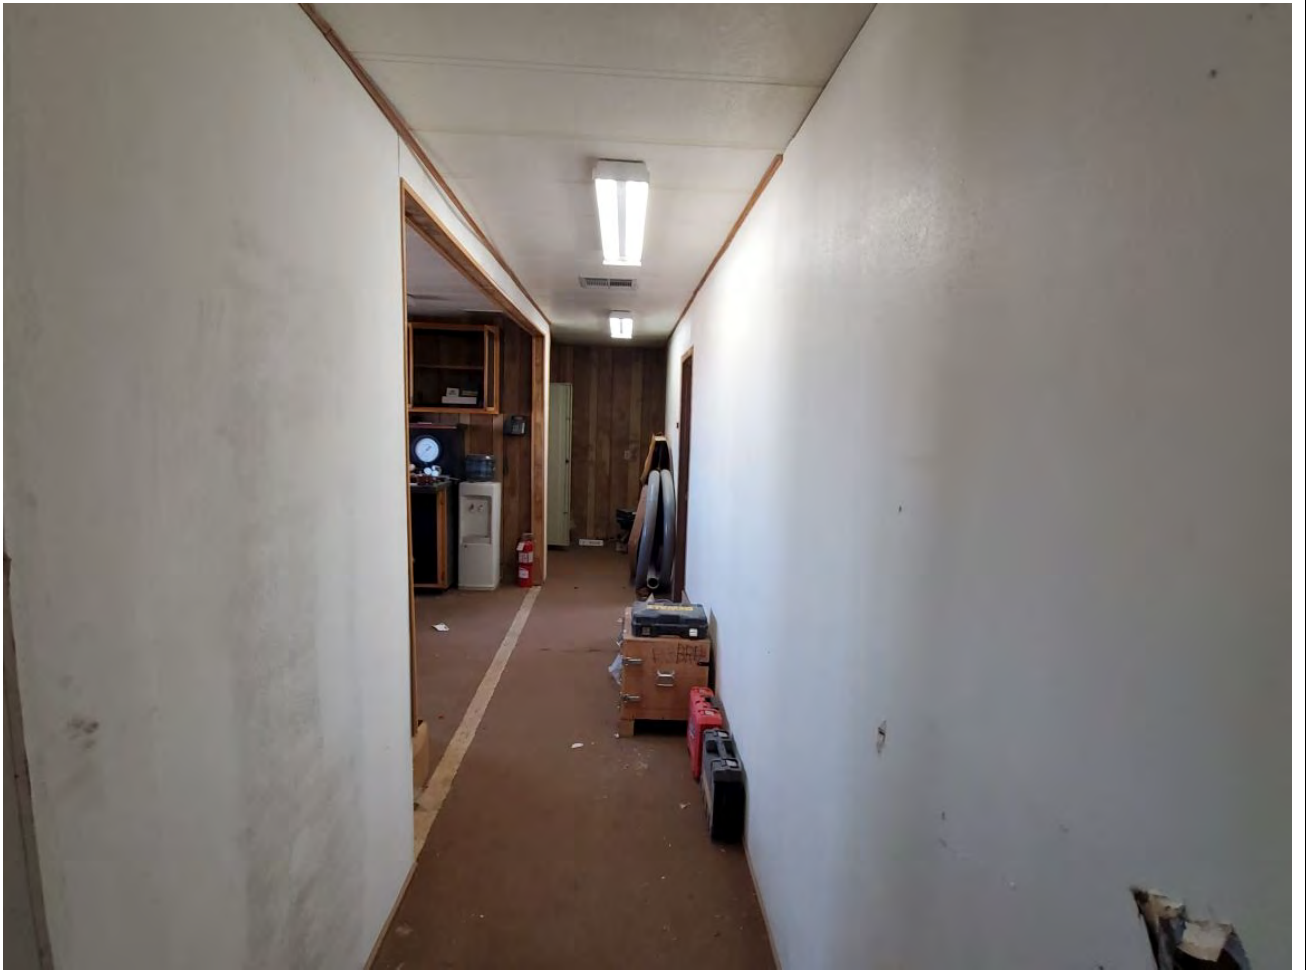
Photo 14: Inside the SF Office

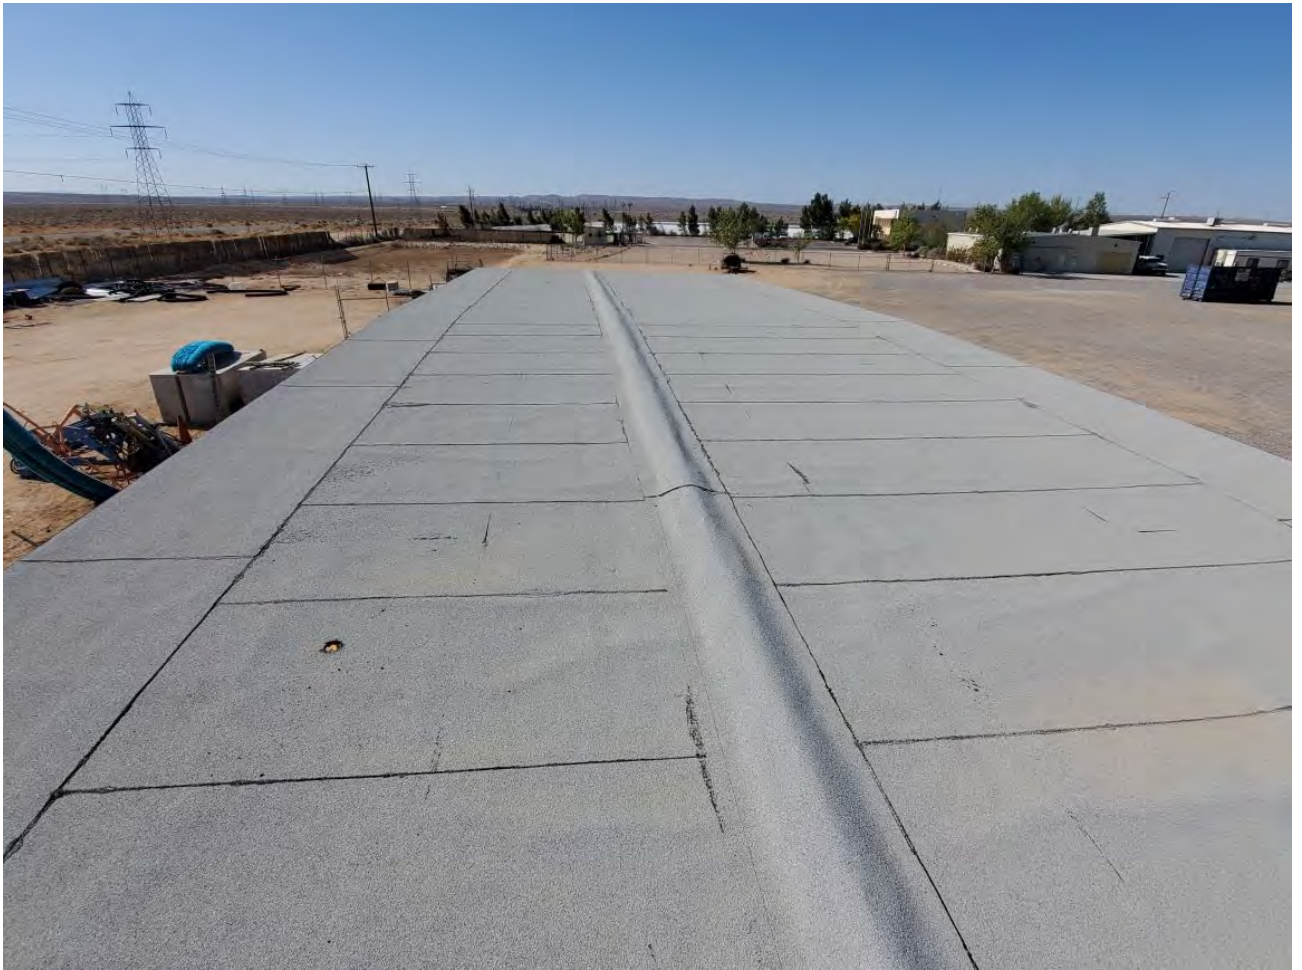
Photo 15: The roof of the SF Office

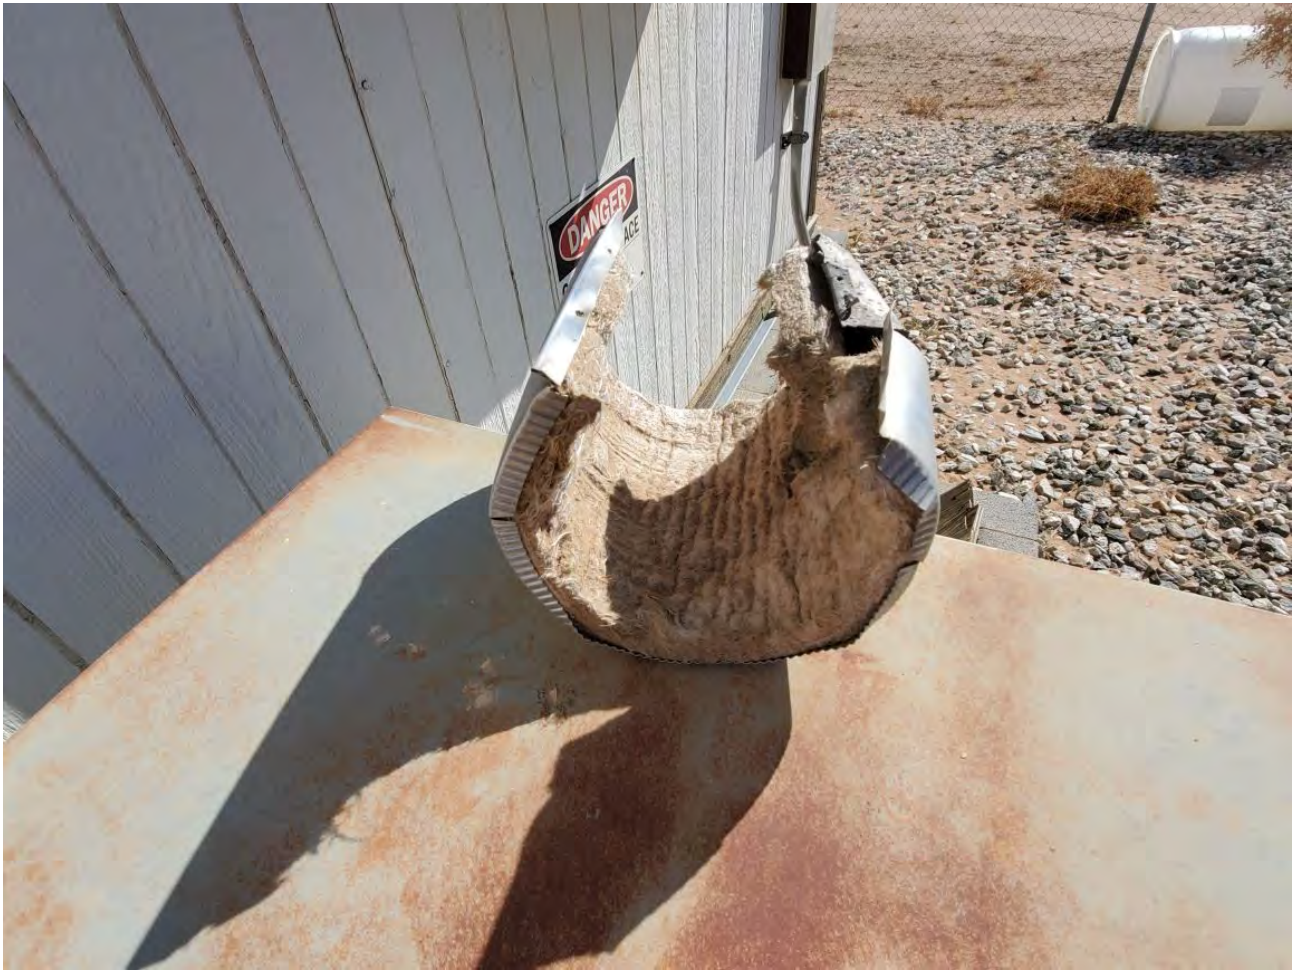
Photo 16: A typical fiberglass insulation coupling cover

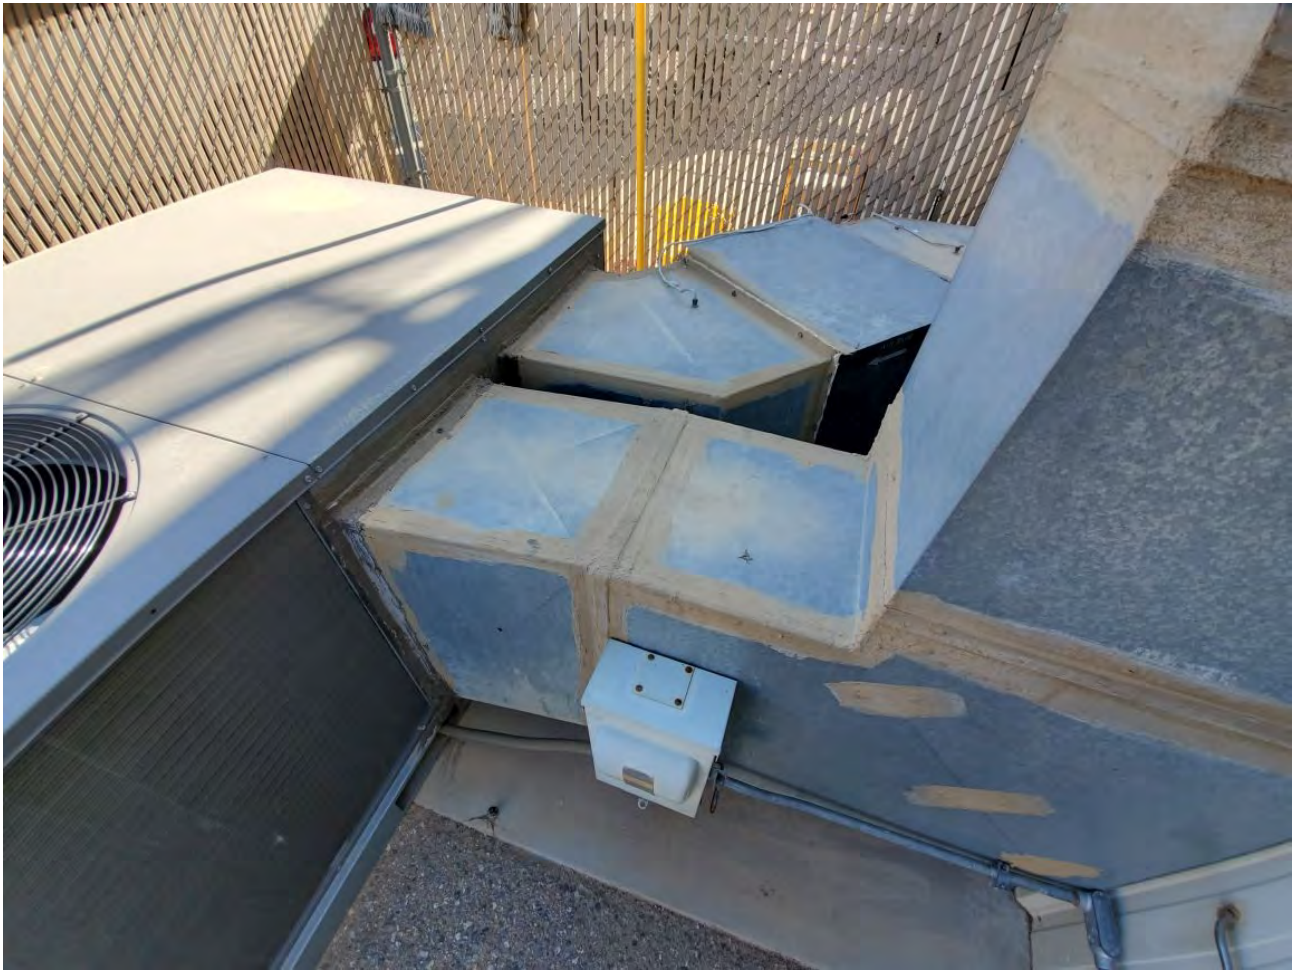
Photo 17:HVAC duct seam caulk at the SEGS III Control Room Building, non-suspect, sampled just to confirm

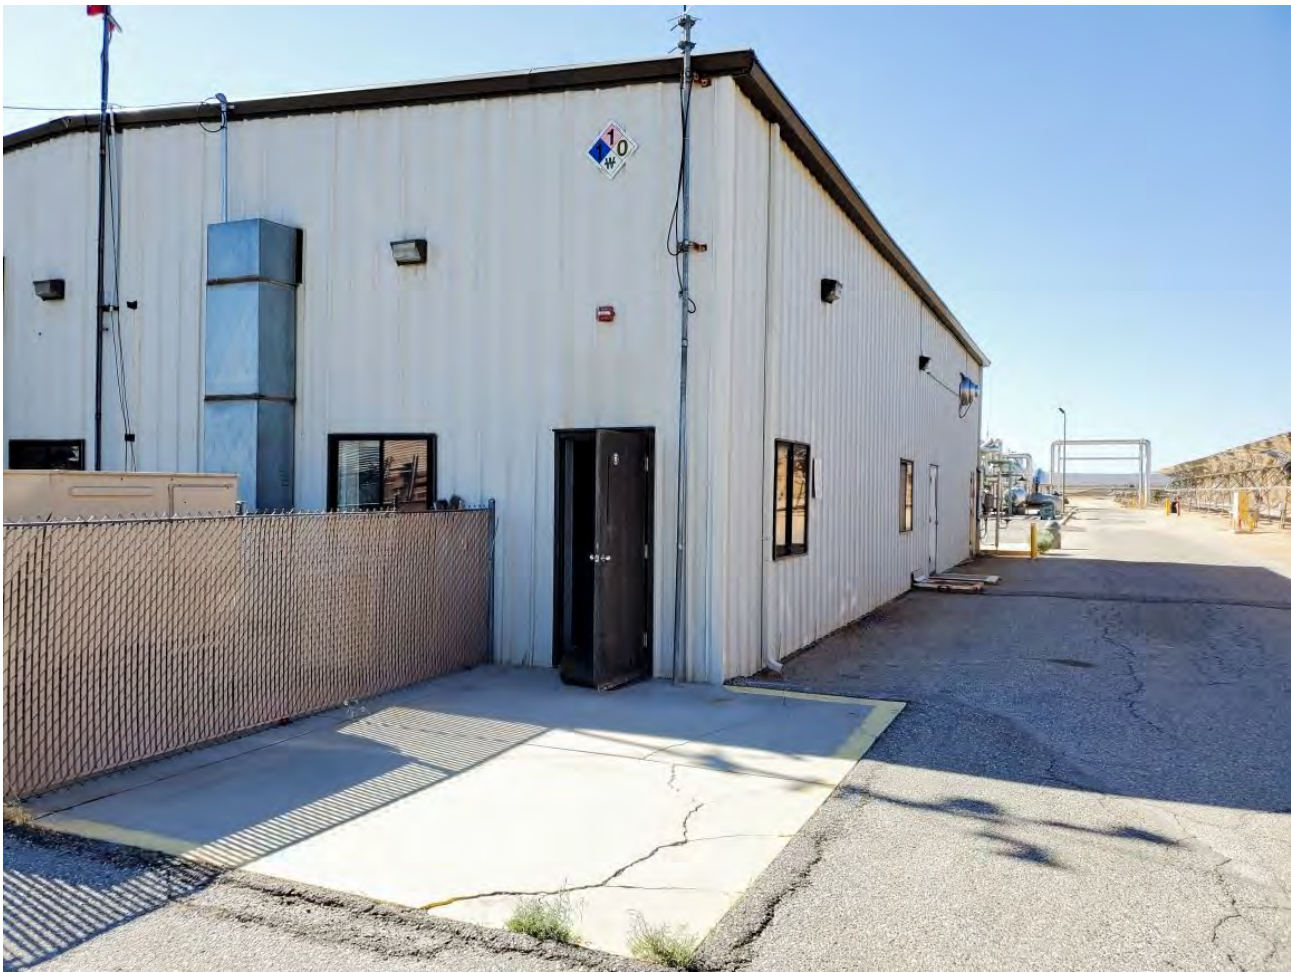
Photo 19: The SEGS III Control Room

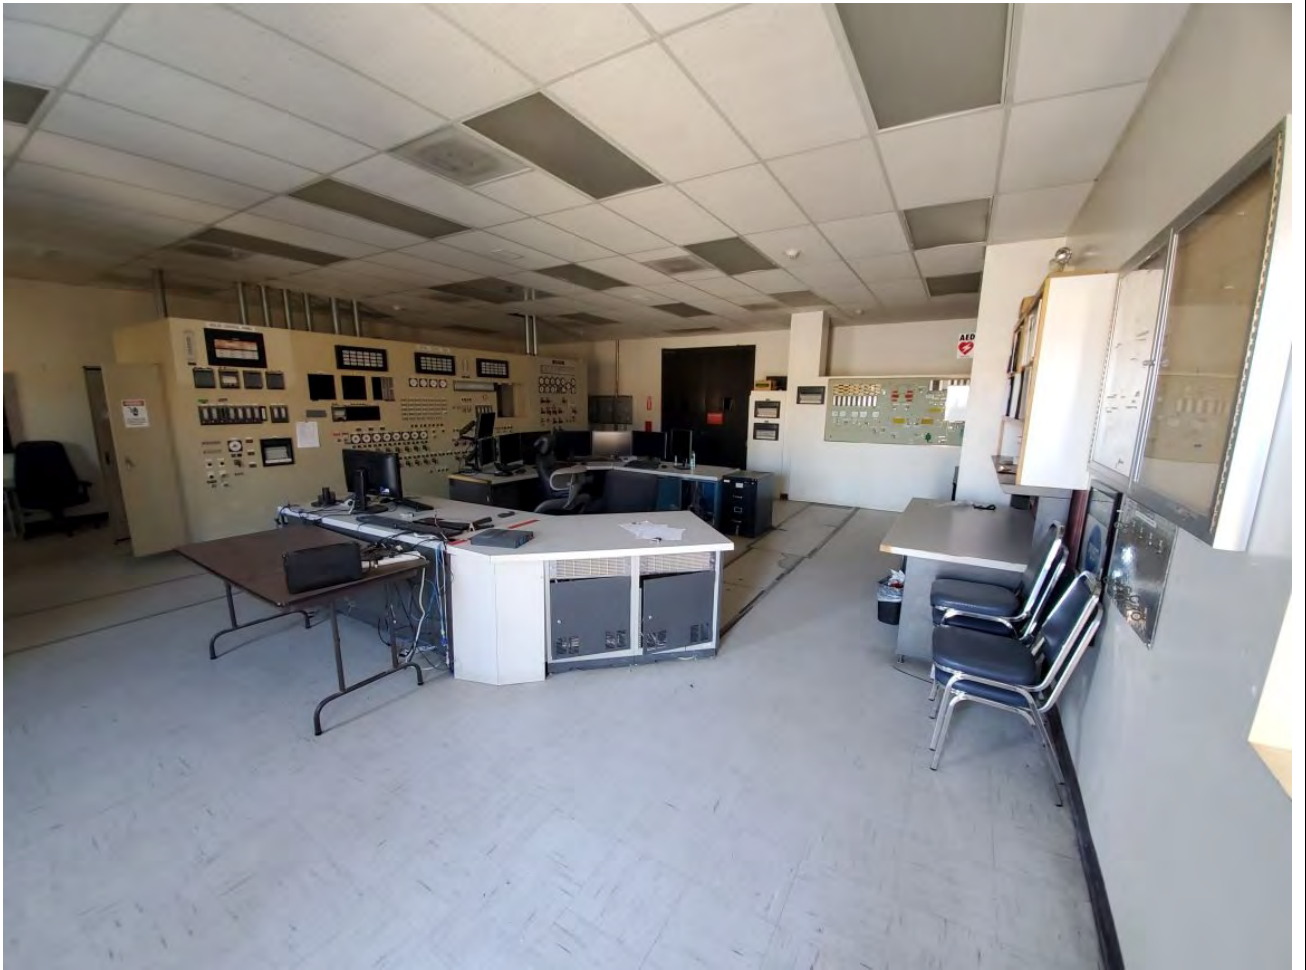
Photo 20: The SEGS III Control Room

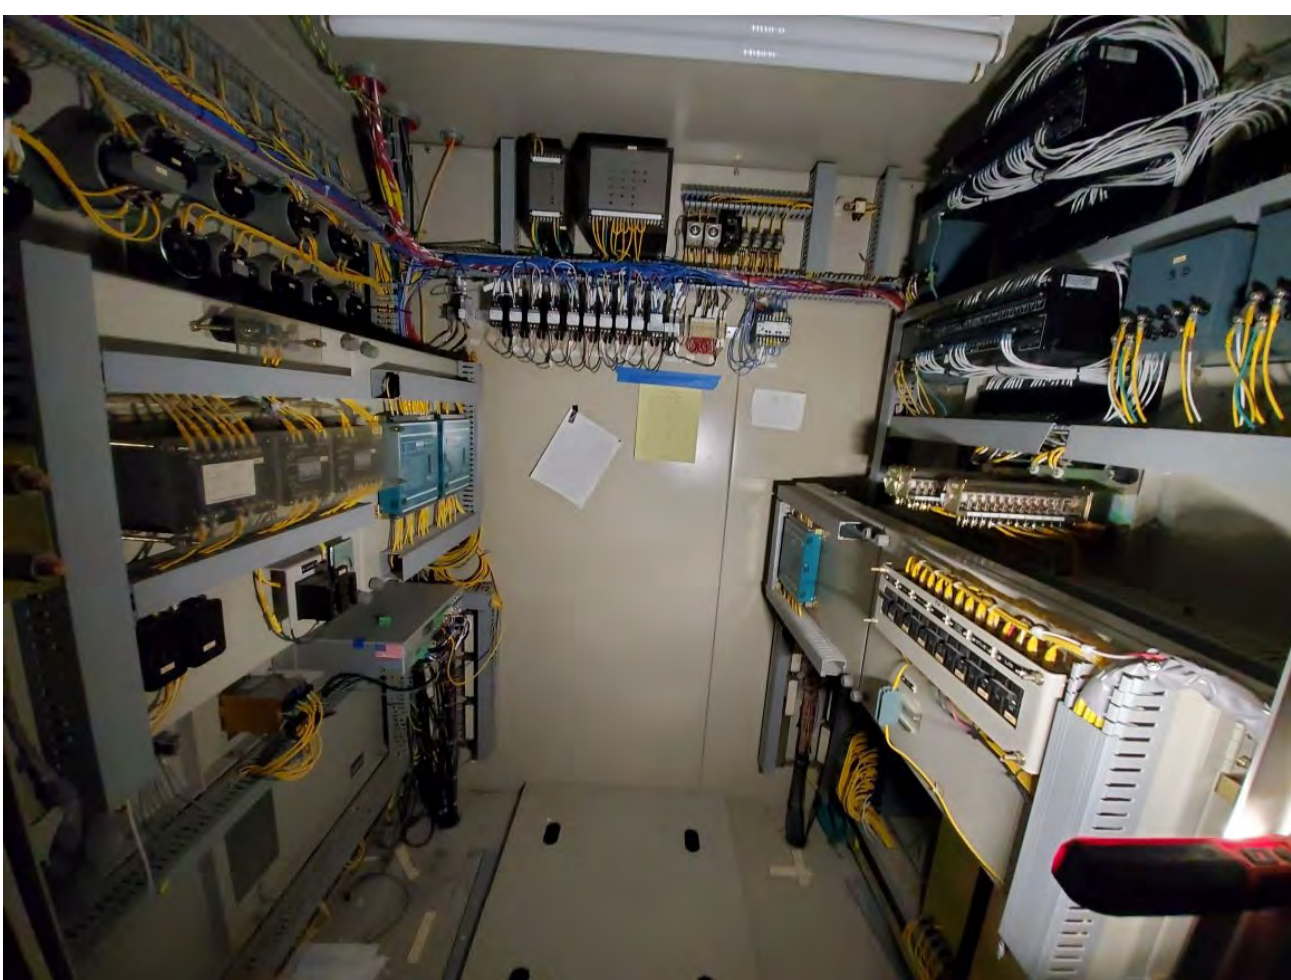
Photo 21: No suspect materials inside the control panels, typical, here in the SEGS III Control Room
