<b>DOCKETED</b>	
<b>Docket Number:</b>	87-AFC-01C
<b>Project Title:</b>	COMPLIANCE-Luz Solar Electric Generating System Cogeneration AFC (150 MW) Units III-VII.
<b>TN #:</b>	241138
<b>Document Title:</b>	Petition to Amend Boundary Change Appendix B Part I - SEGS III-VII
<b>Description:</b>	N/A
<b>Filer:</b>	Scott Galati
<b>Organization:</b>	DayZenLLC
<b>Submitter Role:</b>	Applicant Representative
<b>Submission Date:</b>	1/11/2022 2:18:22 AM
<b>Docketed Date:</b>	1/11/2022

## **APPENDIX B**

Monthly Compliance Reports and Biological Memorandum

Subject: SEGS III-VII Decommissioning (87-AFC-01C) Monthly Compliance Report for June 2021

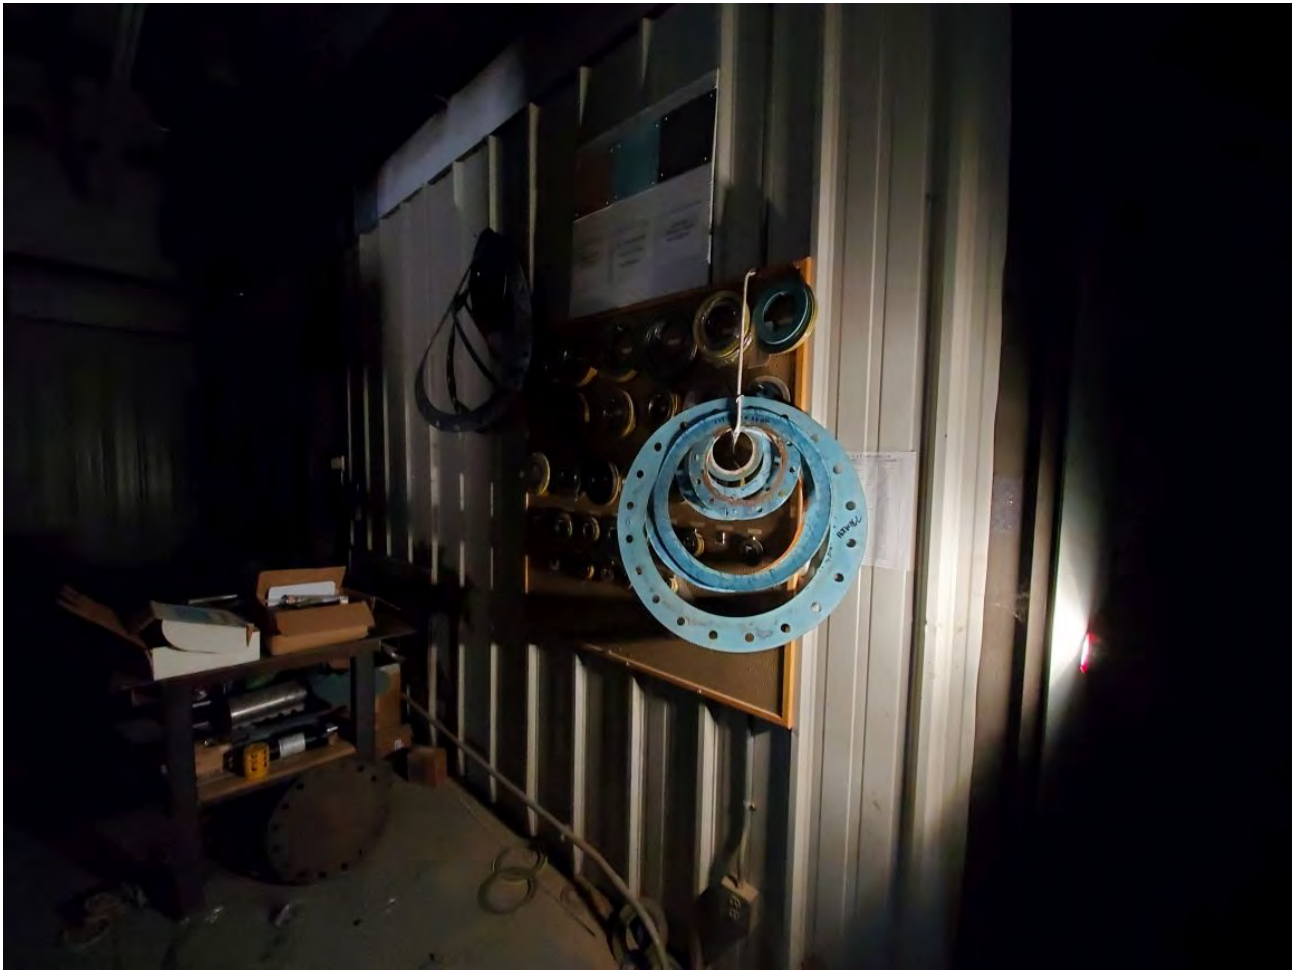
Photo 22: Gaskets in the SEGS III Control Room Building

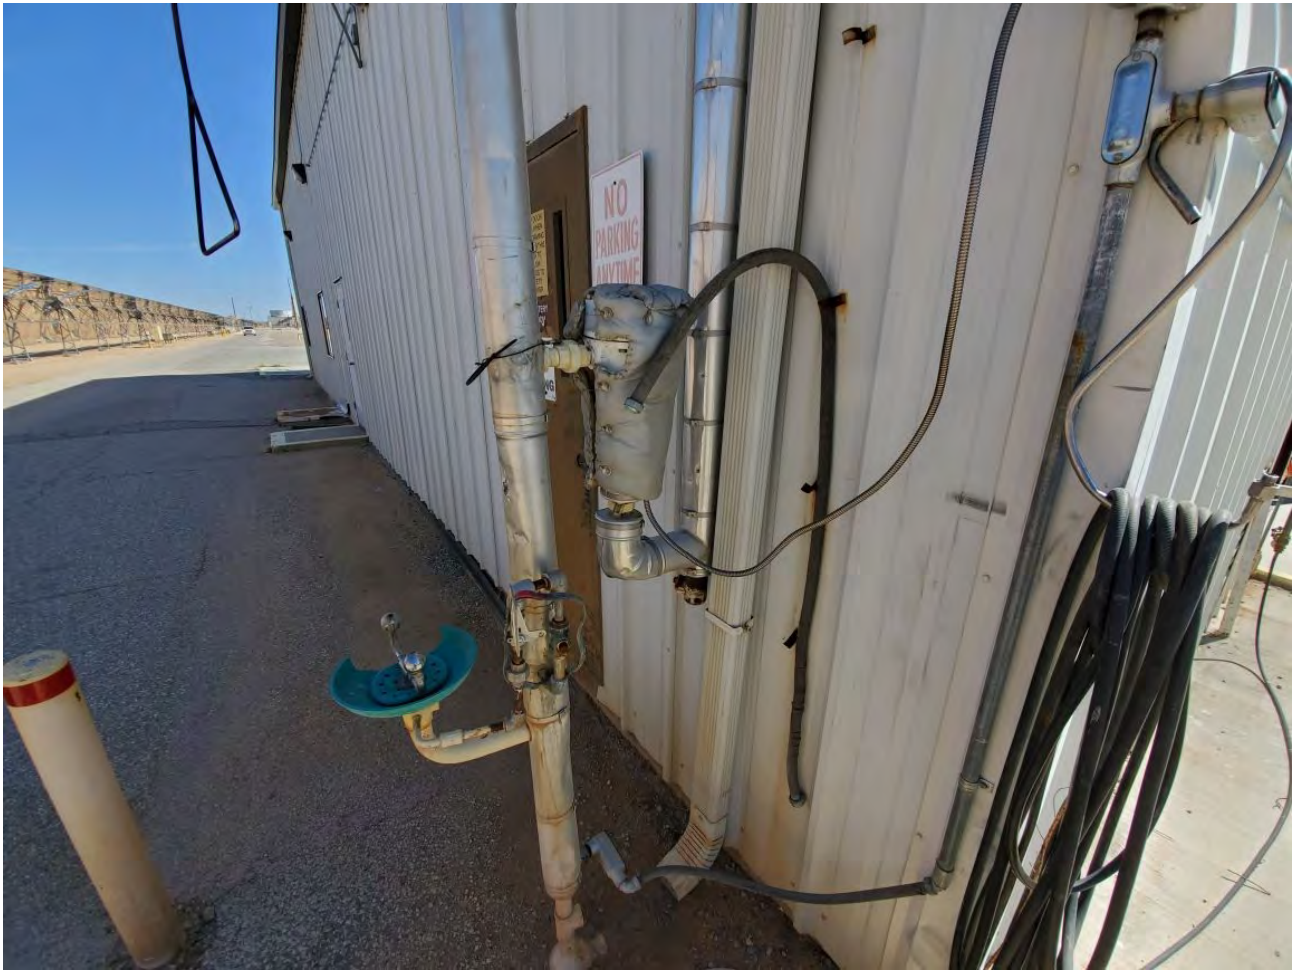
Photo 23: Typical fiberglass pipe insulation at a eye wash station

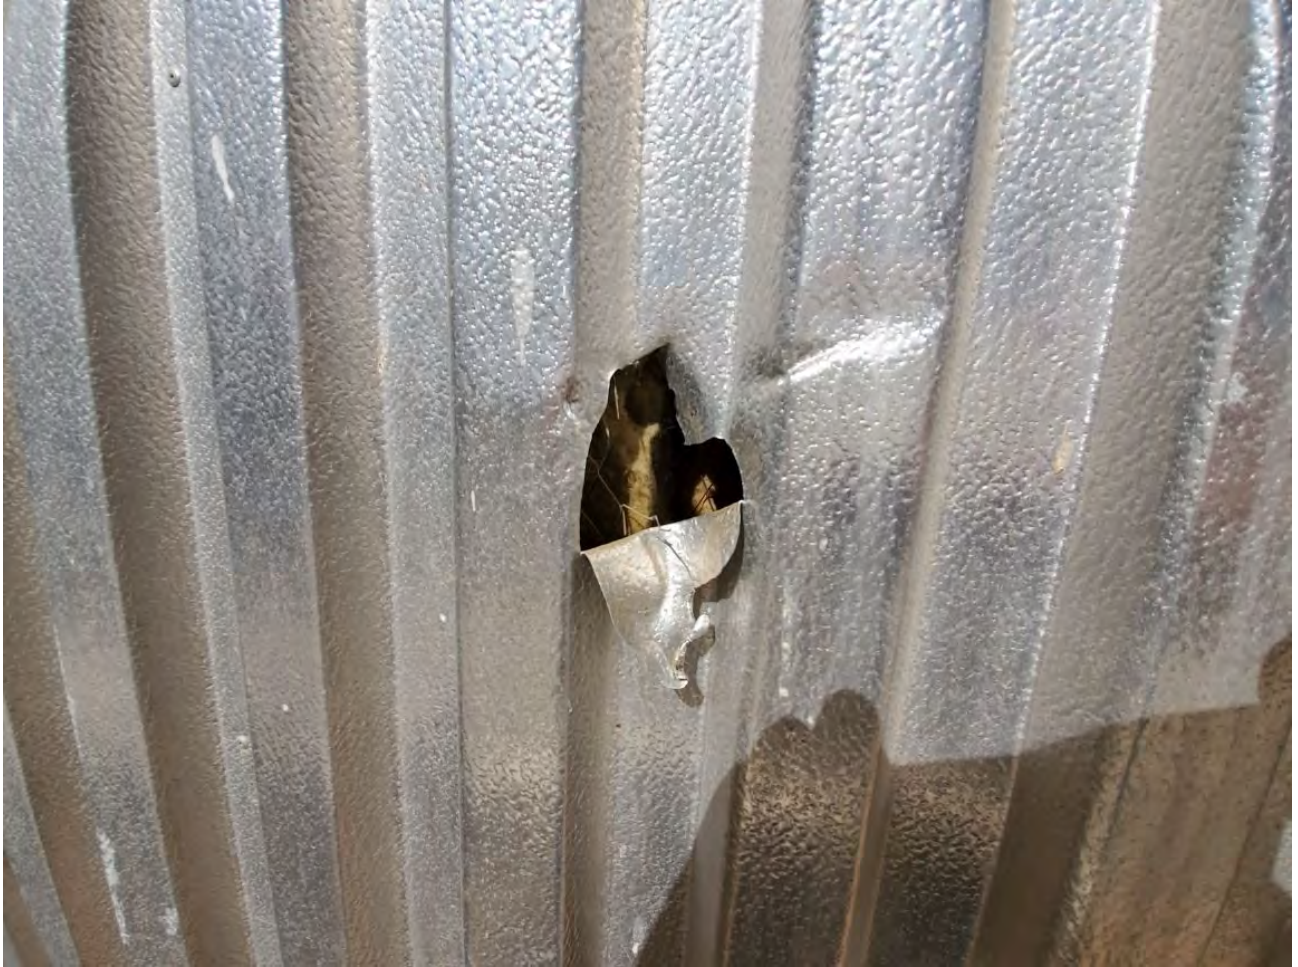
Photo 25: Typical fiberglass boiler insulation

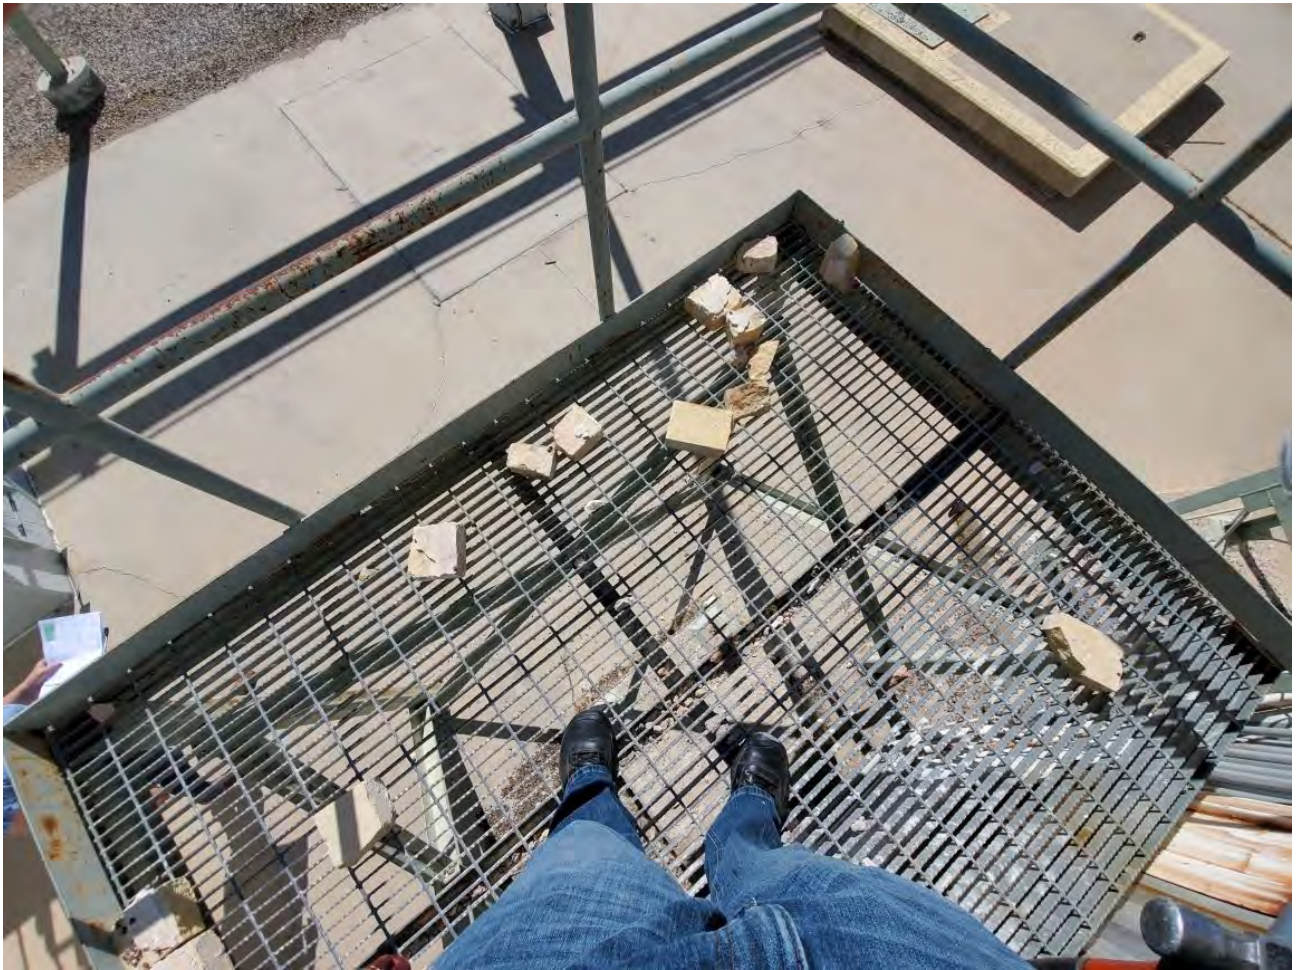
Photo 27: Typical yellow fire brick, here at the SEGS III boiler

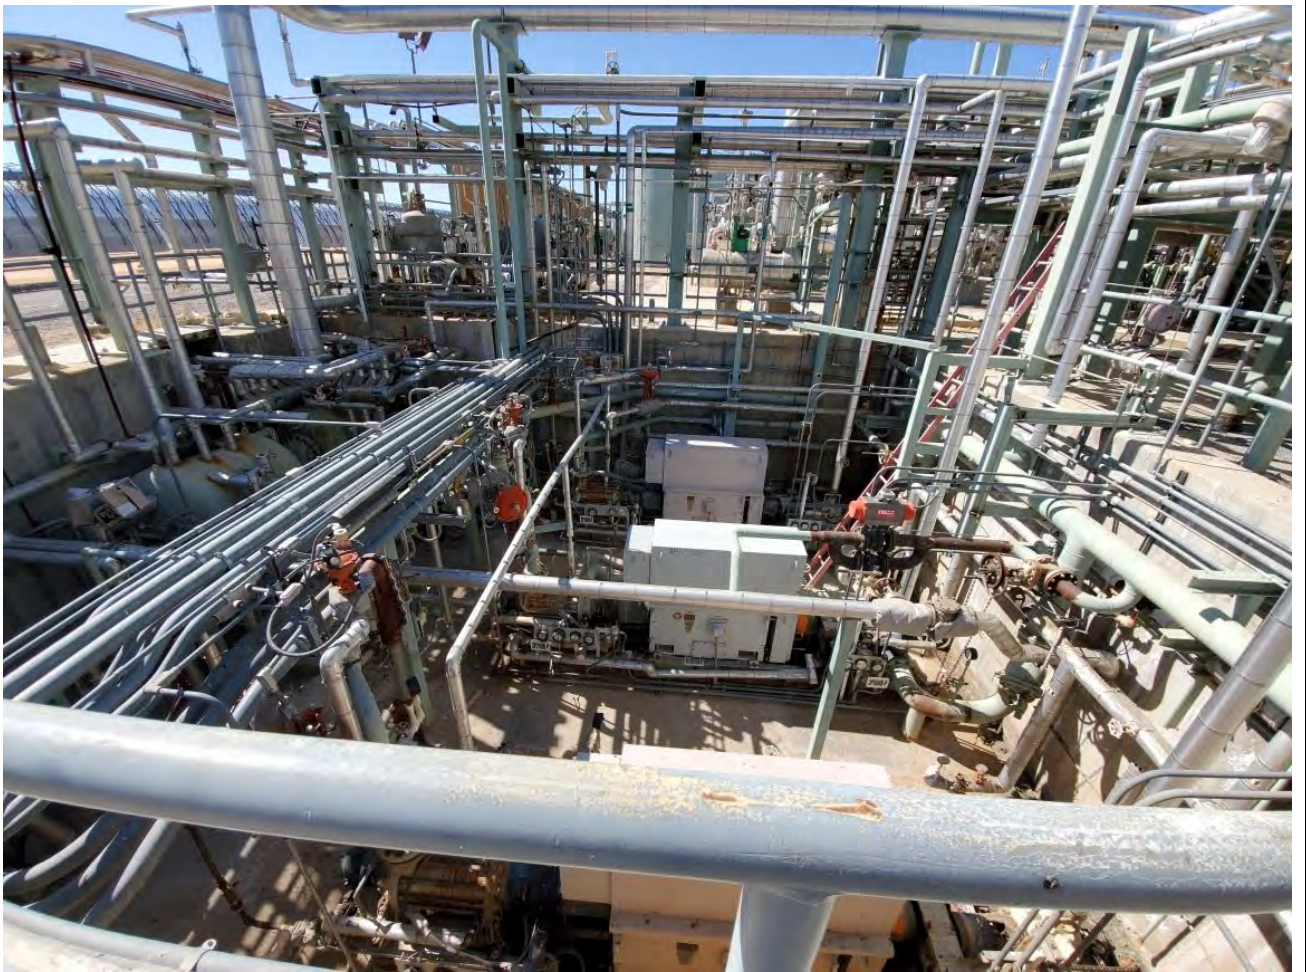
Photo 30: Piping in the SEGS III area

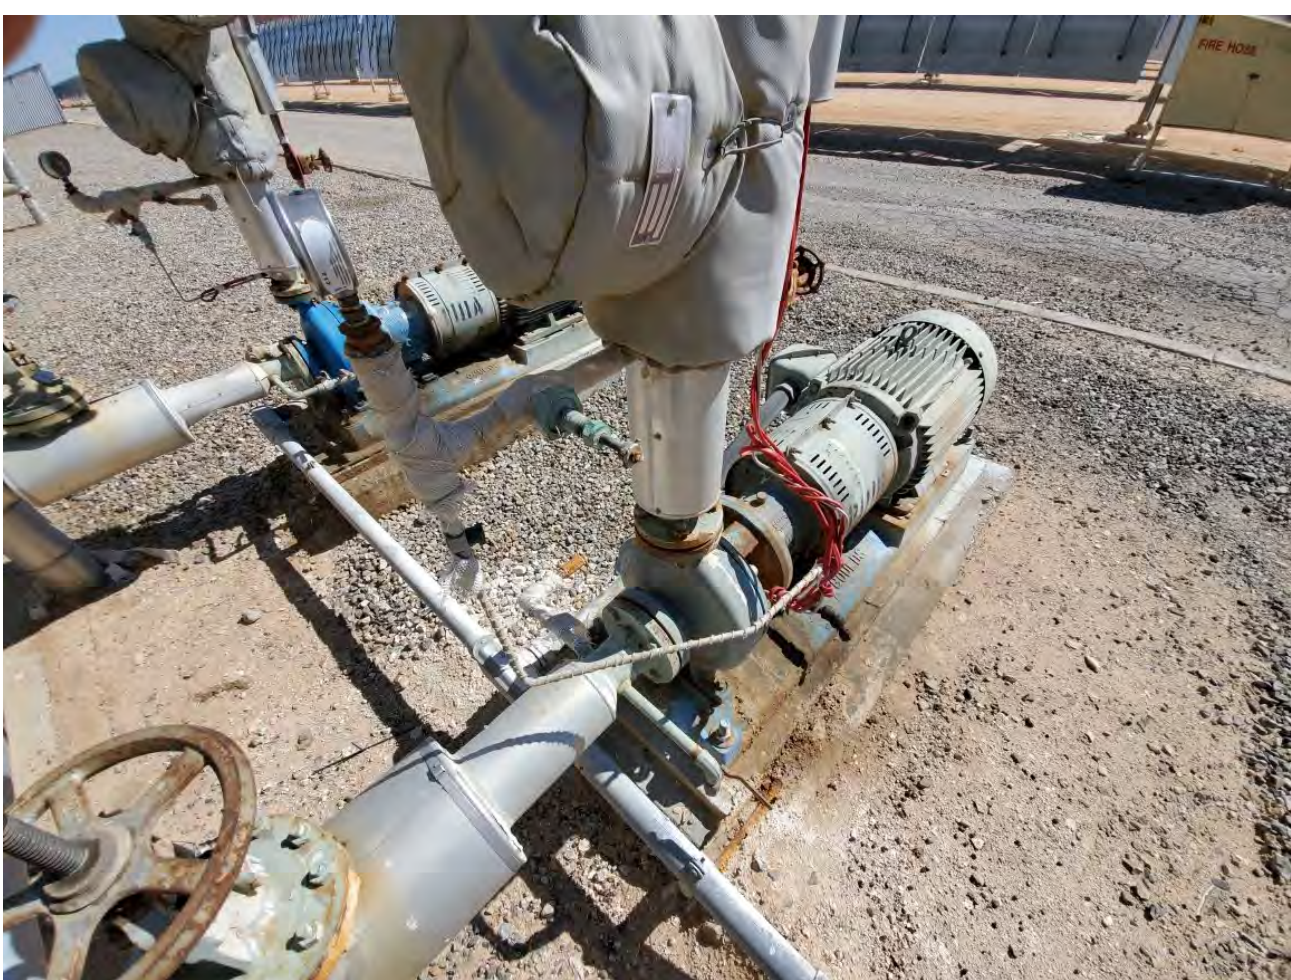
Photo 31: Typical woven fiberglass tape insulation at a gauge

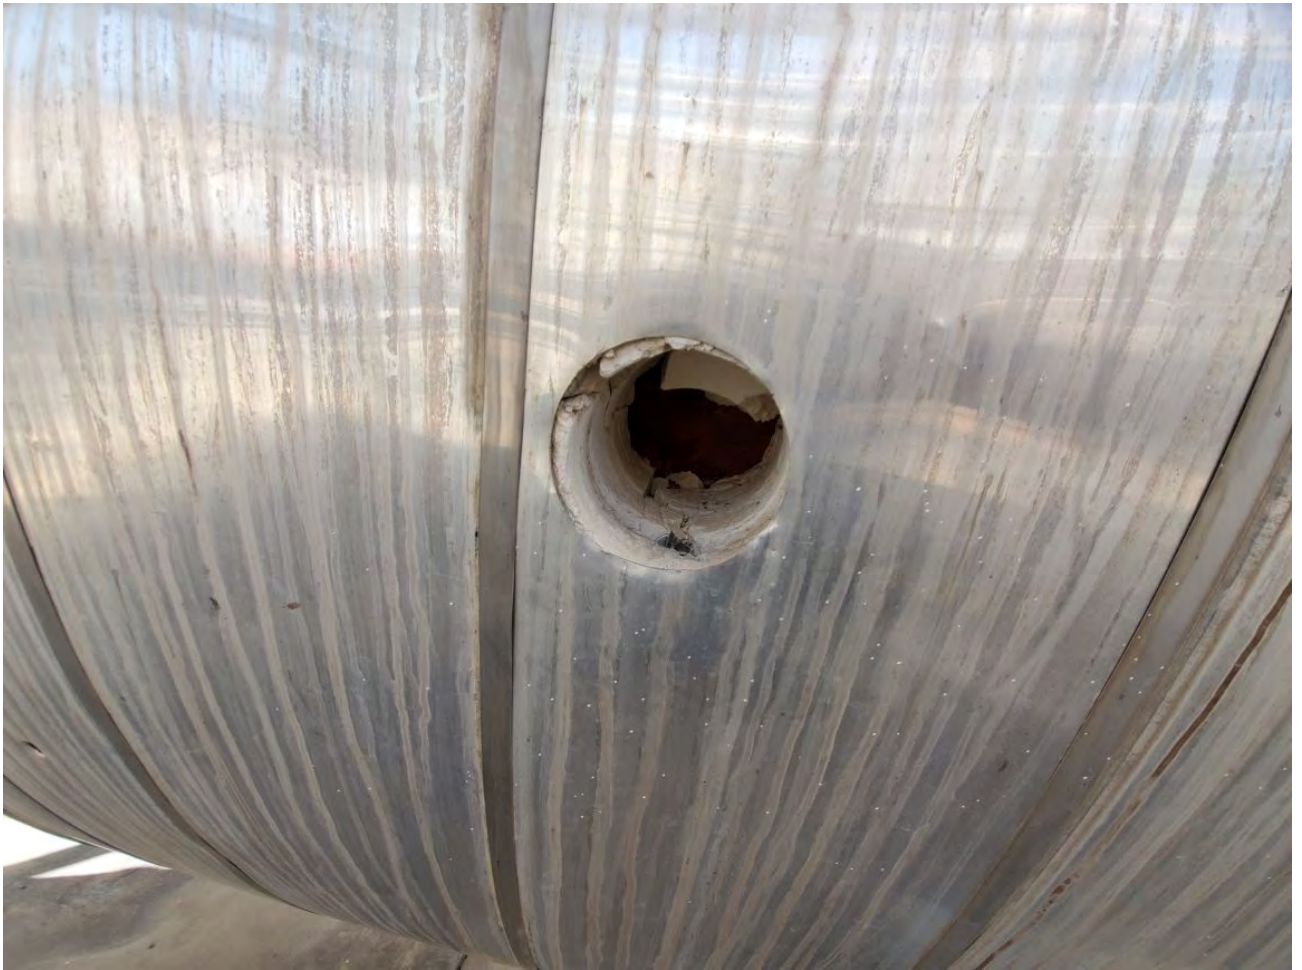
Photo 33: Typical per-formed block insulation on a large tank-shaped device

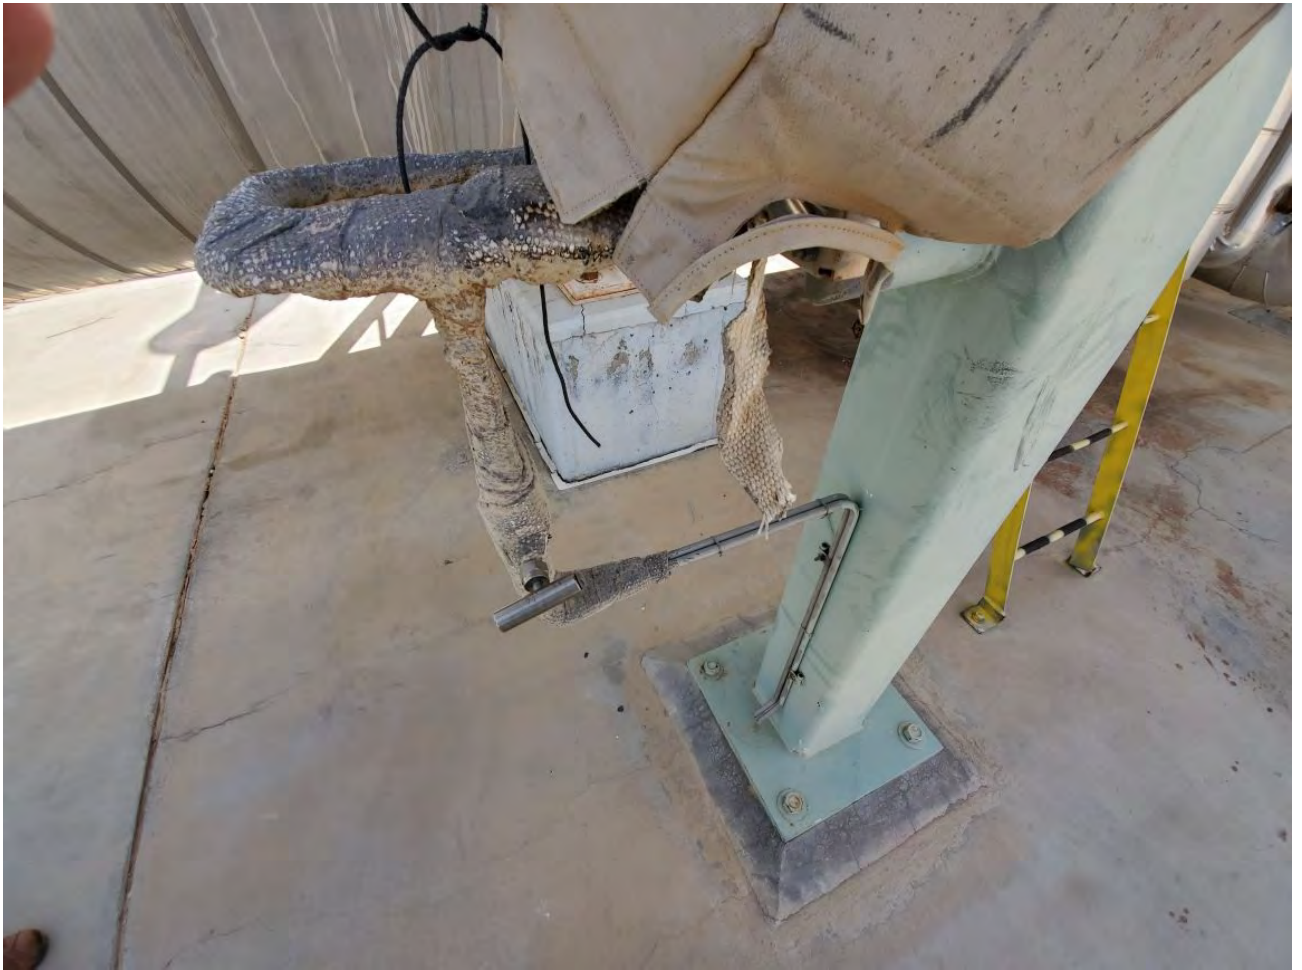
Photo 34: Typical woven fiberglass tape insulation with a mastic coating

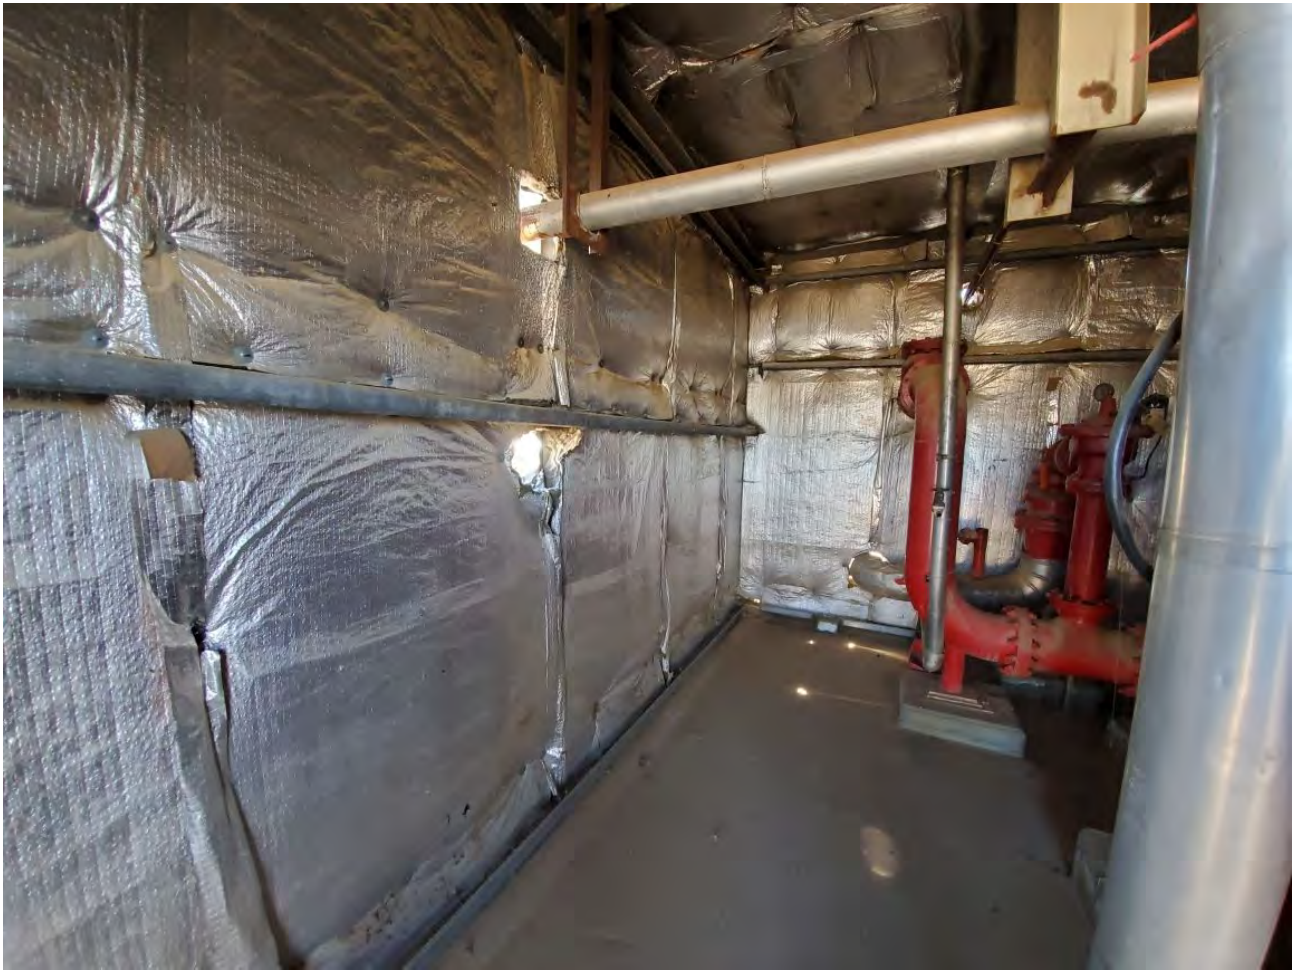
Photo 35: Fiberglass insulation in a fire water pump room

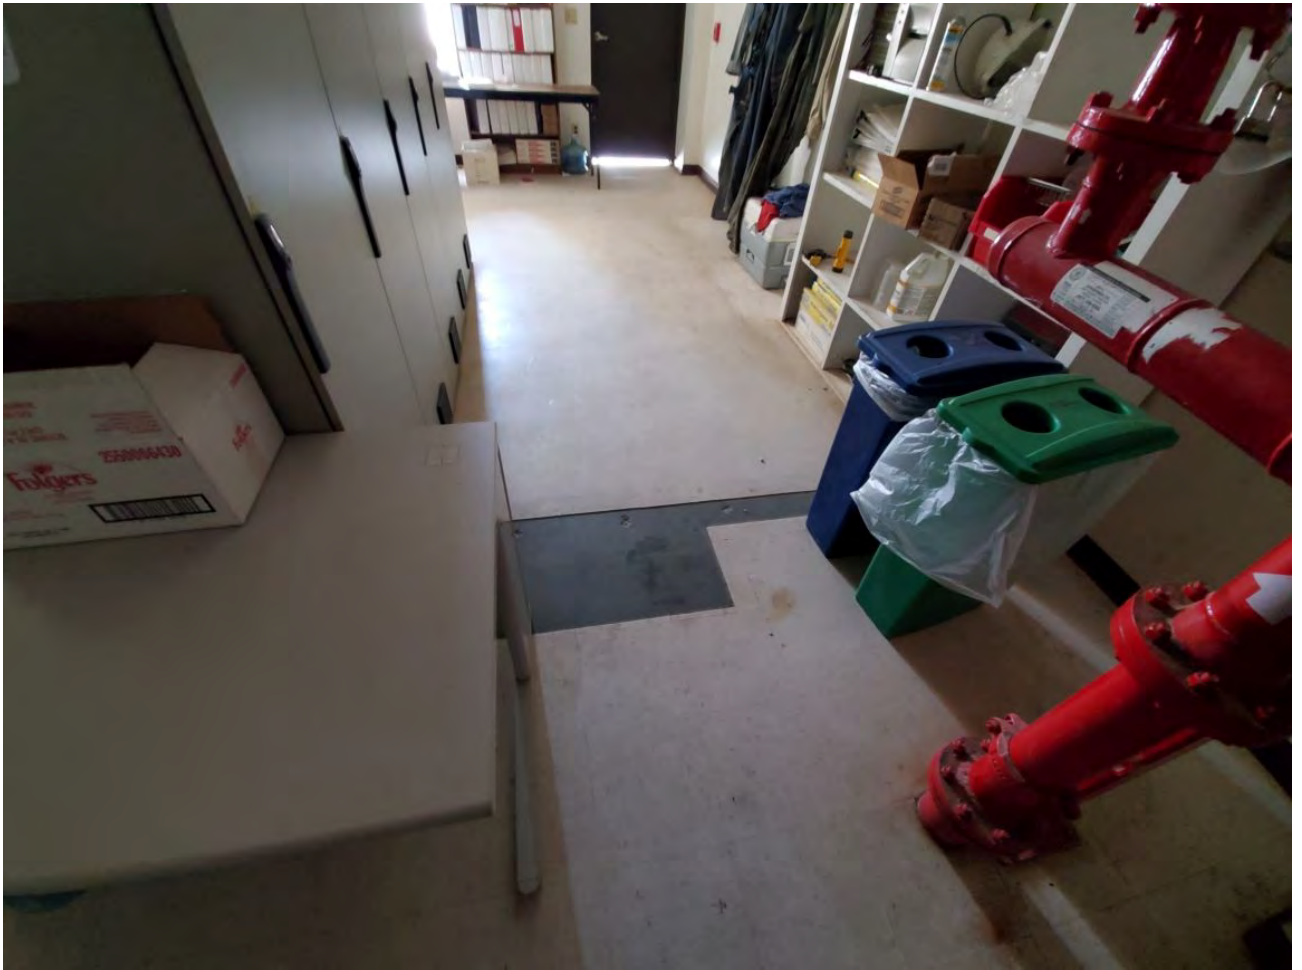
Photo 37: The 12 x 12 vinyl floor tile in the SEGS IV Control Room back room

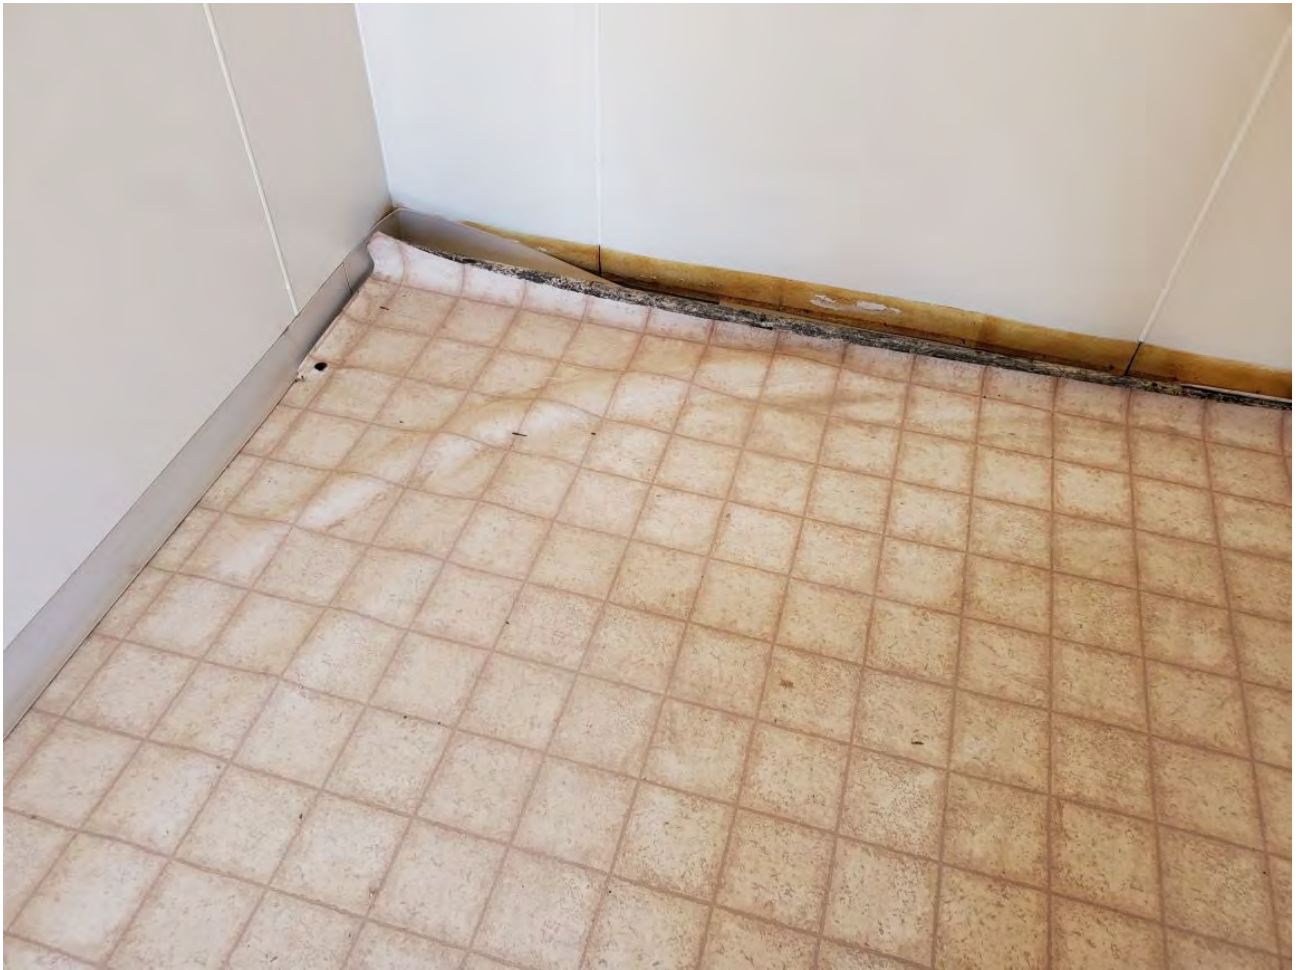
Photo 38: The sheet vinyl flooring in the abandoned restroom building

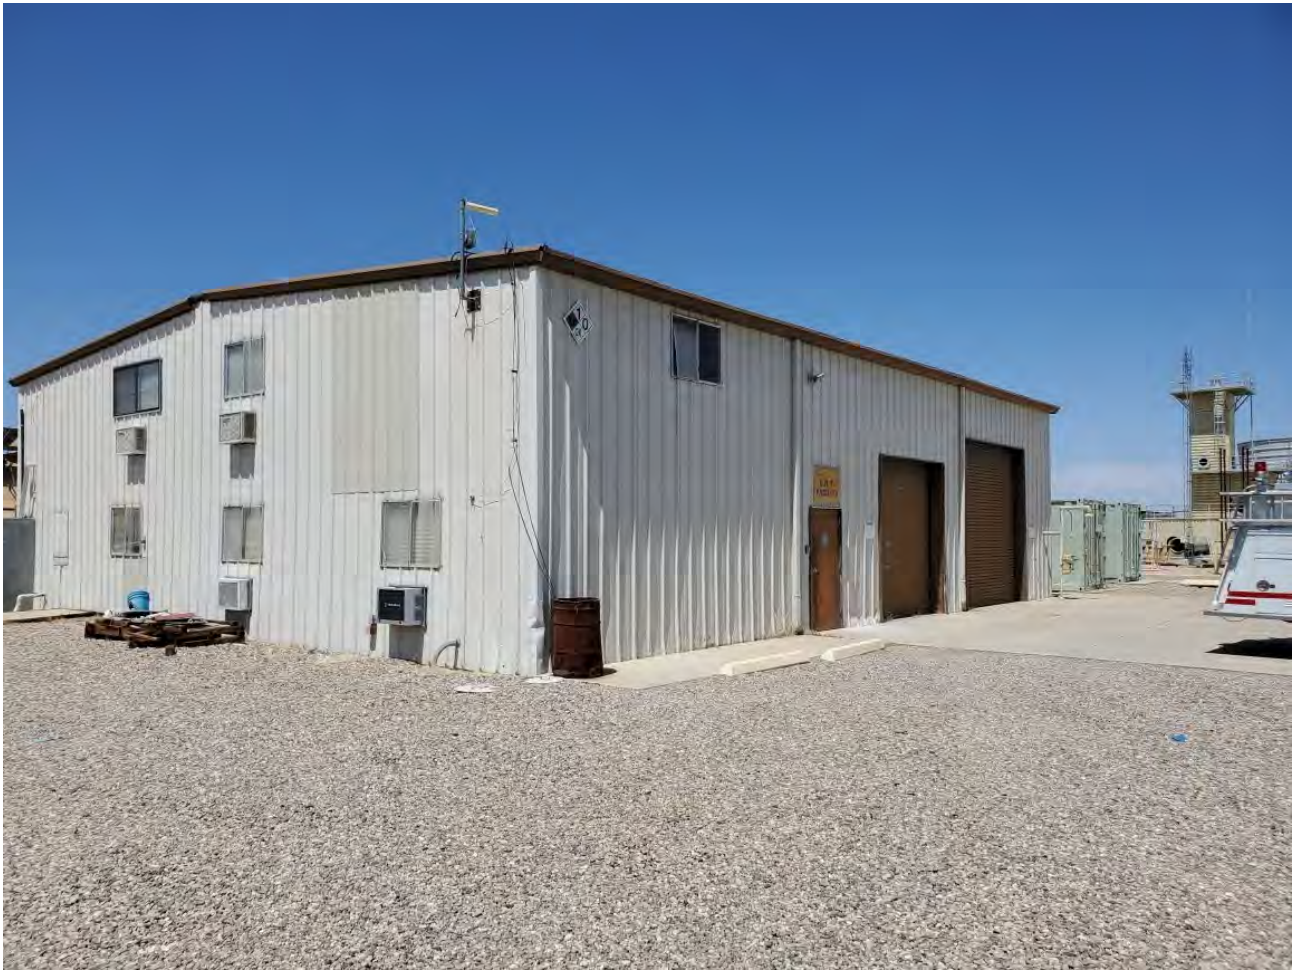
Photo 40: The fire house

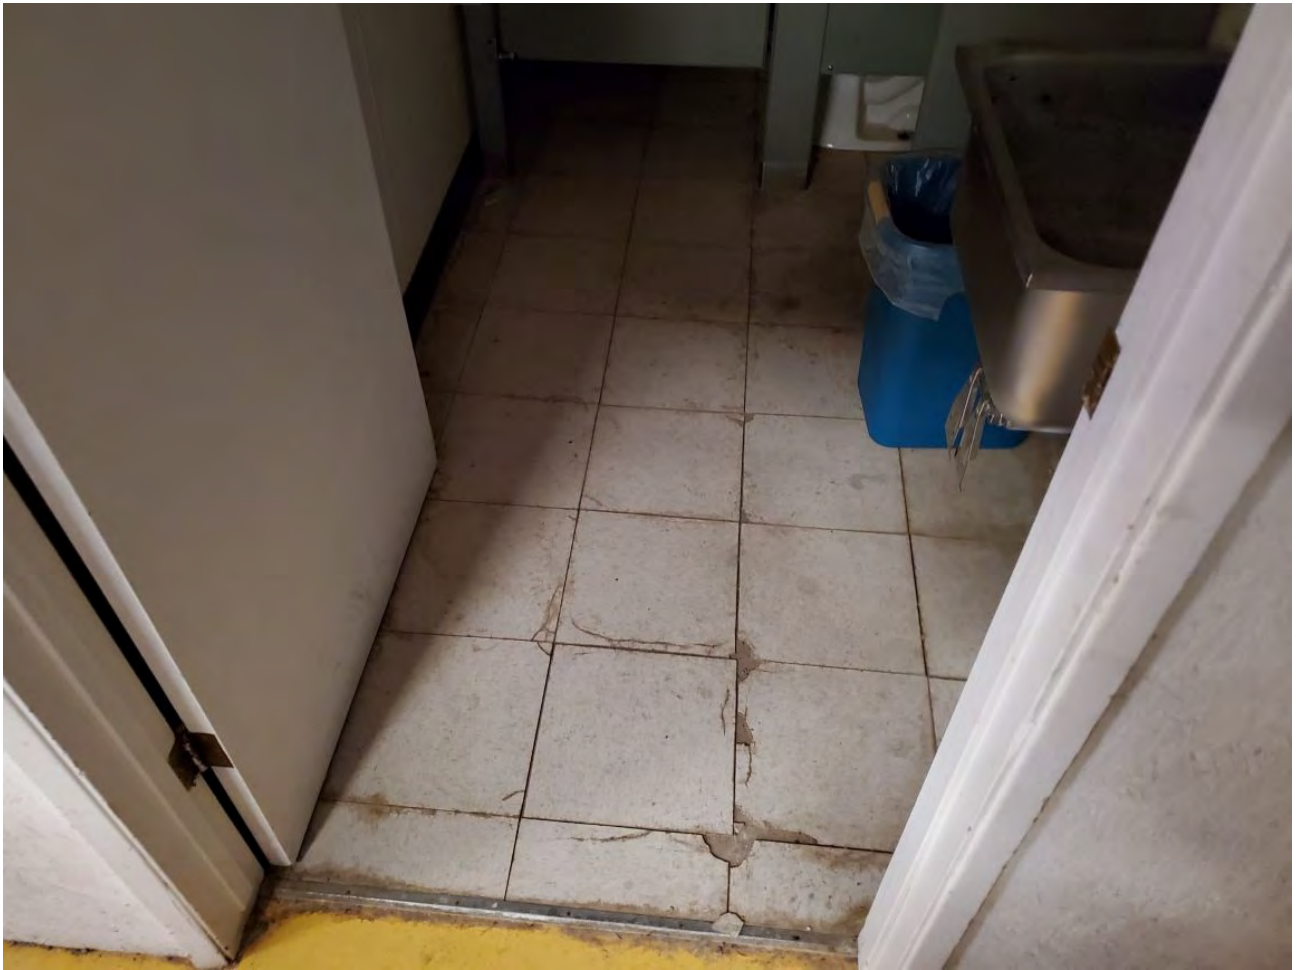
Photo 41:12 x 12 vinyl floor tile in the fire house

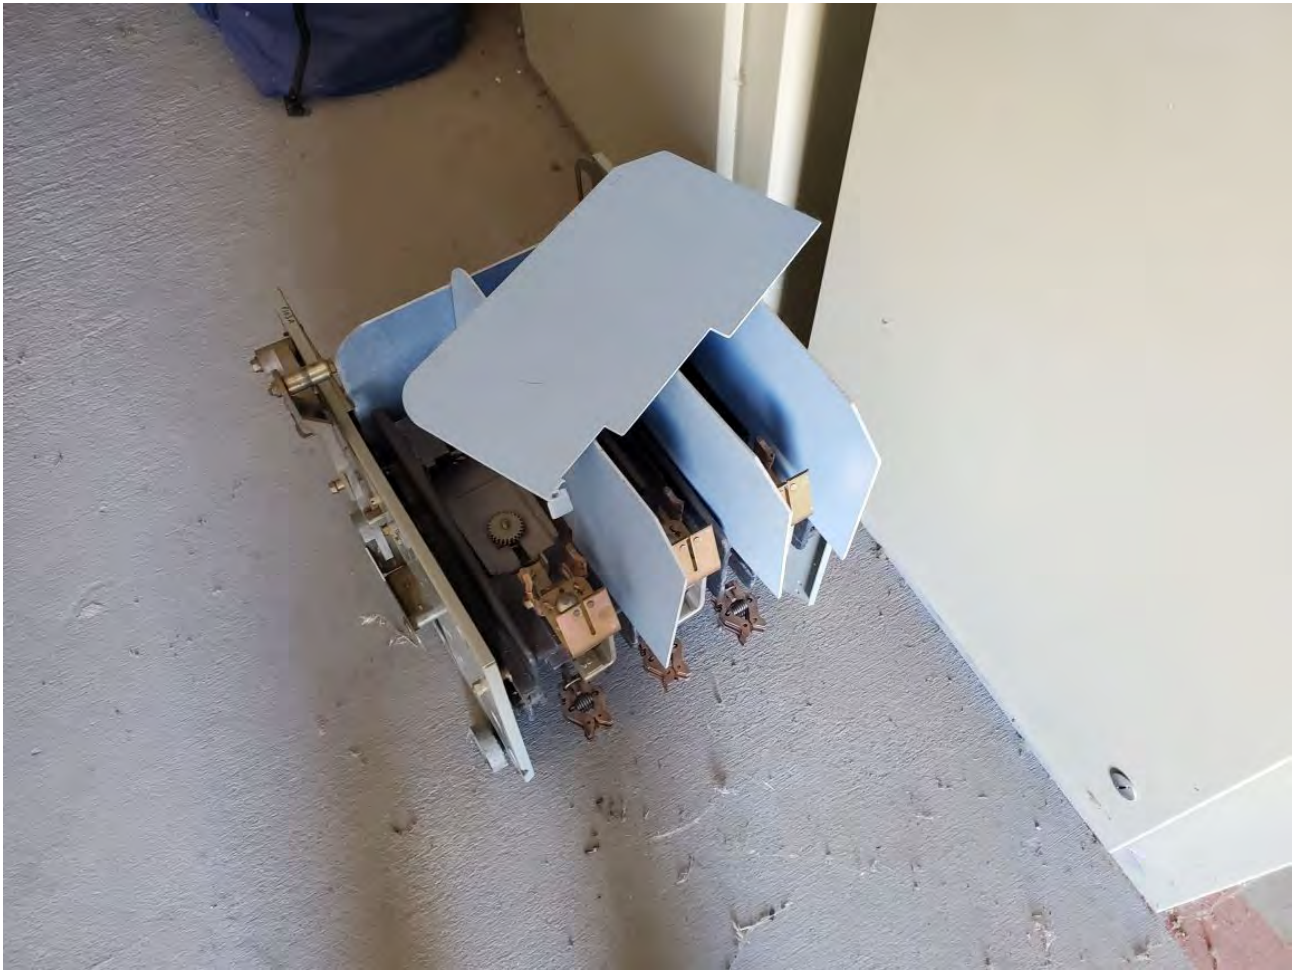
Photo 44: Typical fiberglass-reinforced plastic arc chutes in electrical equipment

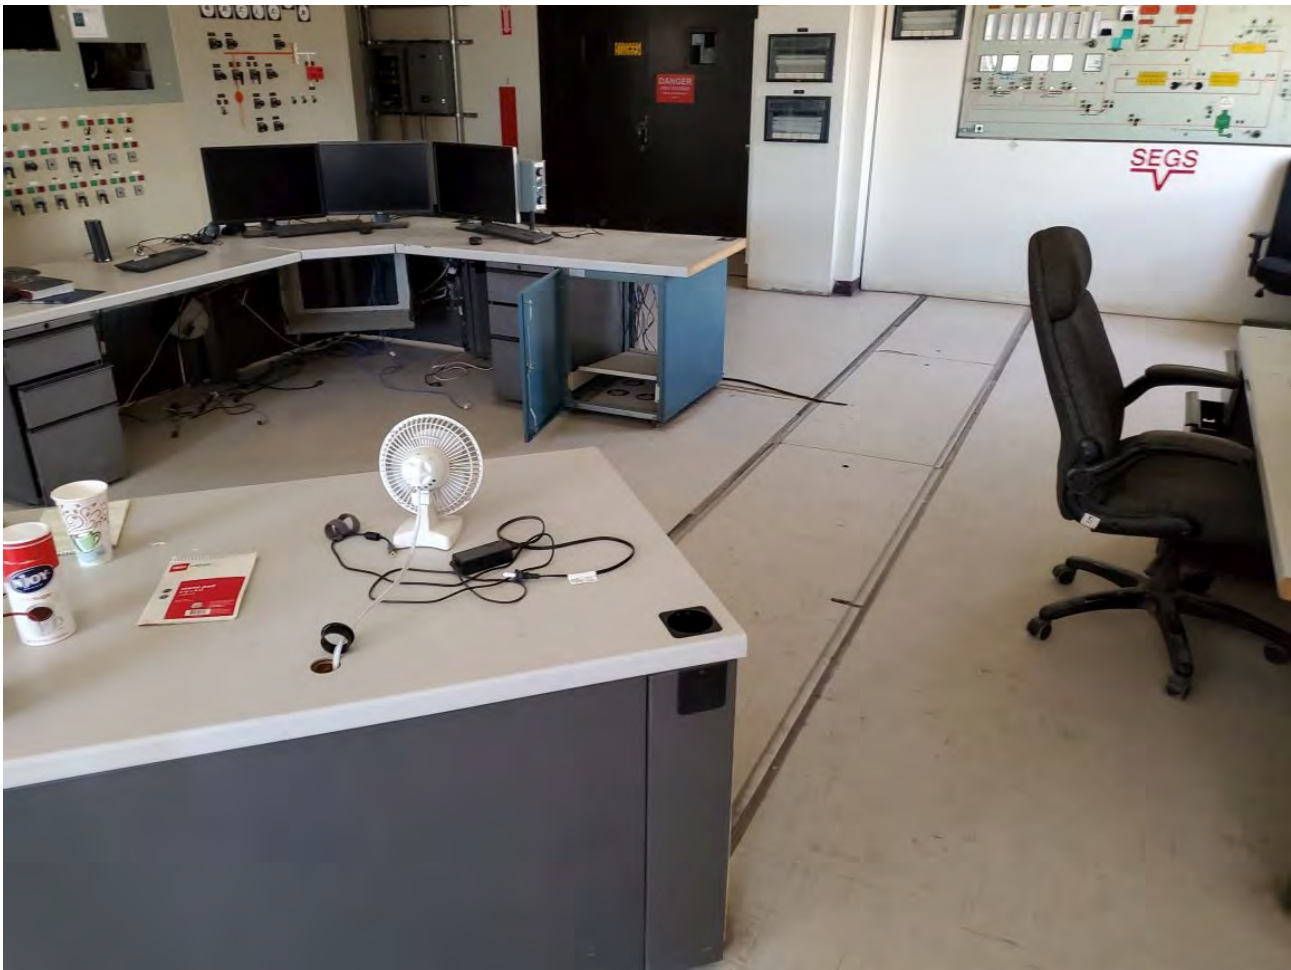
Photo 45: The SEGS IV Control Room

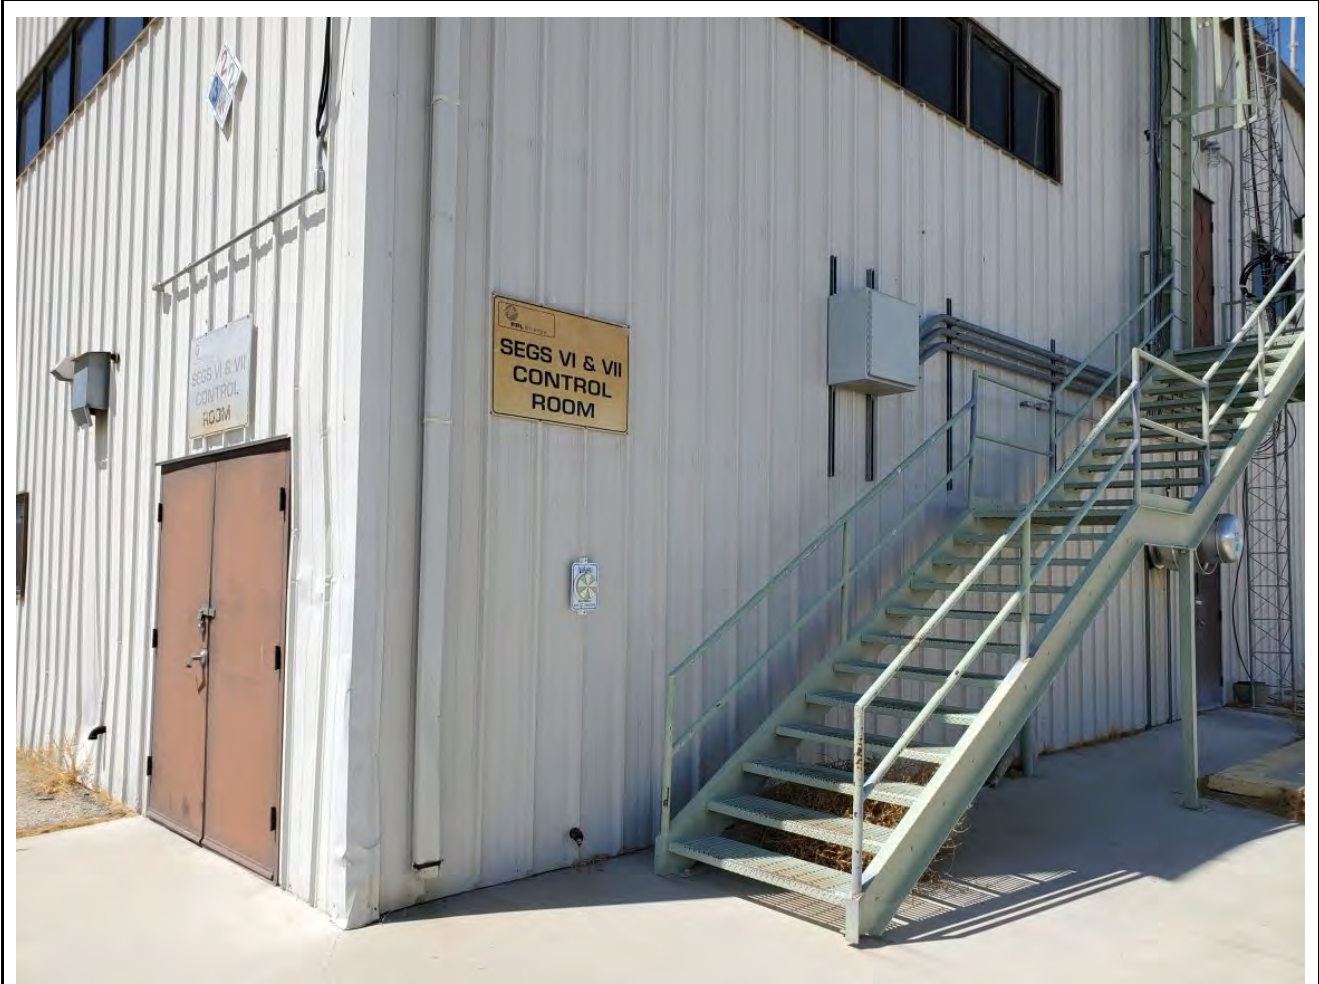
Photo 46: THE SEGS VI& VII Control Room

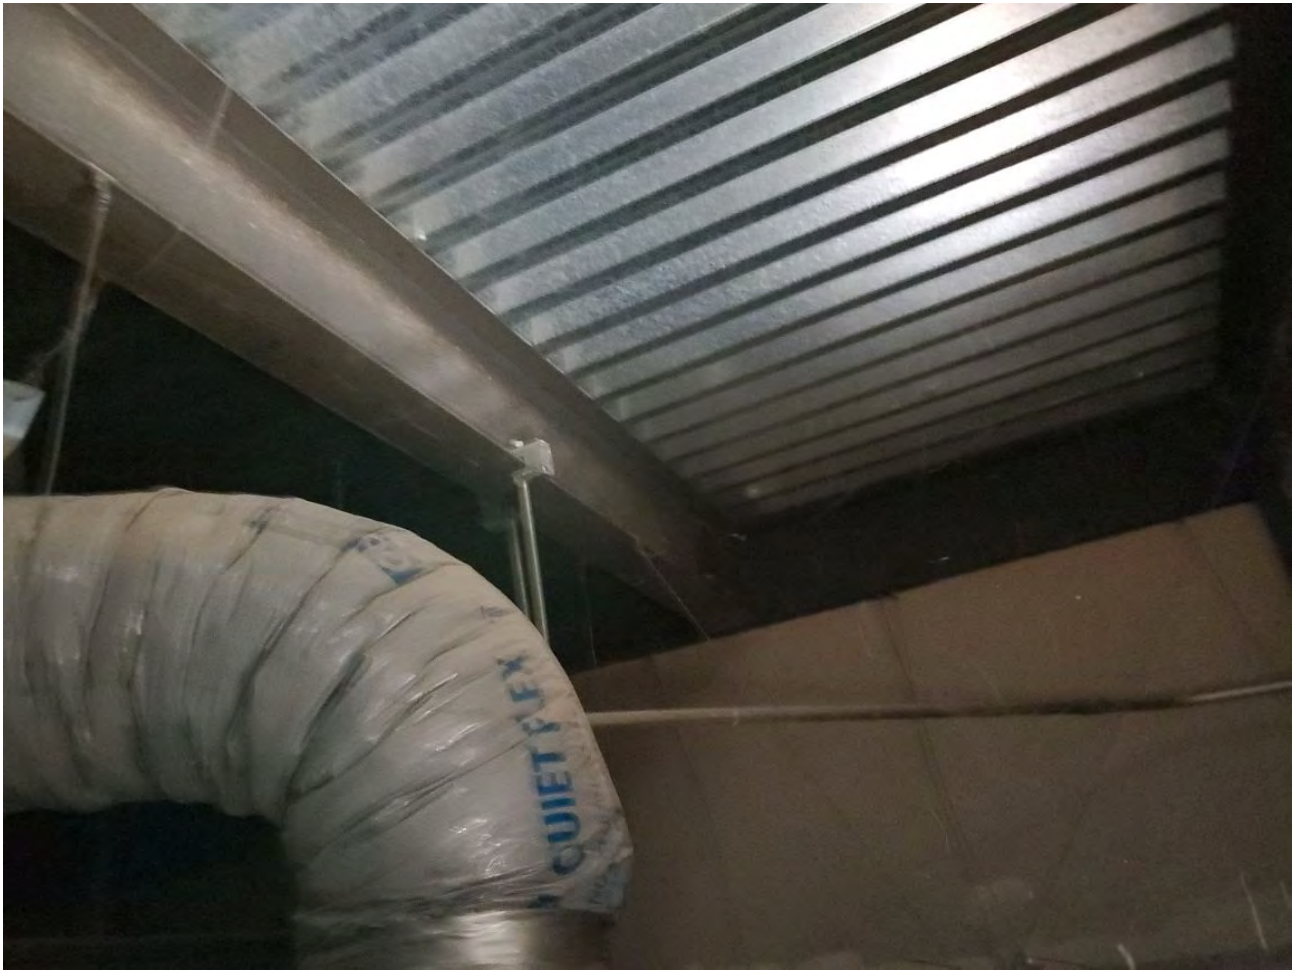
Photo 47: Fiberglass HVAC duct insulation and no structural steel fireproofing in the SEGS VI & VIII Control Room building

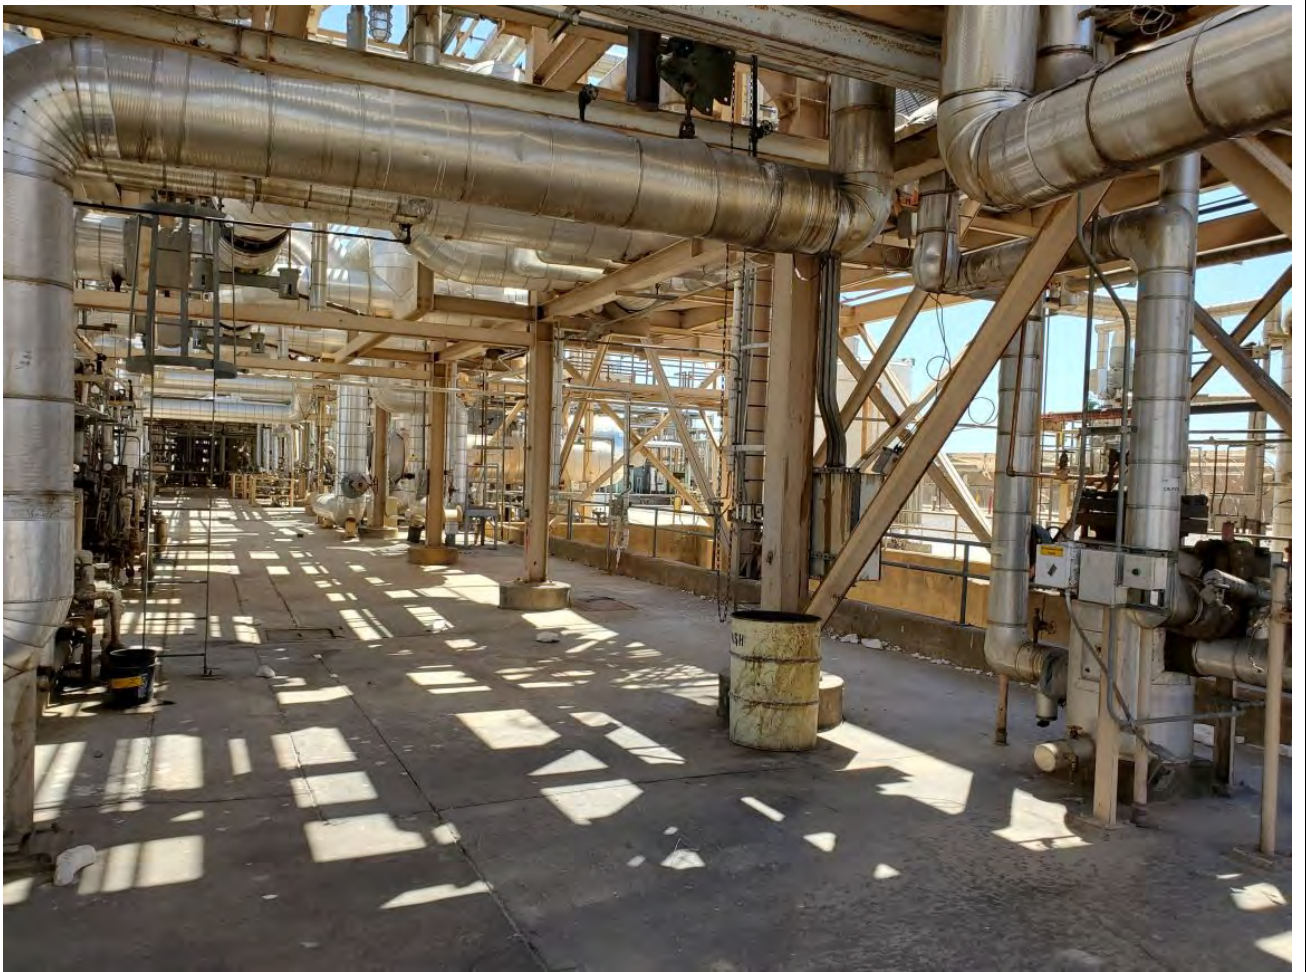
Photo 49: Hot HTF piping
