<b>DOCKETED</b>	
<b>Docket Number:</b>	87-AFC-01C
<b>Project Title:</b>	COMPLIANCE-Luz Solar Electric Generating System Cogeneration AFC (150 MW) Units III-VII.
<b>TN #:</b>	241138
<b>Document Title:</b>	Petition to Amend Boundary Change Appendix B Part I - SEGS III-VII
<b>Description:</b>	N/A
<b>Filer:</b>	Scott Galati
<b>Organization:</b>	DayZenLLC
<b>Submitter Role:</b>	Applicant Representative
<b>Submission Date:</b>	1/11/2022 2:18:22 AM
<b>Docketed Date:</b>	1/11/2022

## **APPENDIX B**

Monthly Compliance Reports and Biological Memorandum

Subject: SEGS III-VII Decommissioning (87-AFC-01C) Monthly Compliance Report for June 2021

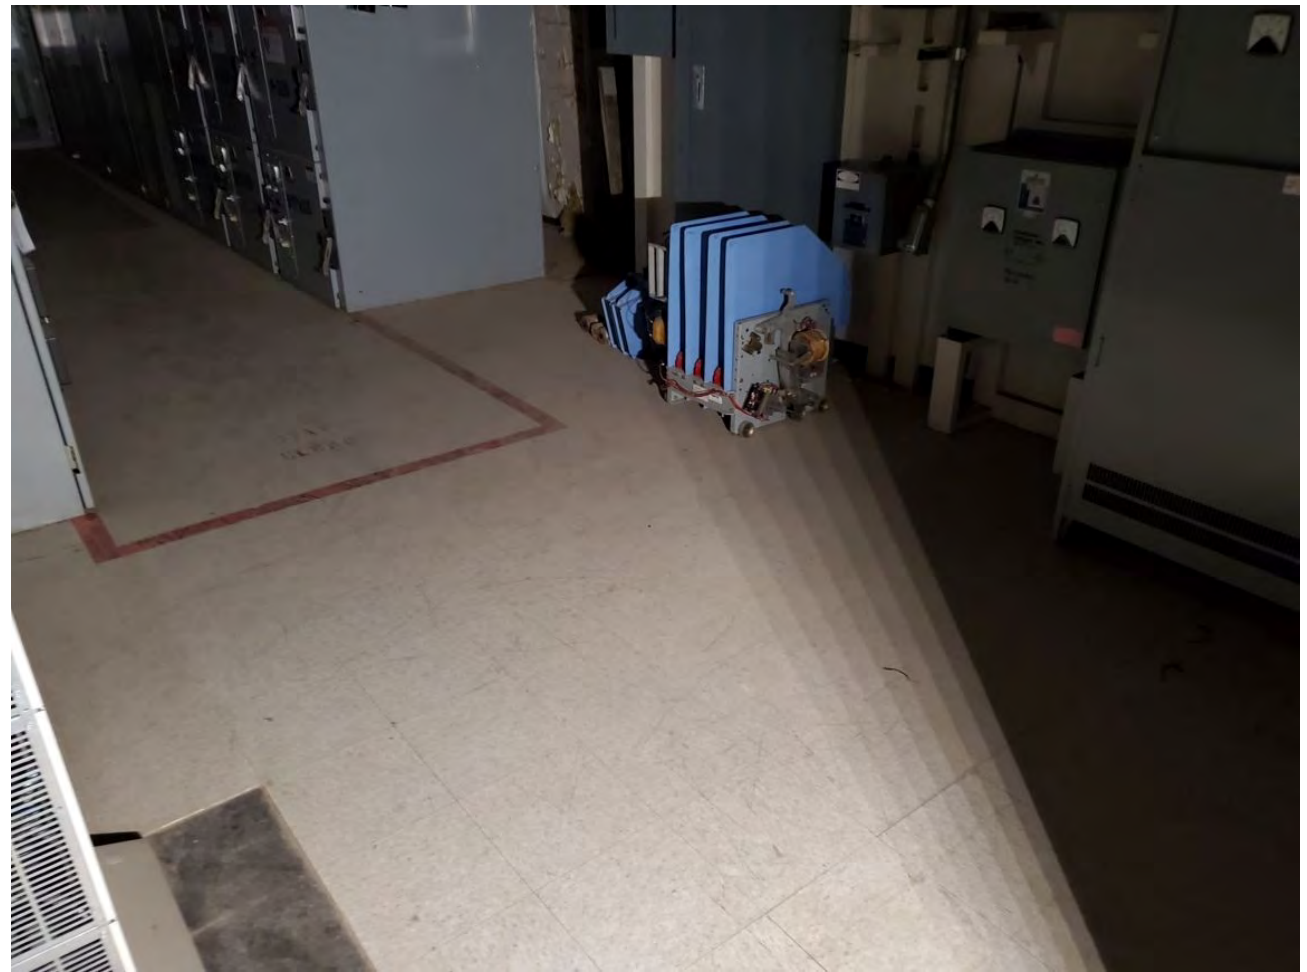
Photo 50: 12 x 12 vinyl floor tile in the electrical panel room in the SEGS VI area

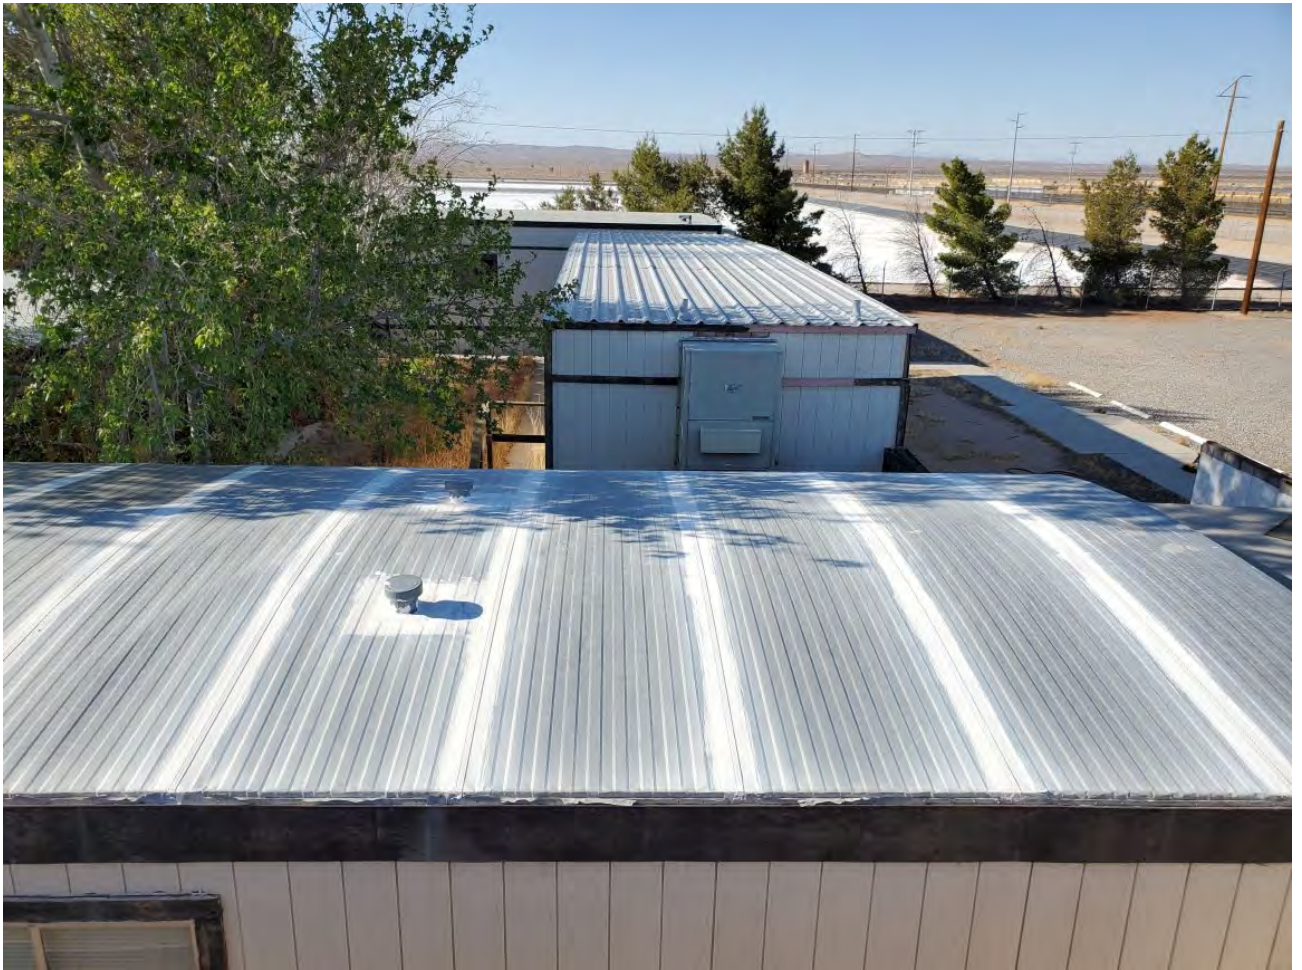
Photo 52: Metal roof with caulk on two of the other trailers

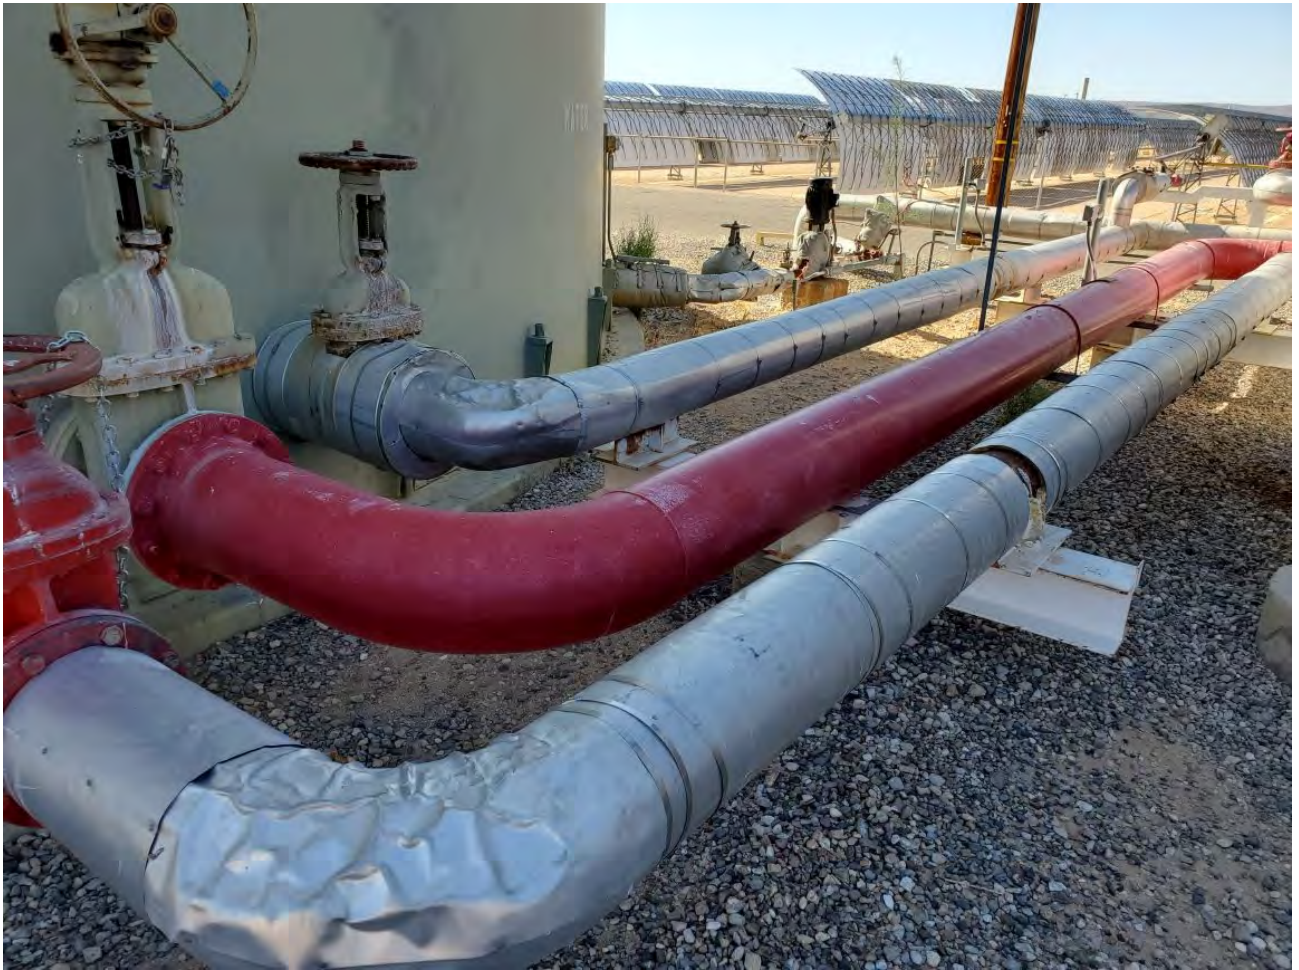
Photo 53: Fiberglass pipe insulation at another fire pump location

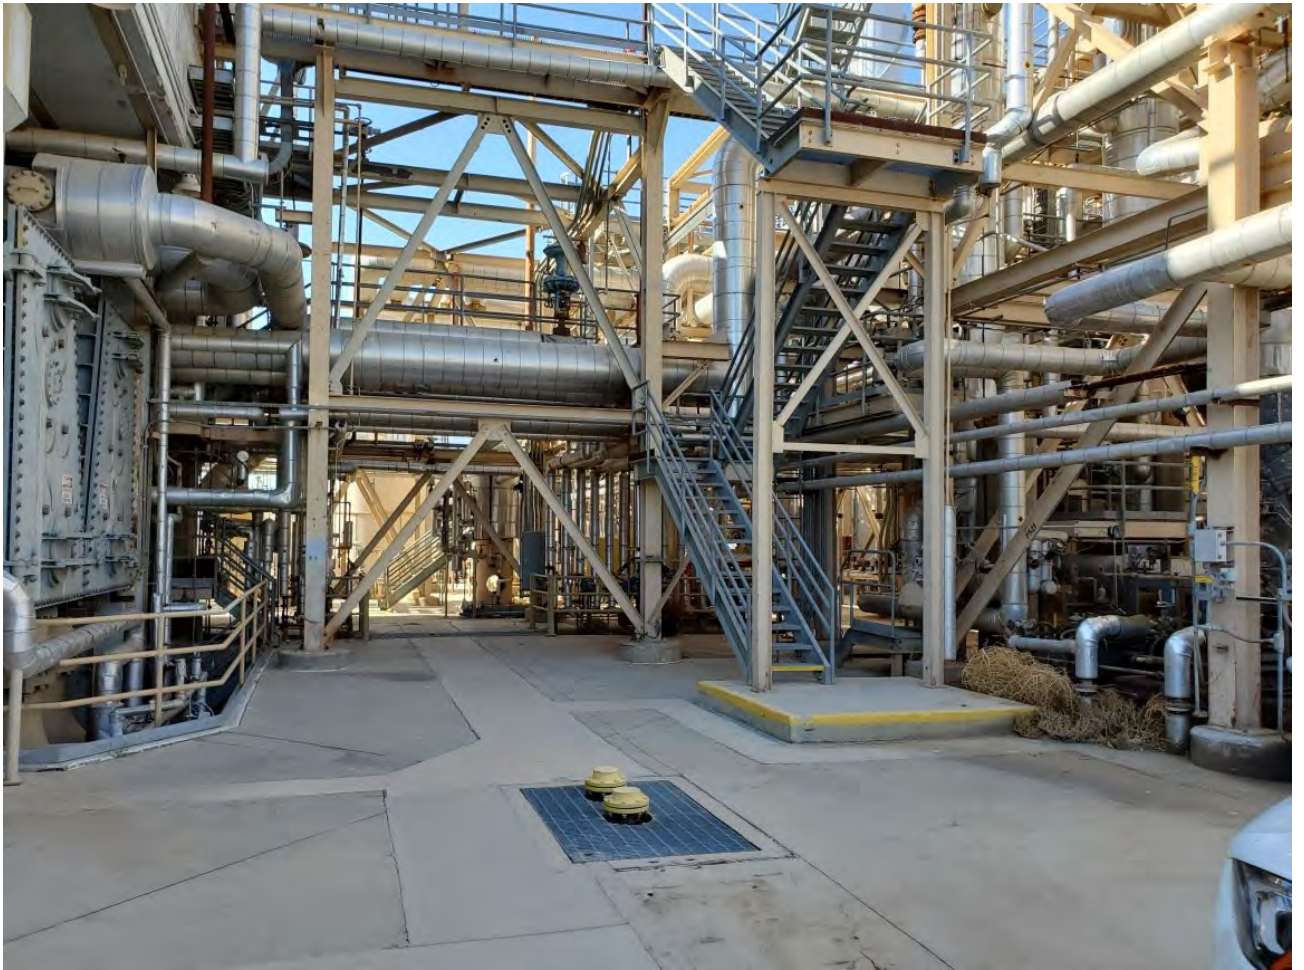
Photo 55: The SEGS VII area

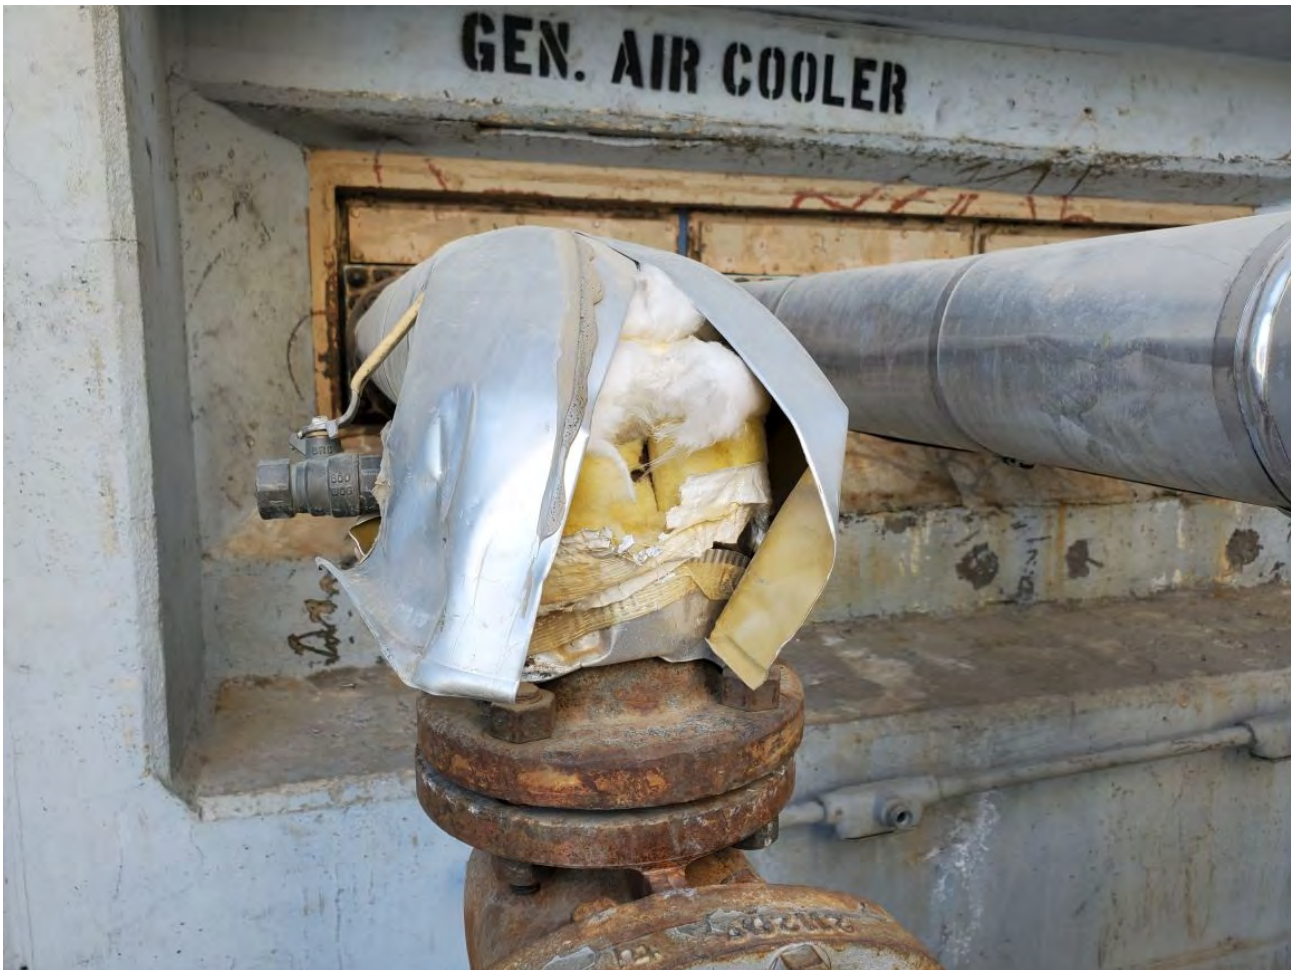
Photo 56: Fiberglass pipe insulation at the SEGS VII generator sir cooler

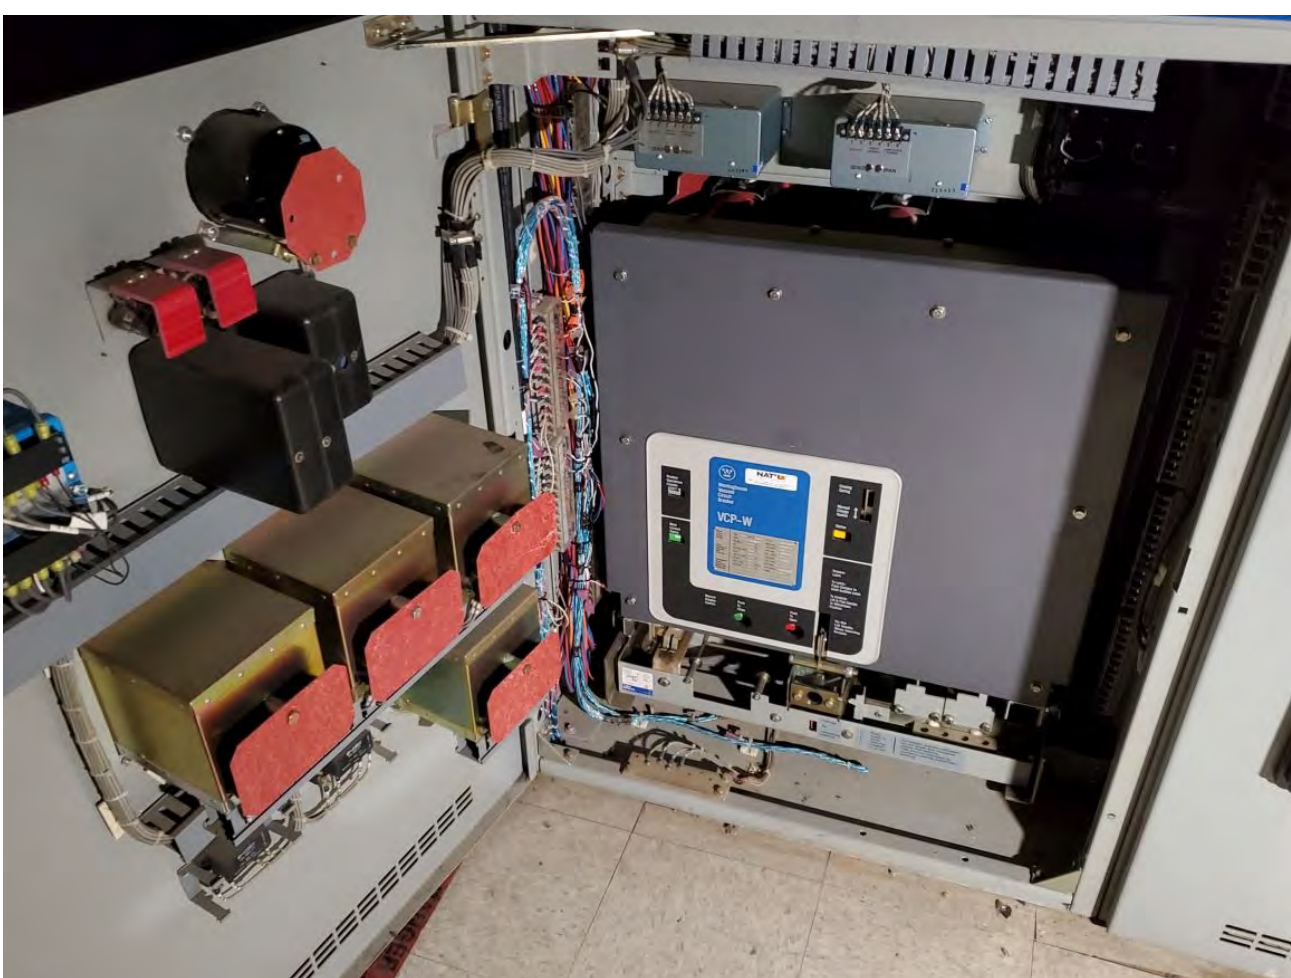
Photo 61: Typical fiberglass reinforced plastic components at a high voltage circuit breaker

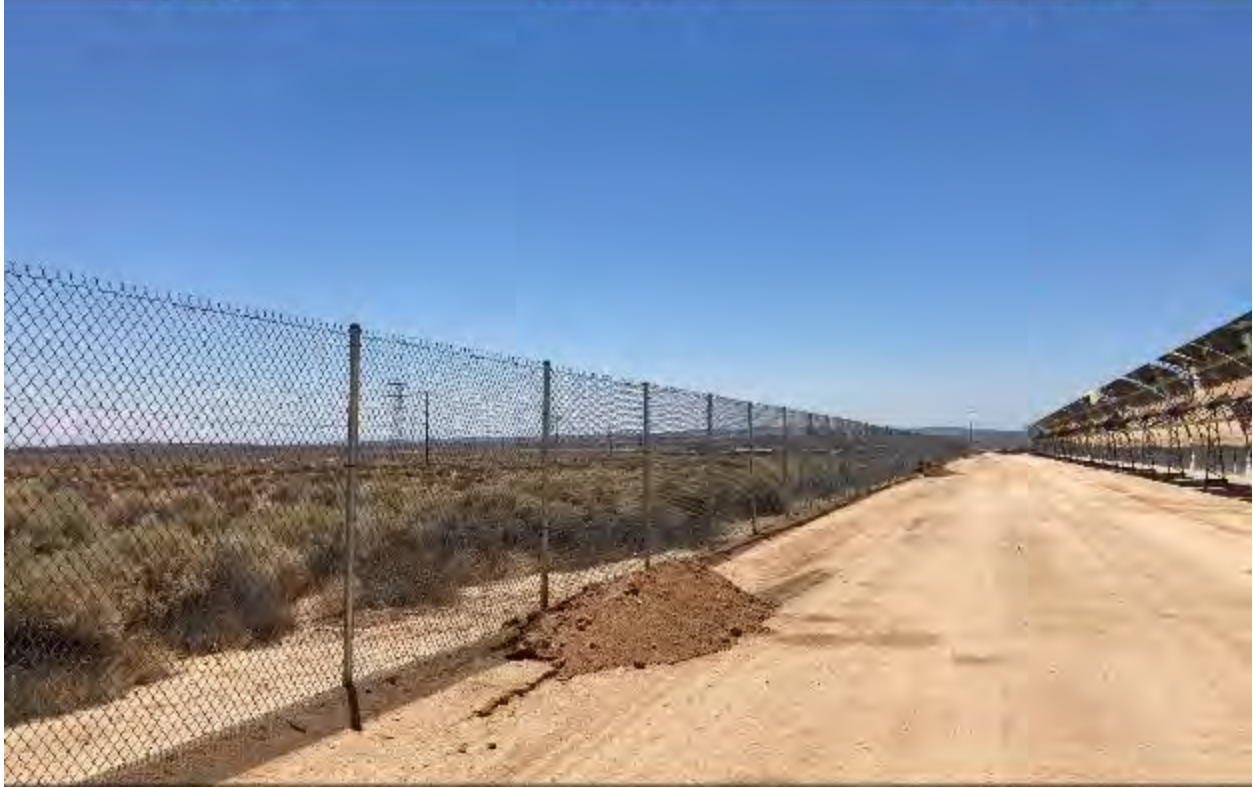
SEGSV: Holes in fence  
covered with soil st...

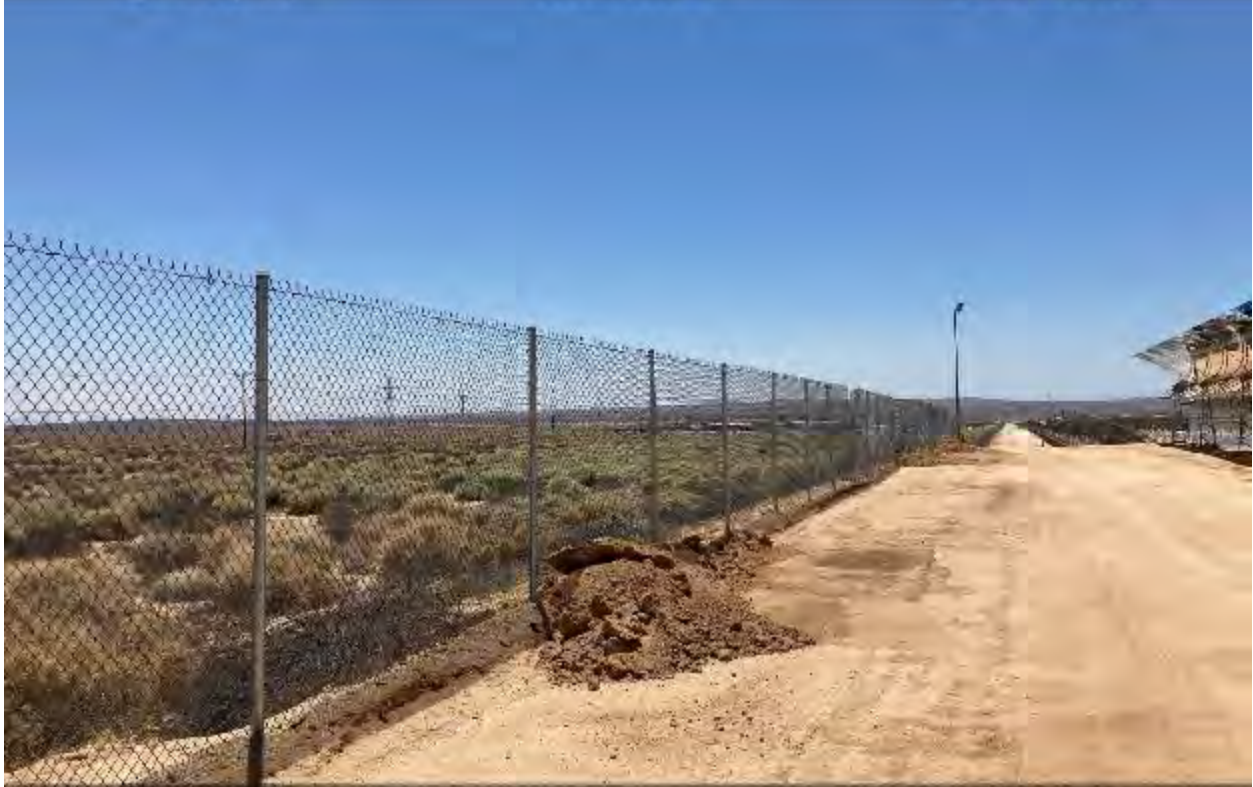
SEGSV: Holes in fence  
covered with soil st...

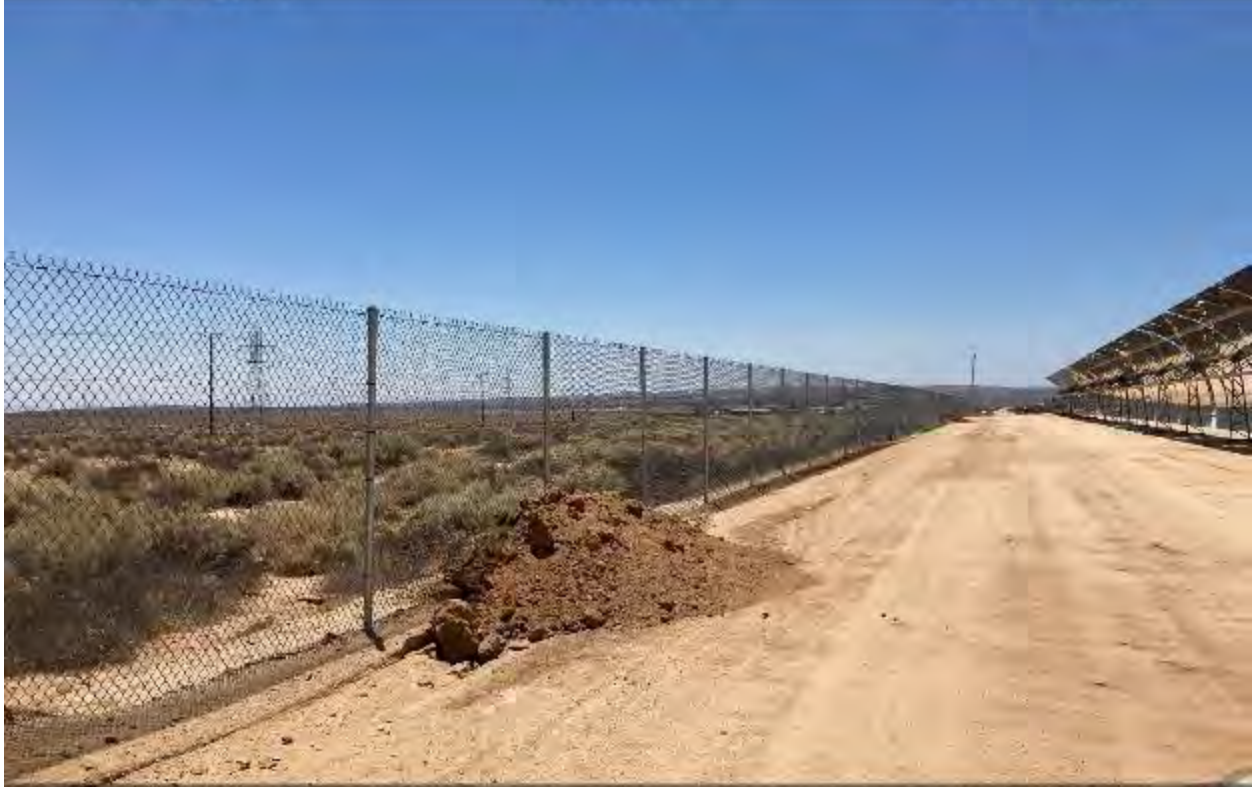
SEGSV: Holes in fence  
covered with soil st...

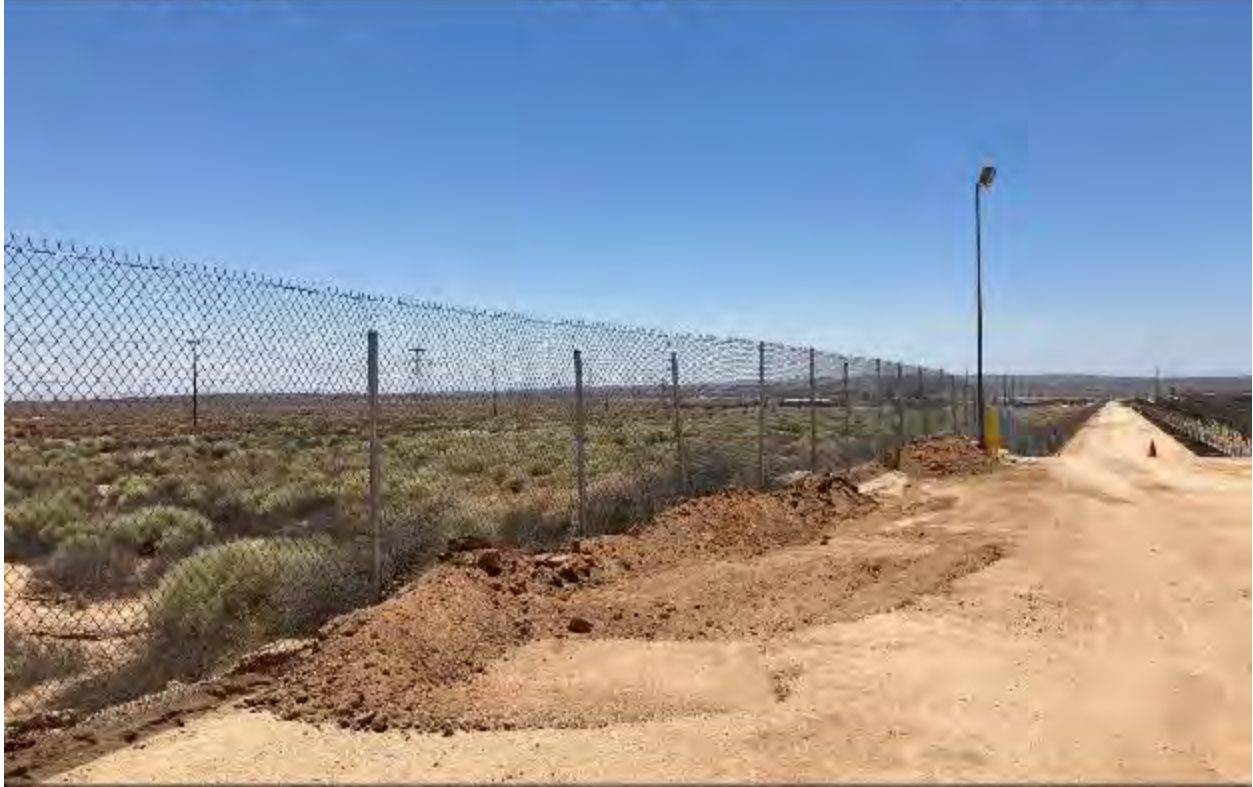
SEGSV: Holes in fence  
covered with soil st...

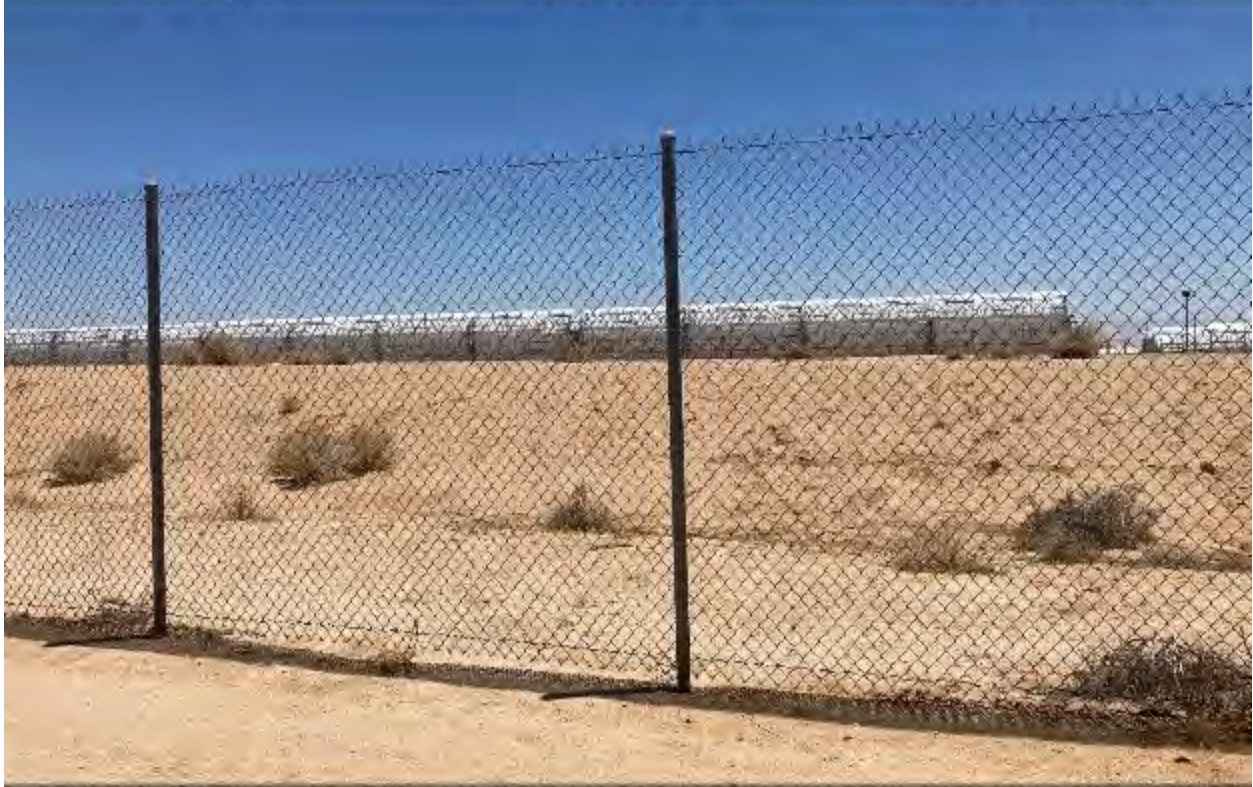
SEGSVI: Holes in  
fence

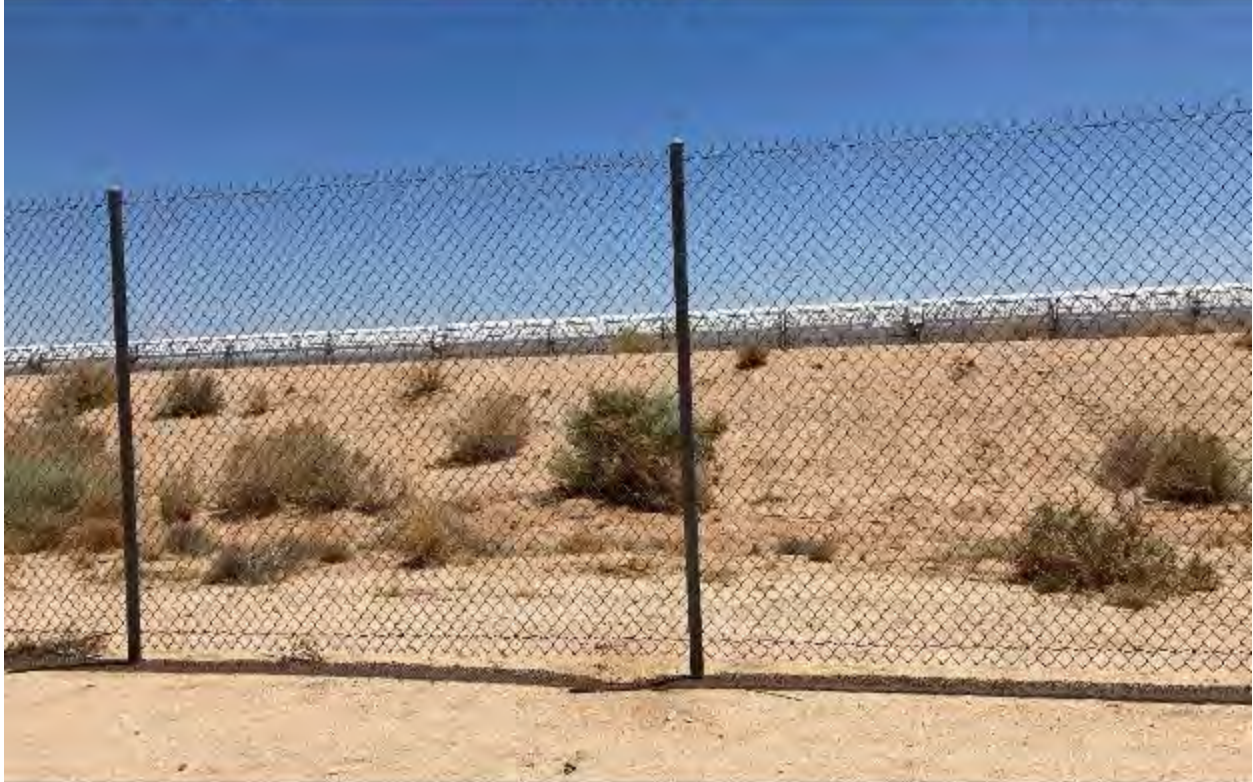
SEGSVI: Holes in  
fence

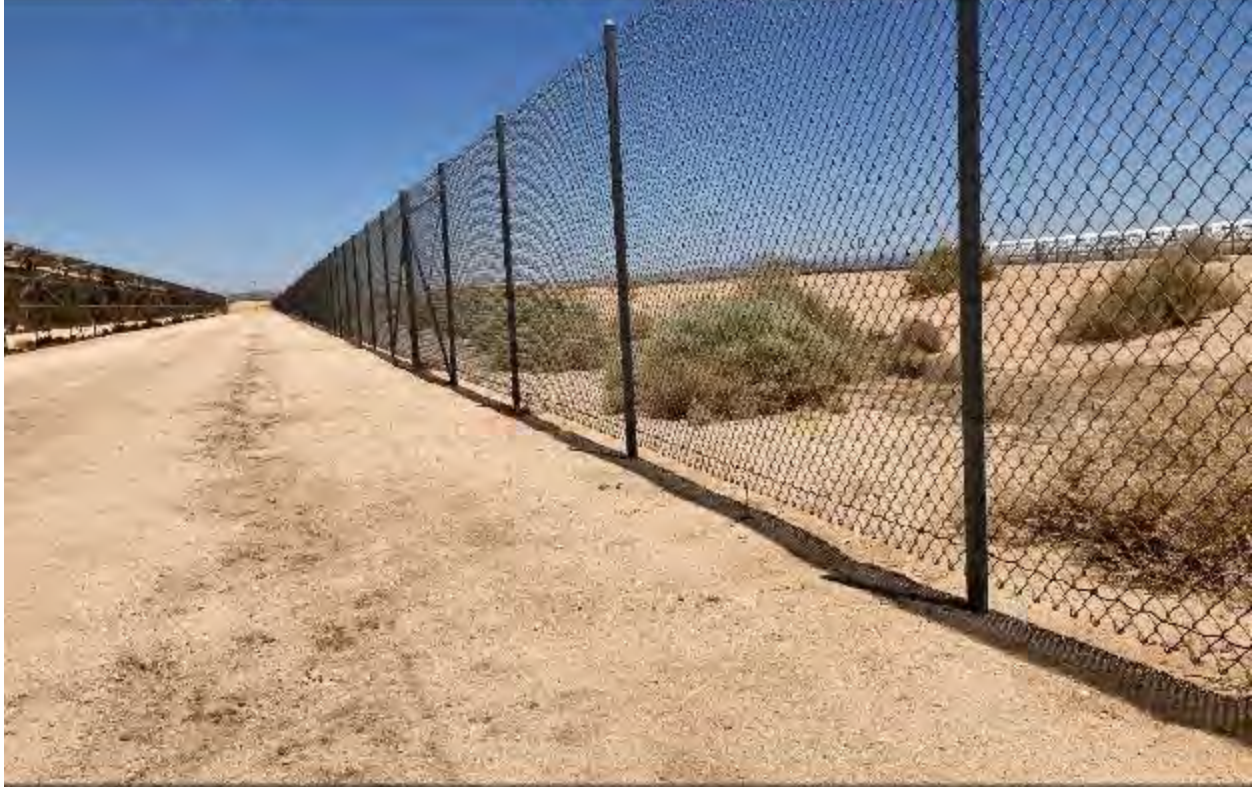
SEGSVI: Holes in  
fence

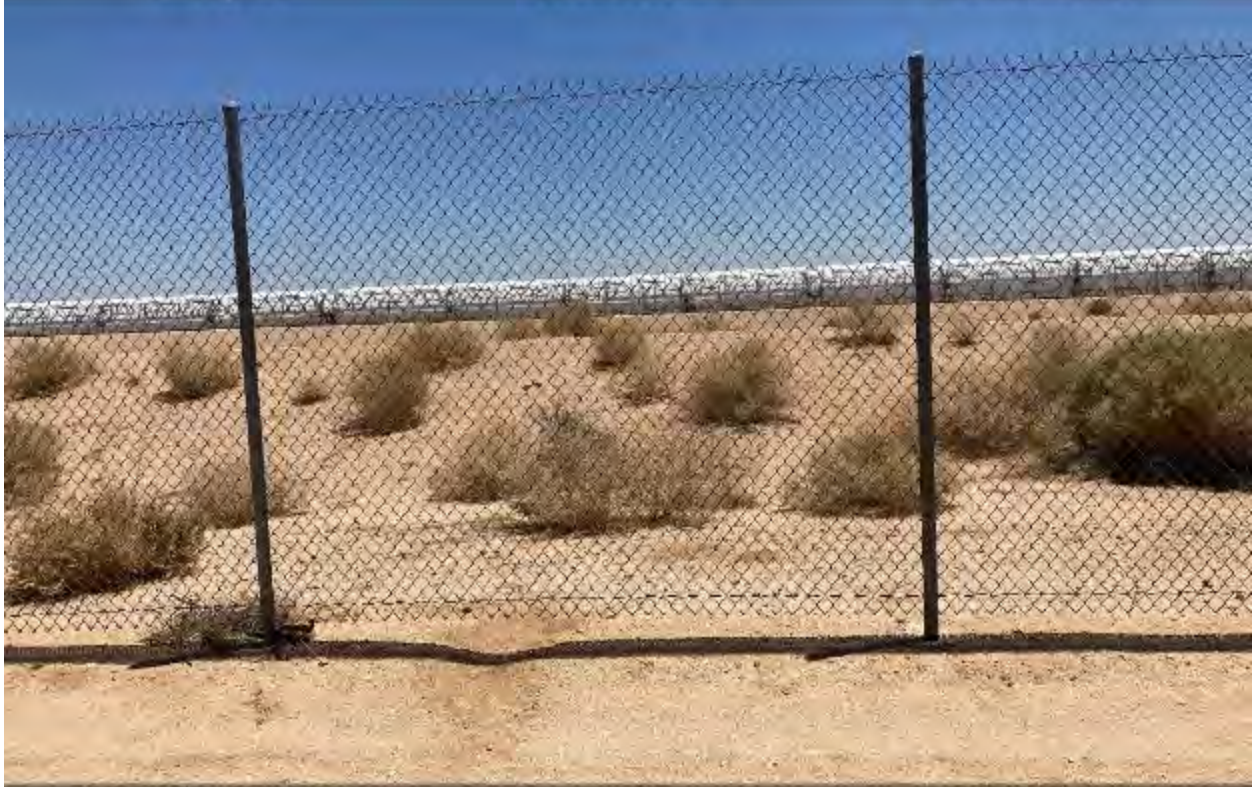
SEGSVI: Holes in  
fence

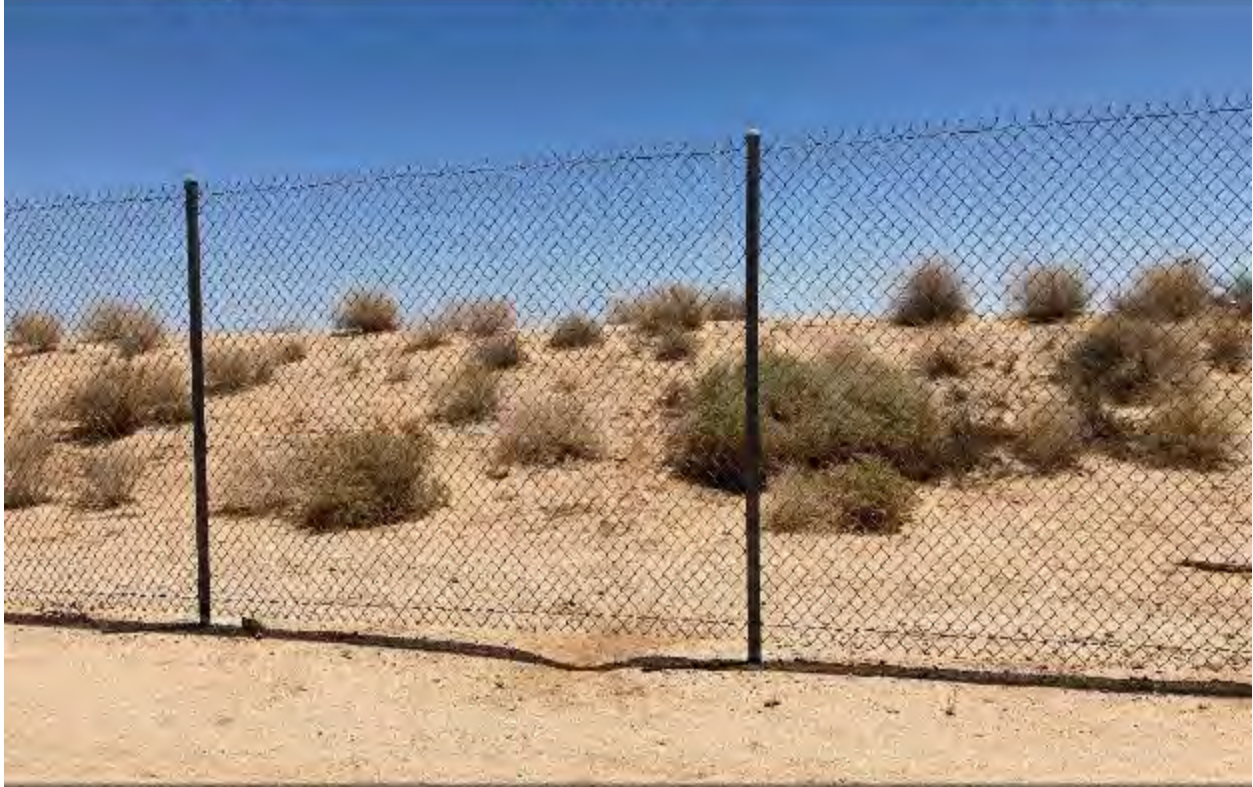
SEGSVI: Holes in  
fence

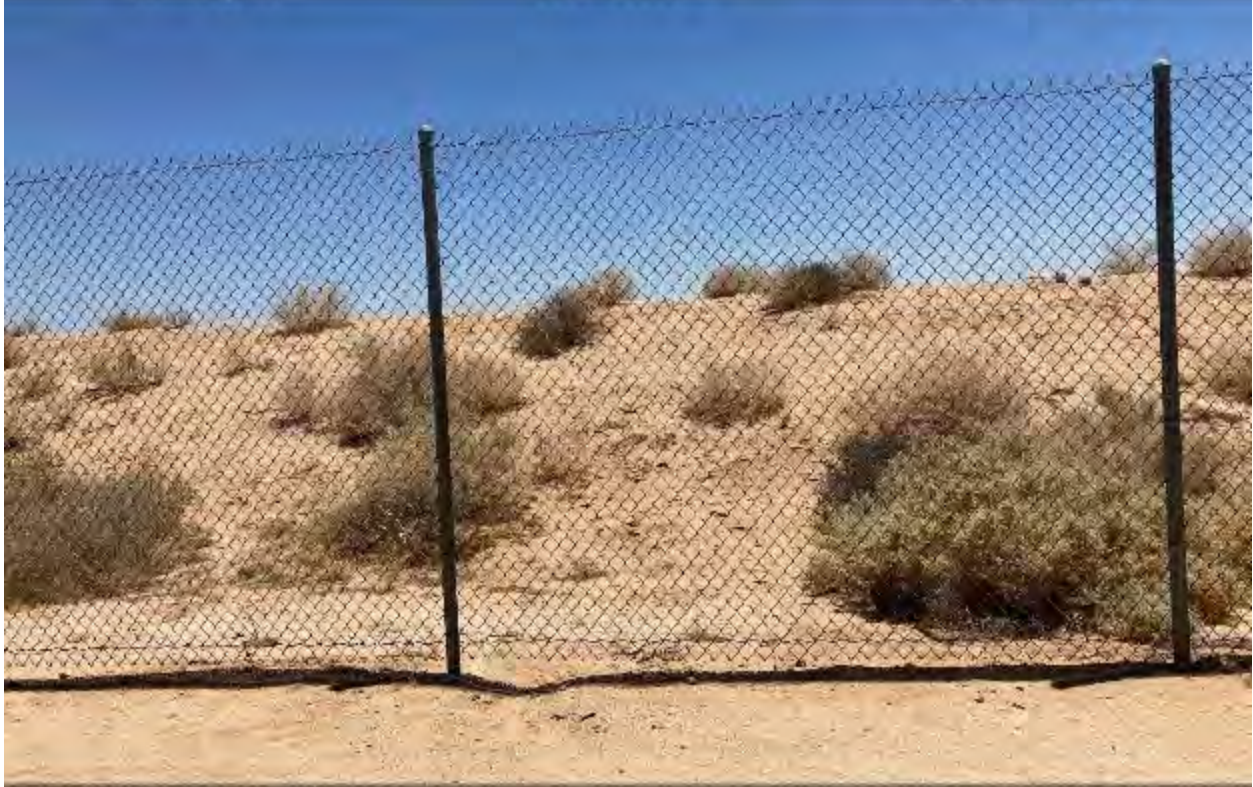
SEGSVI: Holes in  
fence

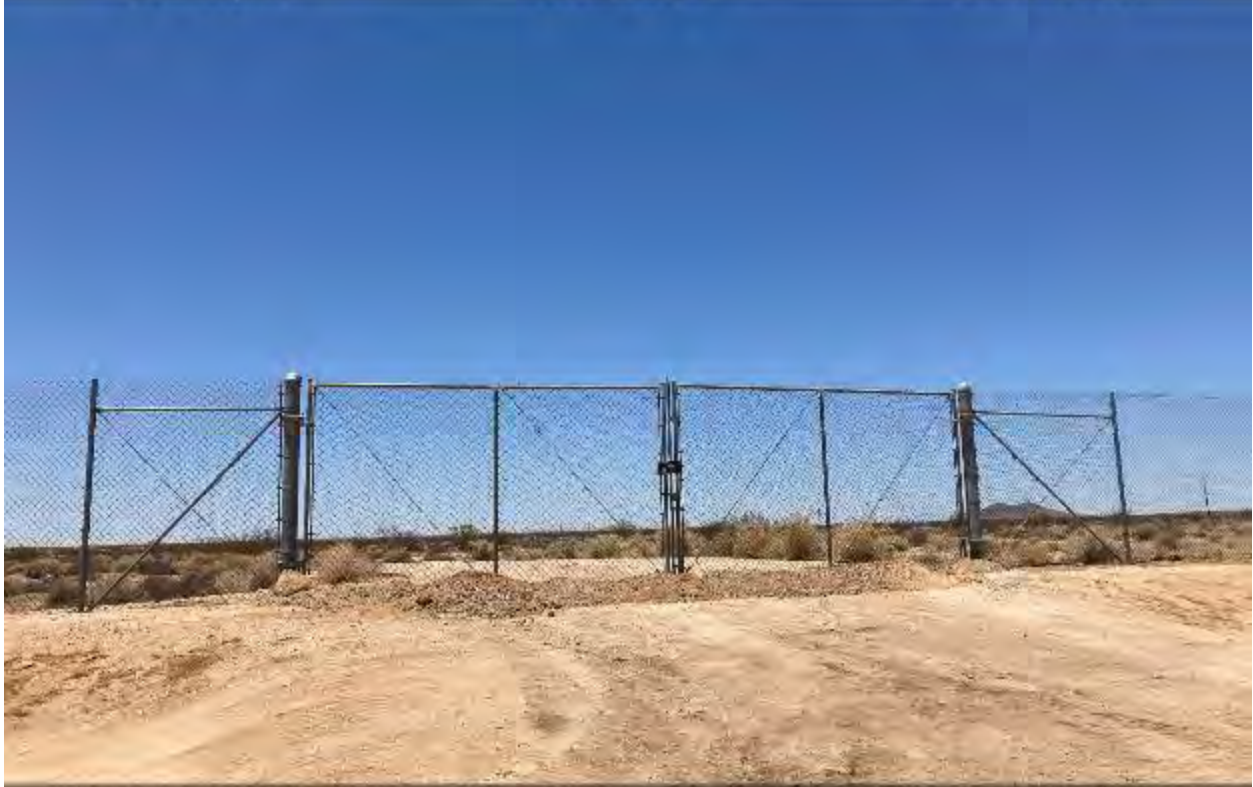
SEGSVI: Holes in  
fence patched

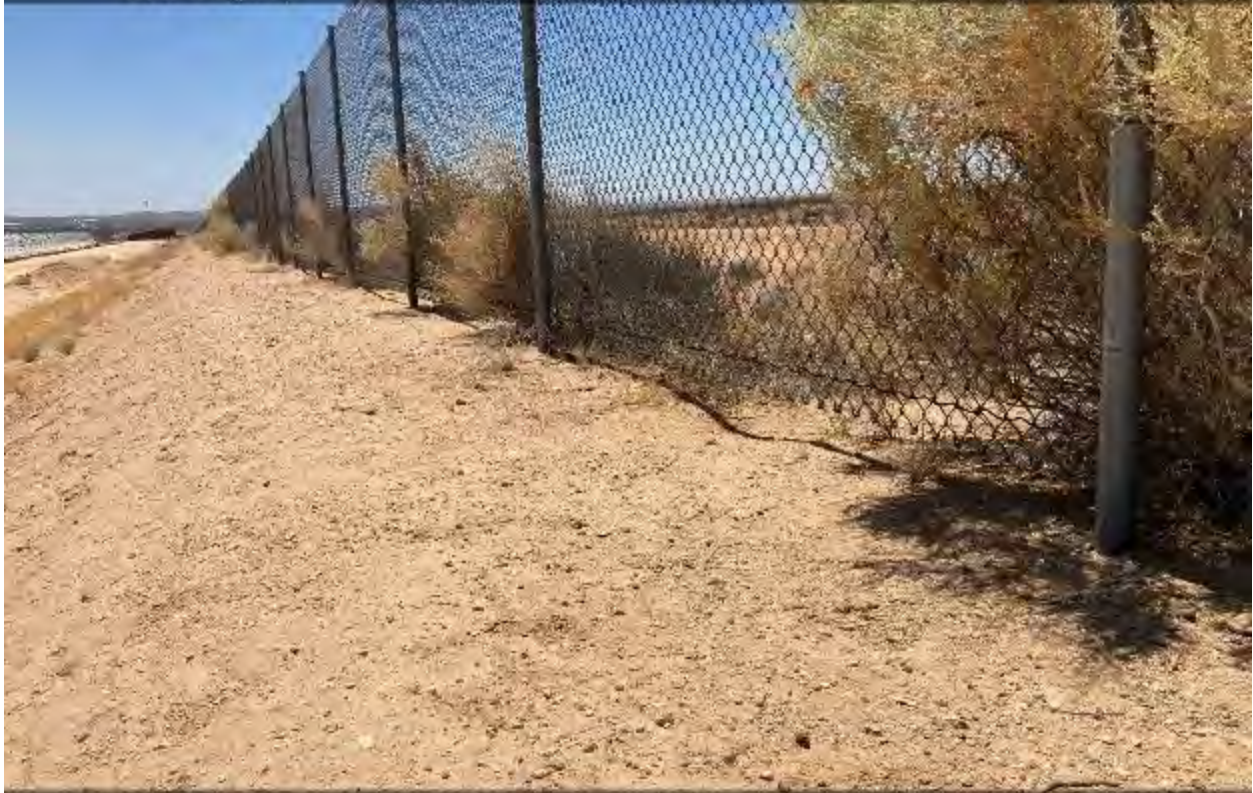
SEGSVI: Holes in  
fence

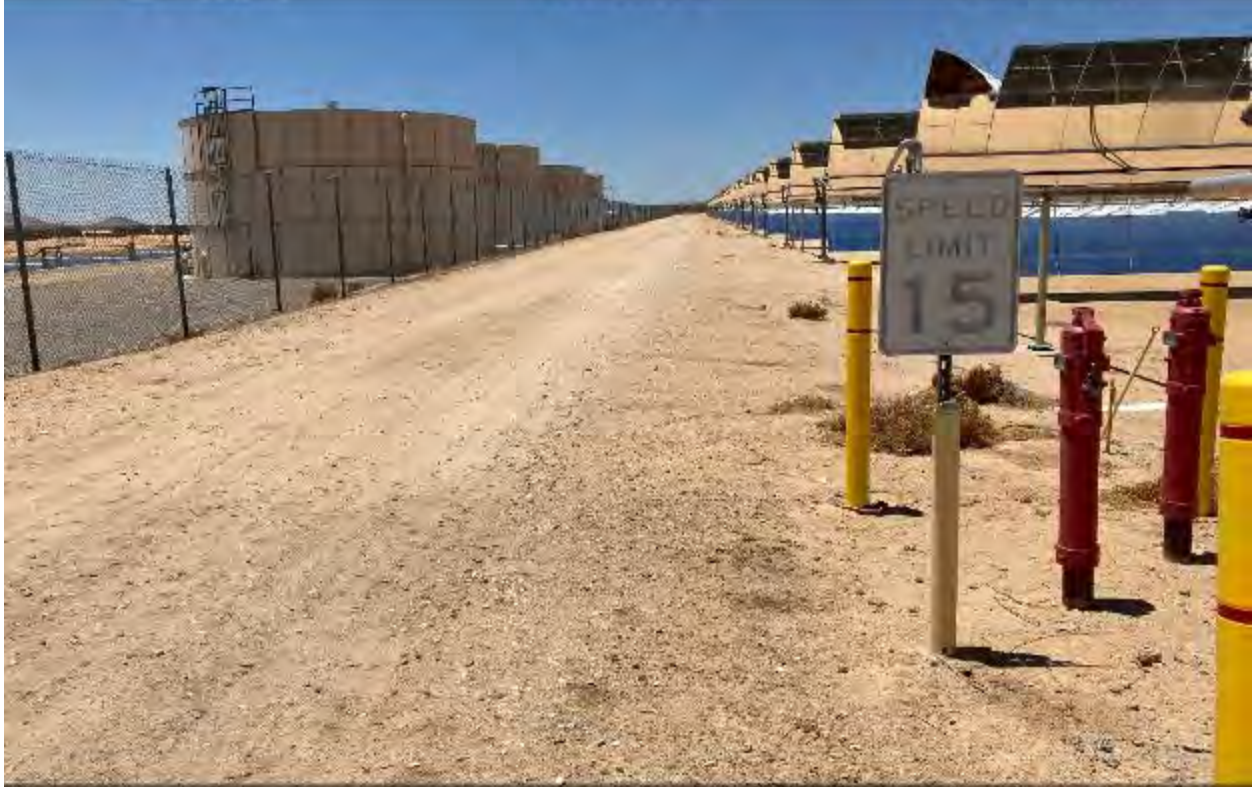
SEGSVI: 15 MPH signs  
observed

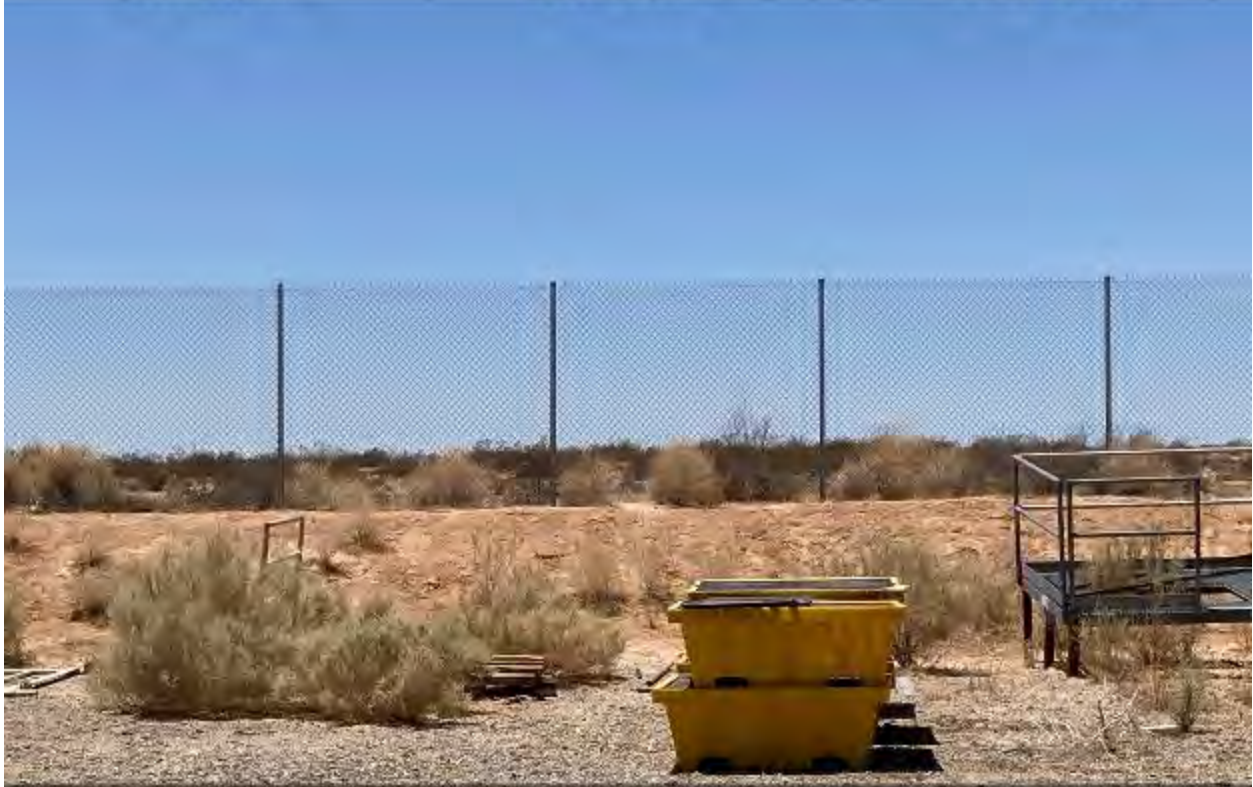
WOPE: holes in fence

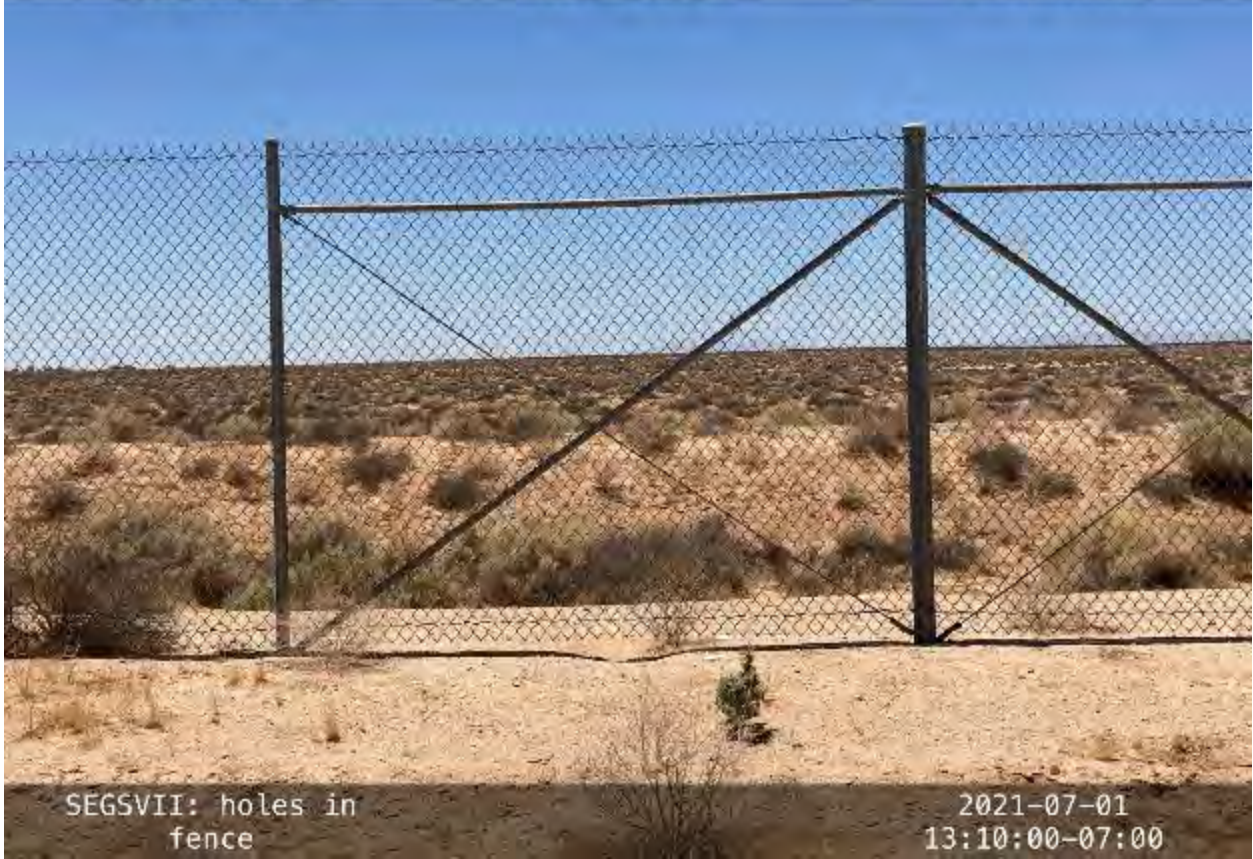
SEGSVII: holes in  
fence
