<b>DOCKETED</b>	
<b>Docket Number:</b>	87-AFC-01C
<b>Project Title:</b>	COMPLIANCE-Luz Solar Electric Generating System Cogeneration AFC (150 MW) Units III-VII.
<b>TN #:</b>	241138
<b>Document Title:</b>	Petition to Amend Boundary Change Appendix B Part I - SEGS III-VII
<b>Description:</b>	N/A
<b>Filer:</b>	Scott Galati
<b>Organization:</b>	DayZenLLC
<b>Submitter Role:</b>	Applicant Representative
<b>Submission Date:</b>	1/11/2022 2:18:22 AM
<b>Docketed Date:</b>	1/11/2022

## **APPENDIX B**

Monthly Compliance Reports and Biological Memorandum

Subject: SEGS III-VII Decommissioning (87-AFC-01C) Monthly Compliance Report for June 2021

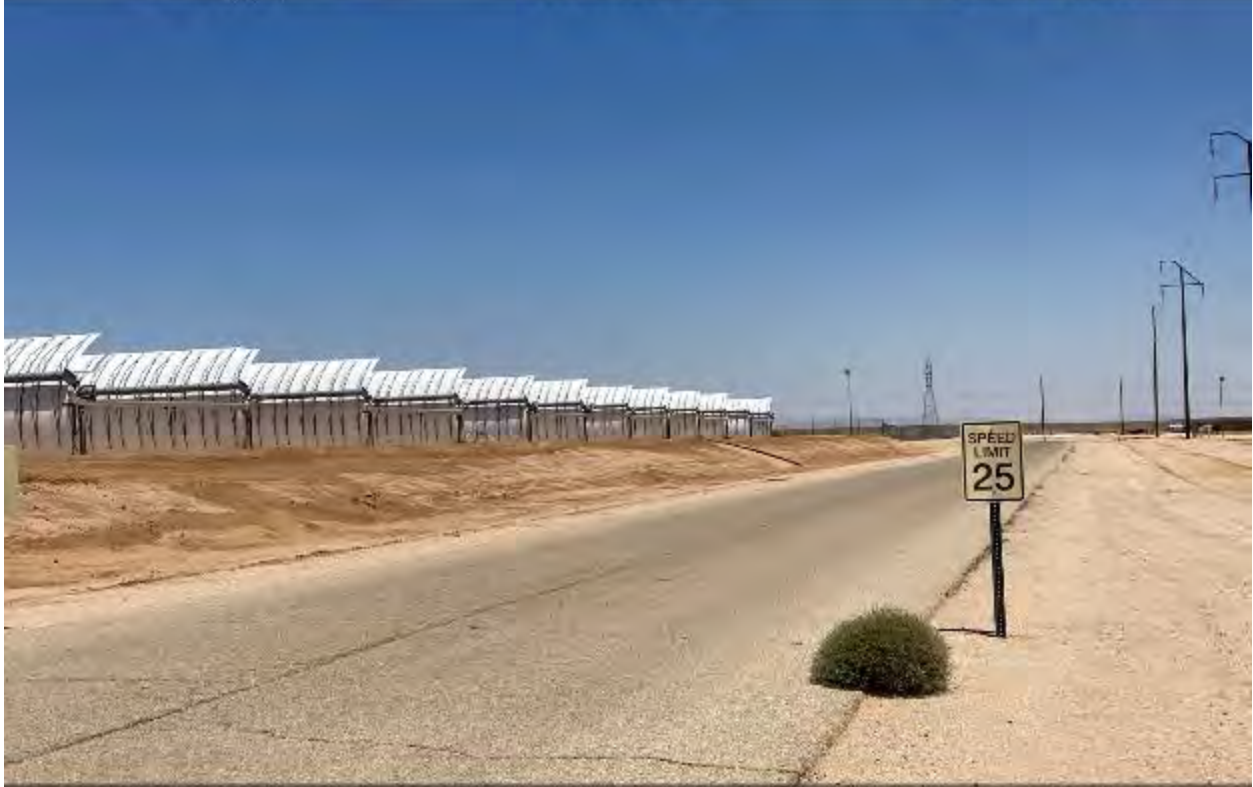
25 MPH signs observed

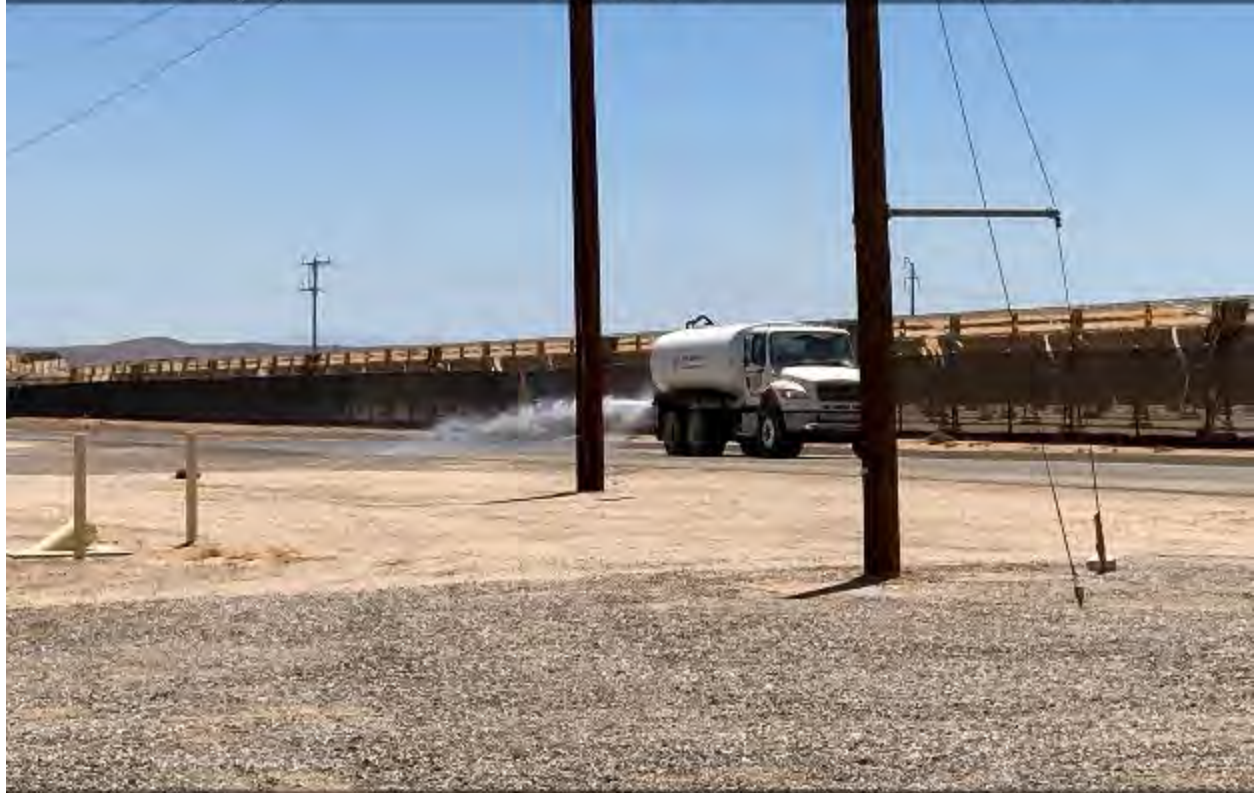
Dust suppression

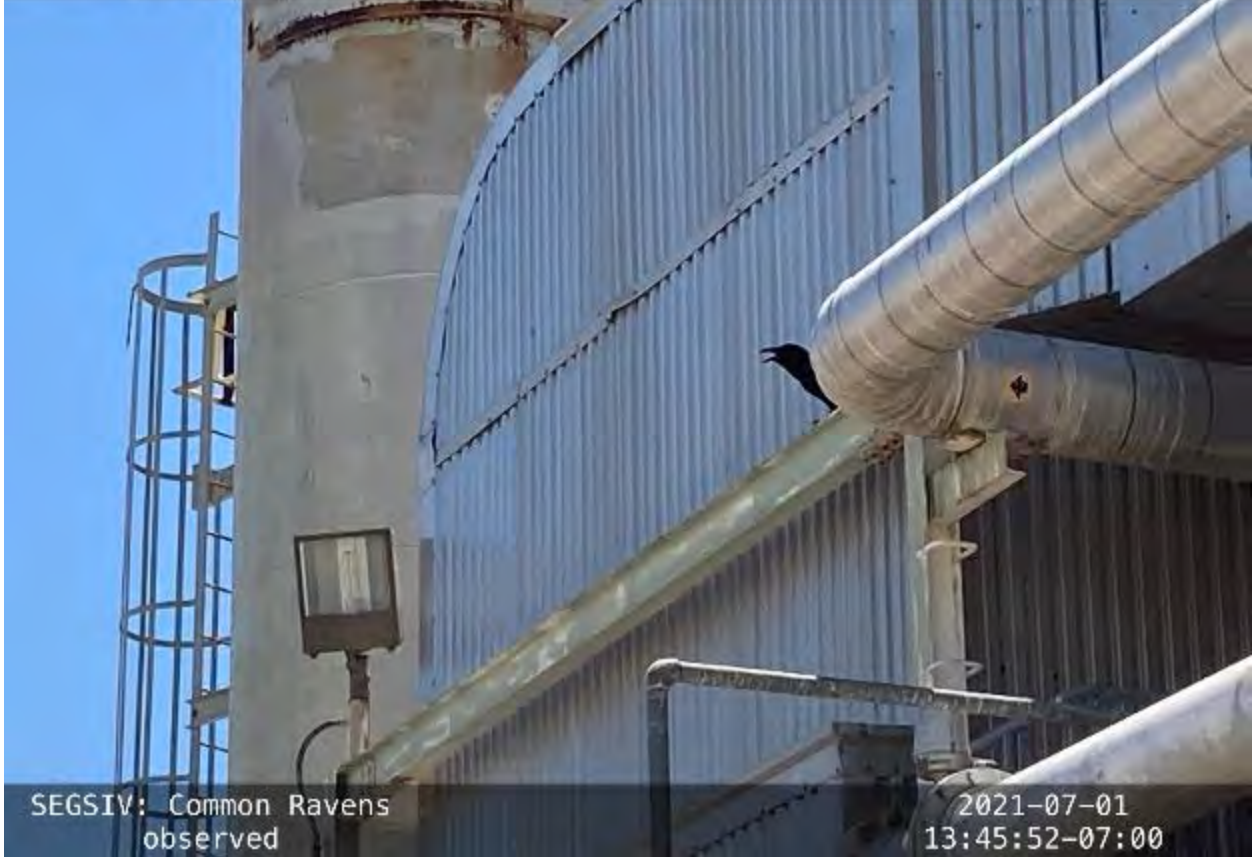
SEGSIV: Common Ravens  
observed

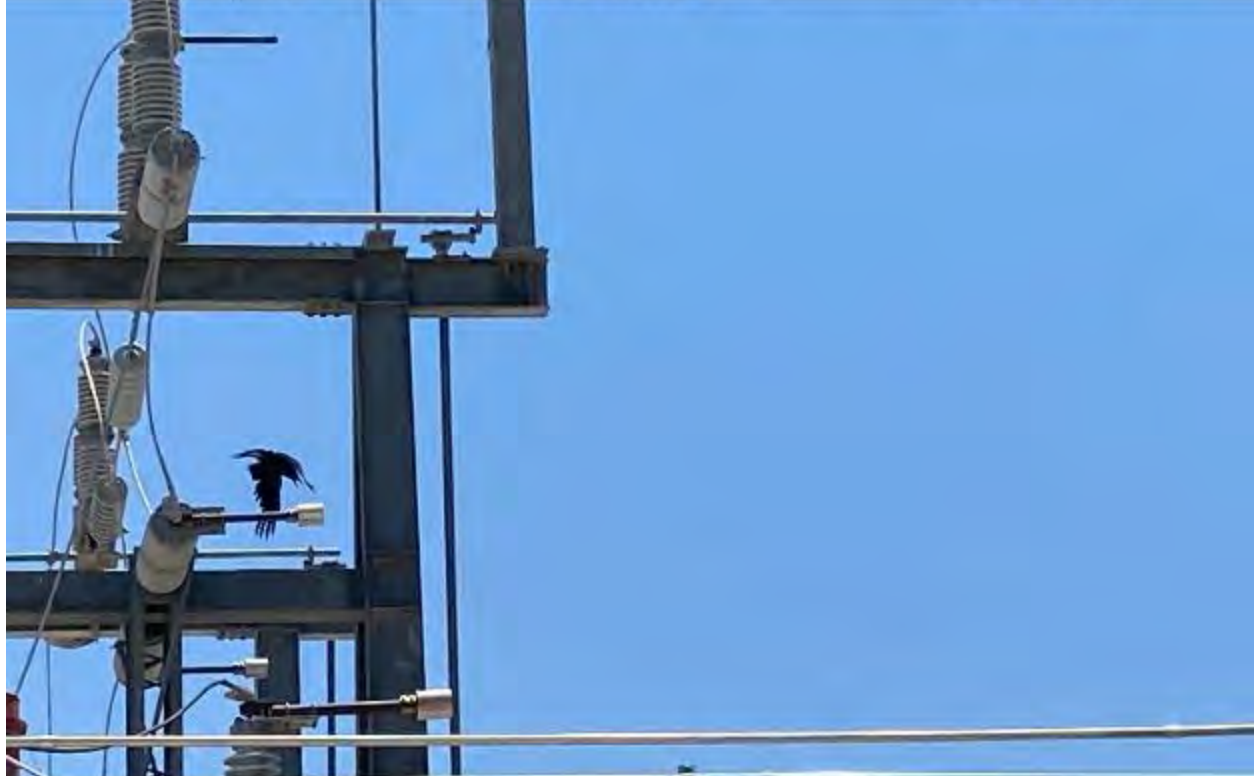
SEGSIV: Common Ravens  
observed

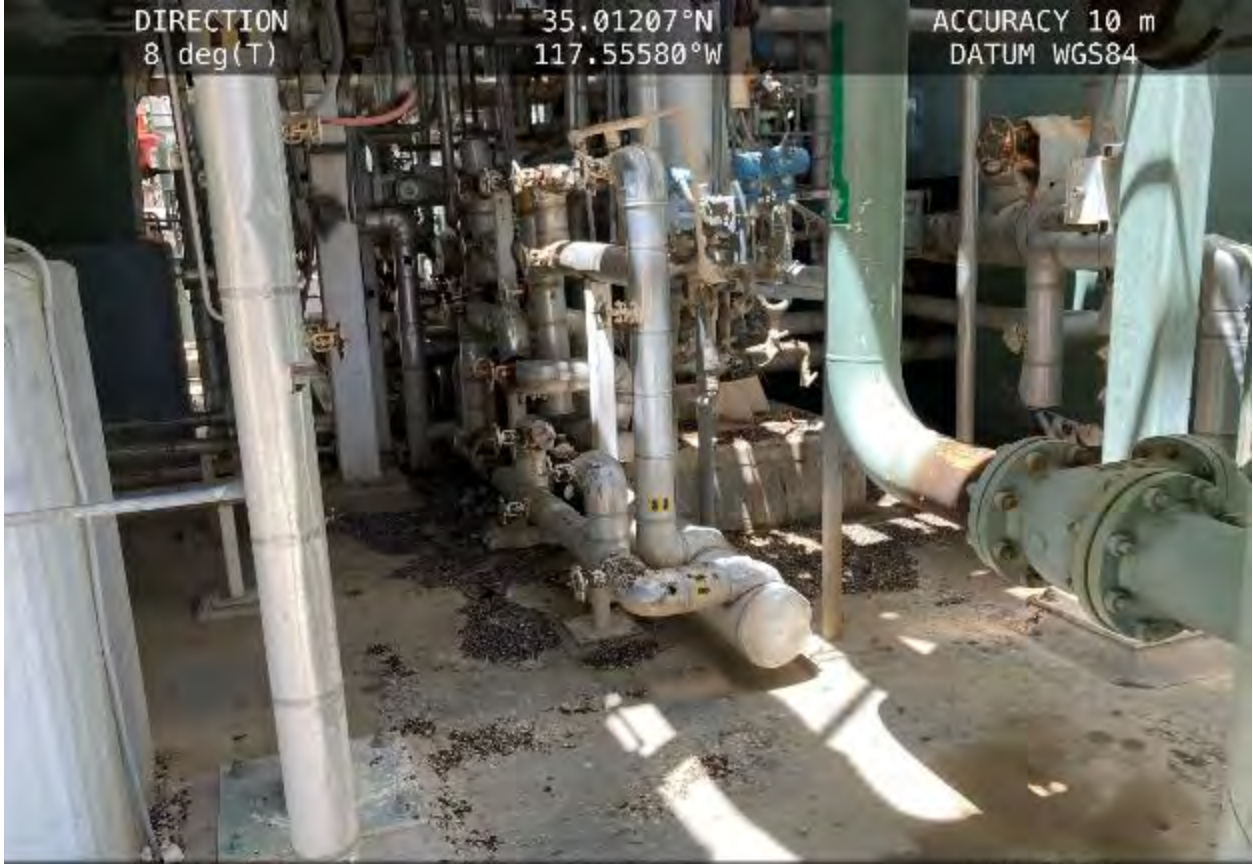
SEGSIV: Bird feces

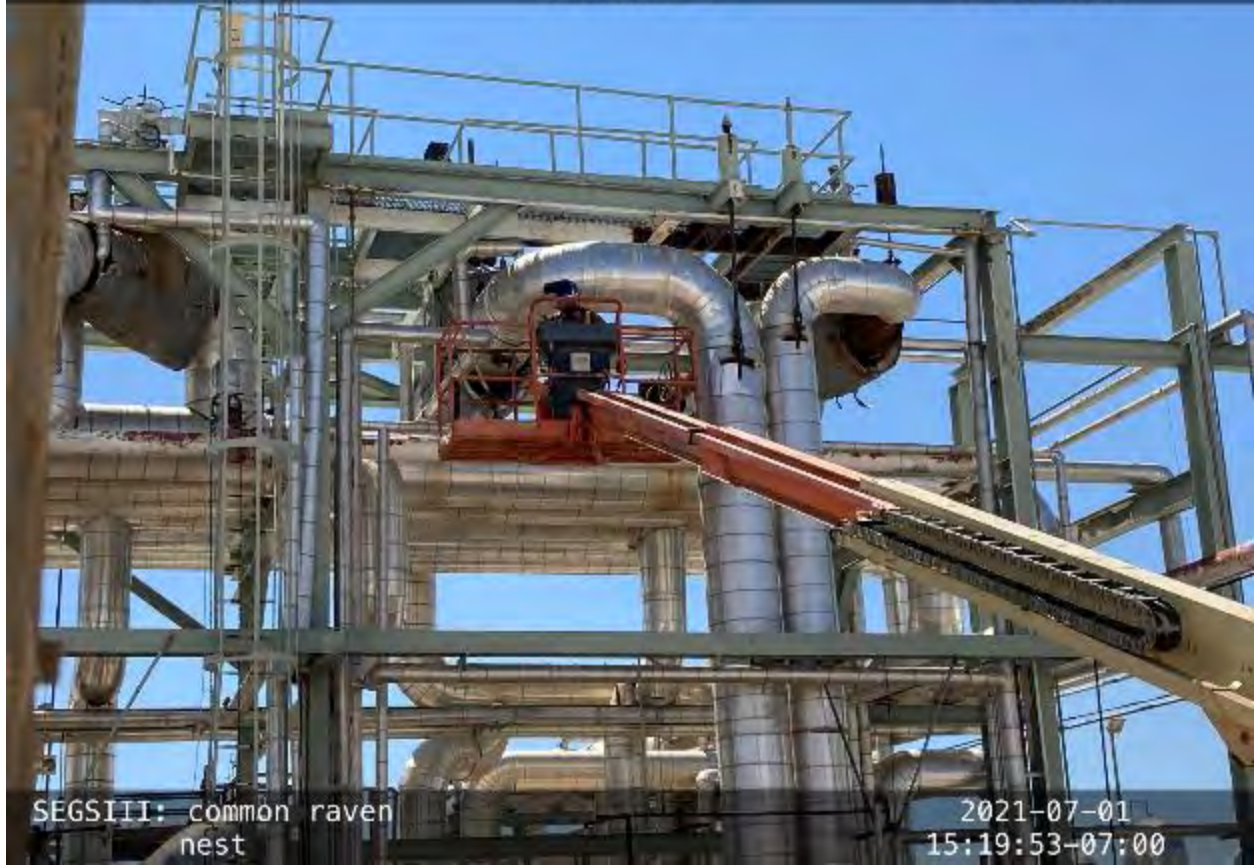
**Notes on Photos Taken Onsite:** Photos capture: Fence gaps observed, and those mended gaps, SEGS IV Power Block bird activity, SEGS III power block demo activity and common Raven's nest observed via bucket truck by contractor confirmed to be abandoned.

SEGSIII: common raven  
nest

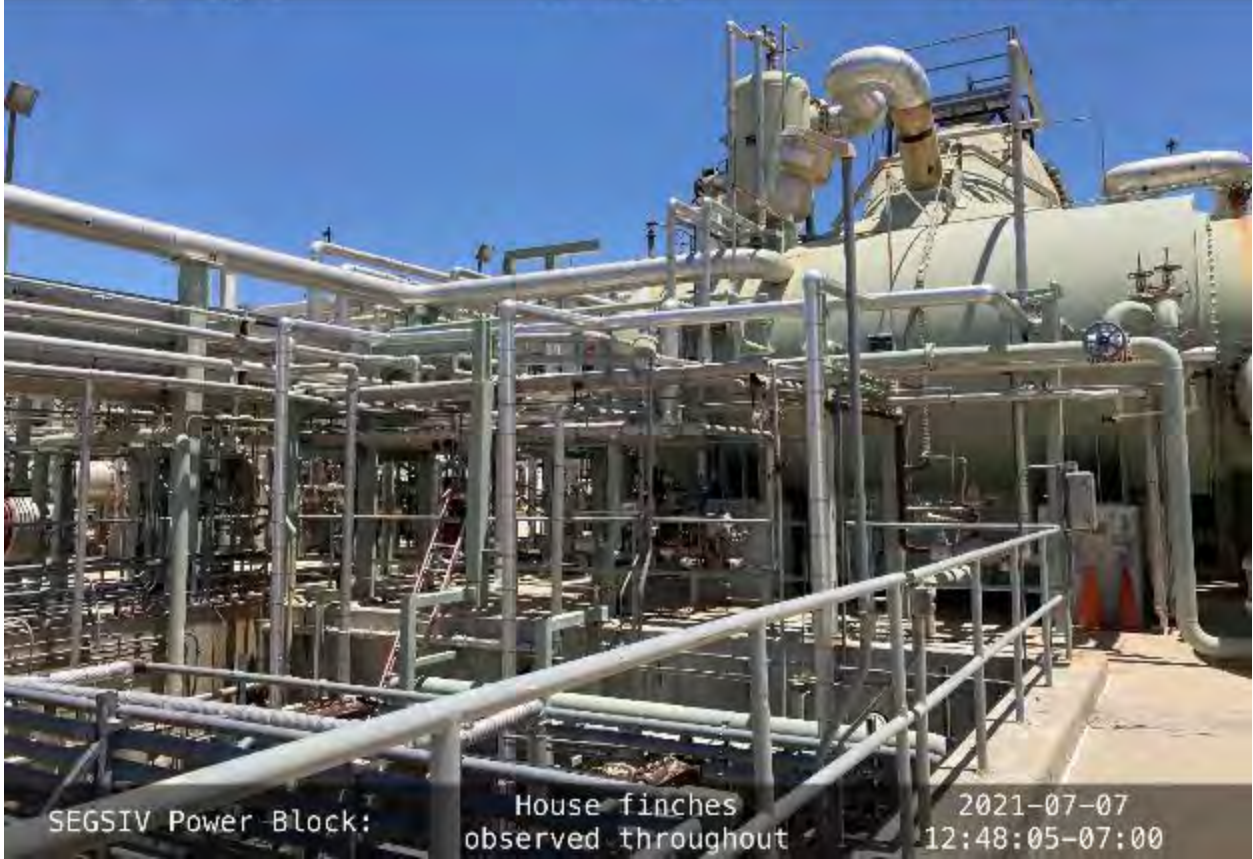
**Notes on Photos Taken Onsite:** APPROX. 100 house finches observed at SEG SIV Power Block pipes. Will continue to monitor area potential nesting occurring. Crews should avoid area. NO <sup>immediate</sup> work is scheduled in SEG SIV power block, except demolishing cooling tower next week.

SEGSIV Power Block:

House finches  
observed throughout

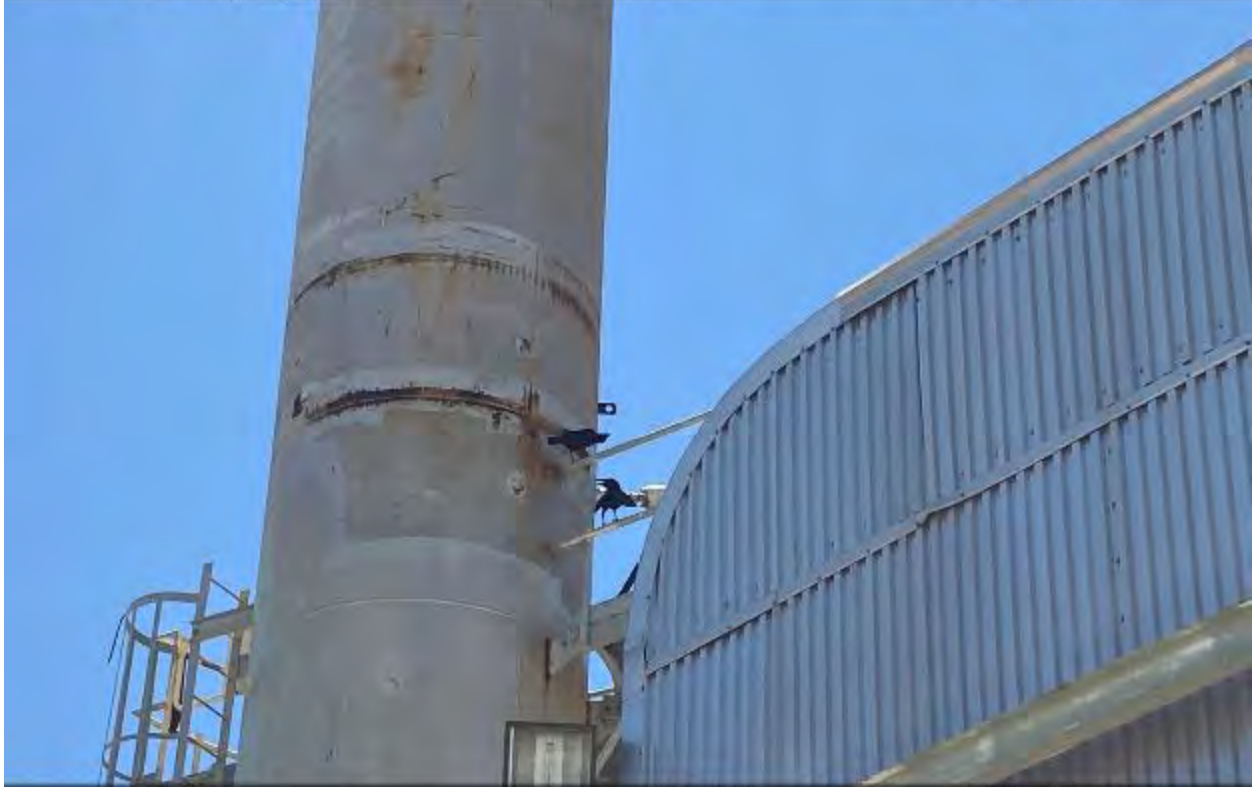
SEGSIV Power Block:

Common ravens  
perched

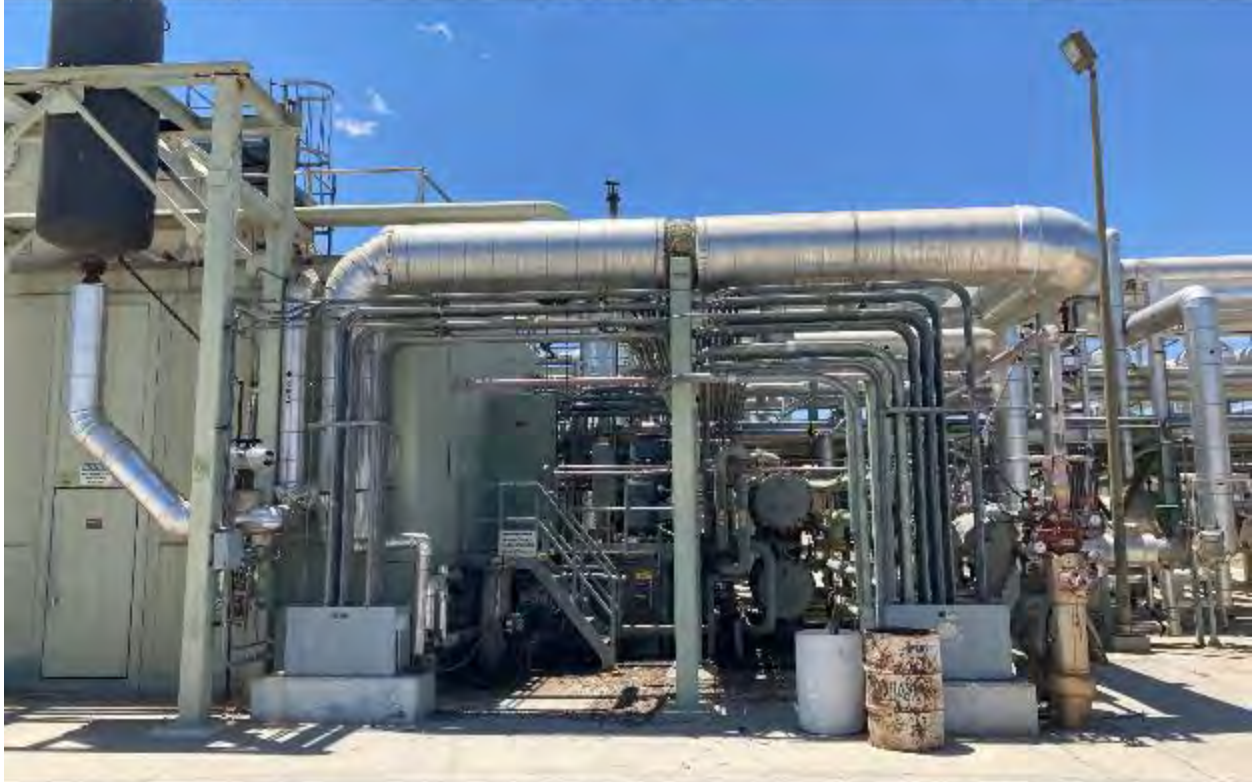
SEGSIV Power Block:

Significant house  
finch activity

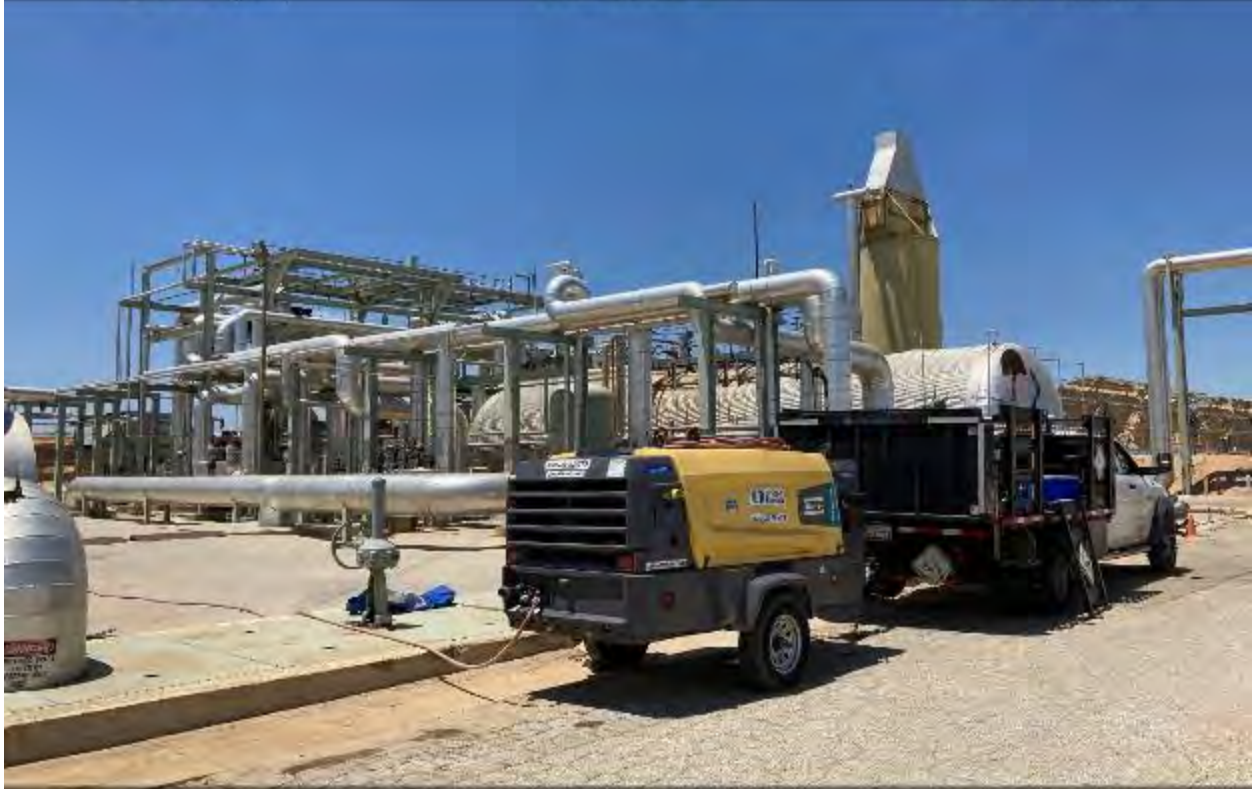
SEGSIV Power Block:

HTF draining taking  
place

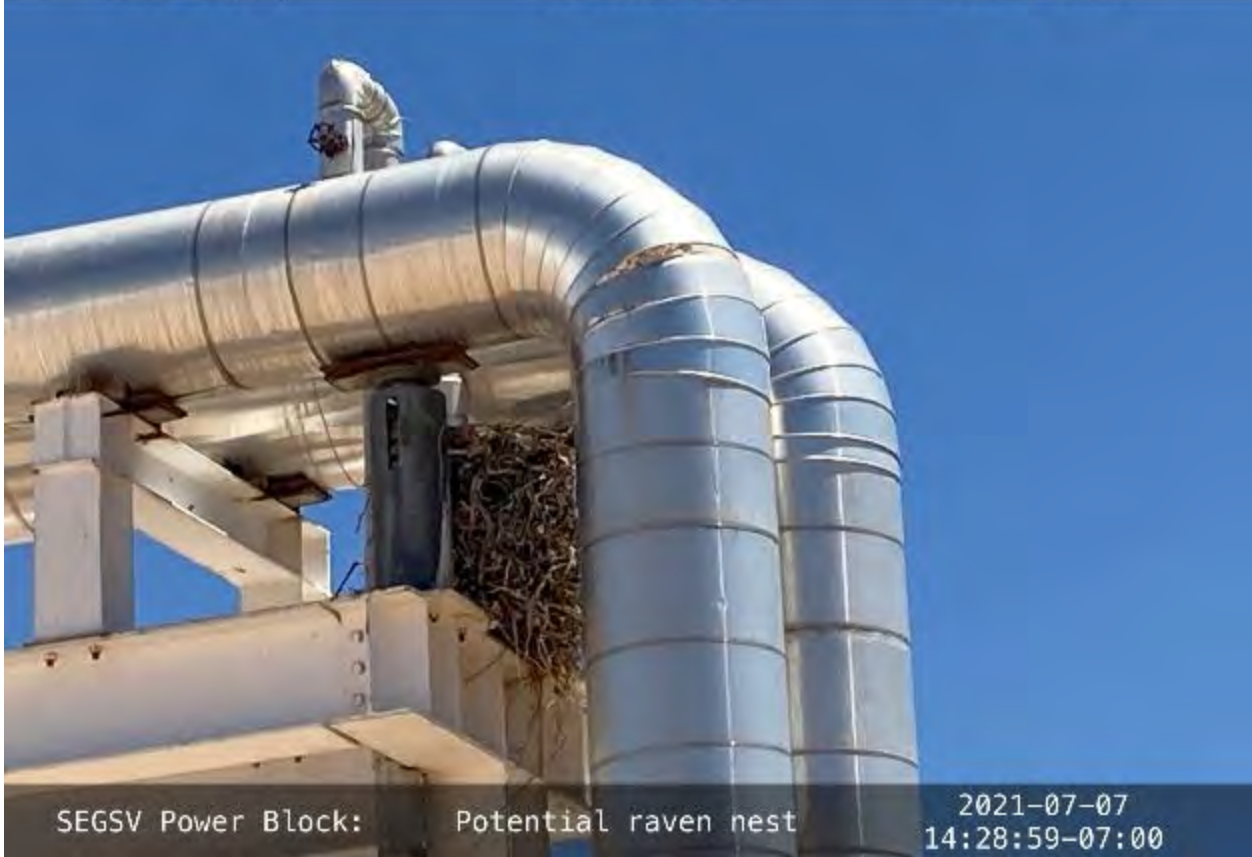
SEGSV Power Block:

Potential raven nest

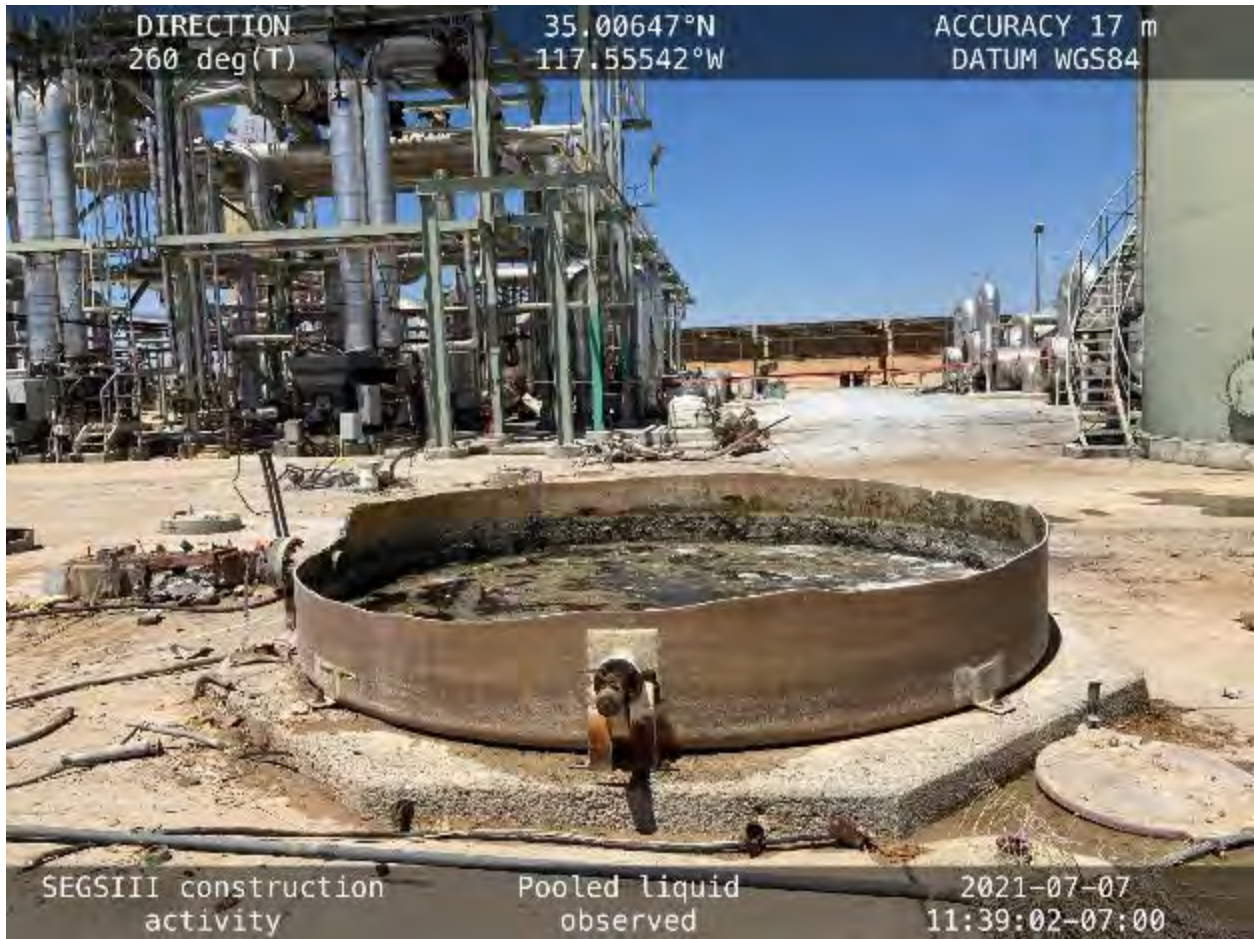
Pooled liquid  
observed

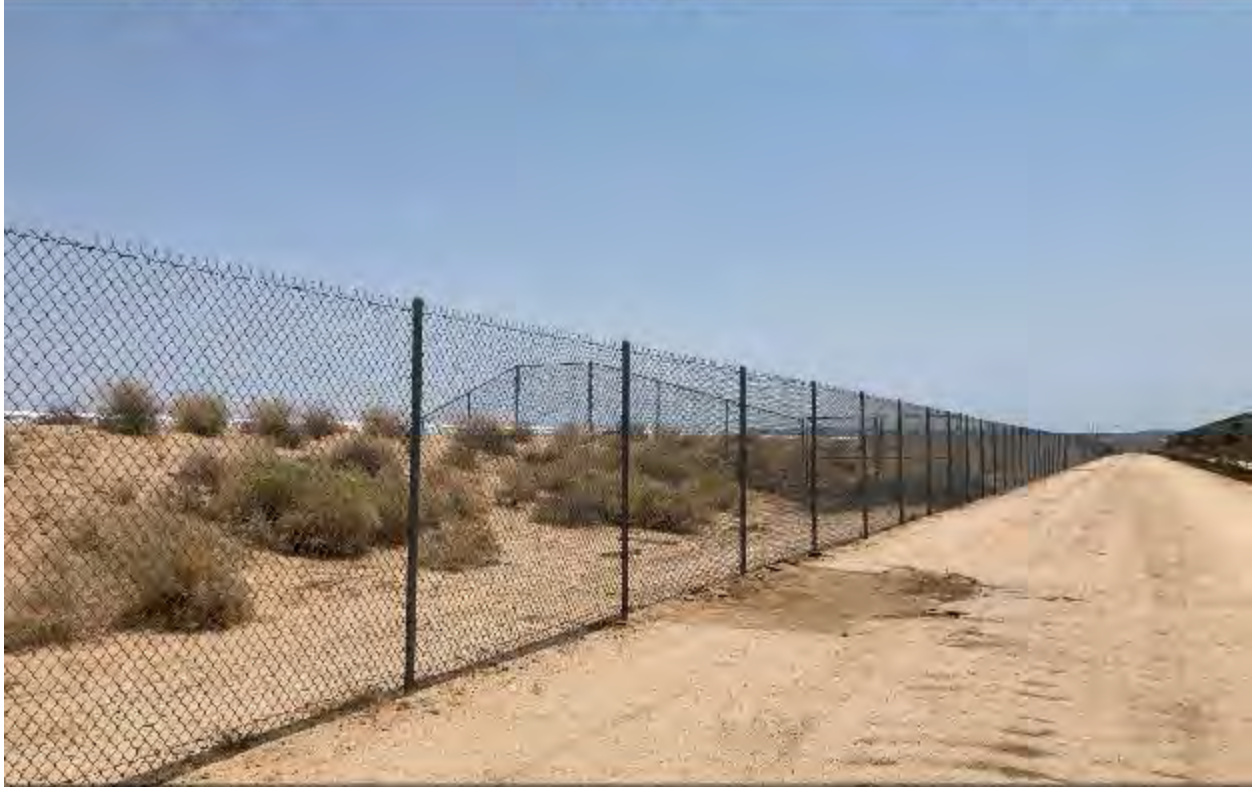
SEGSVI fence gap  
filled

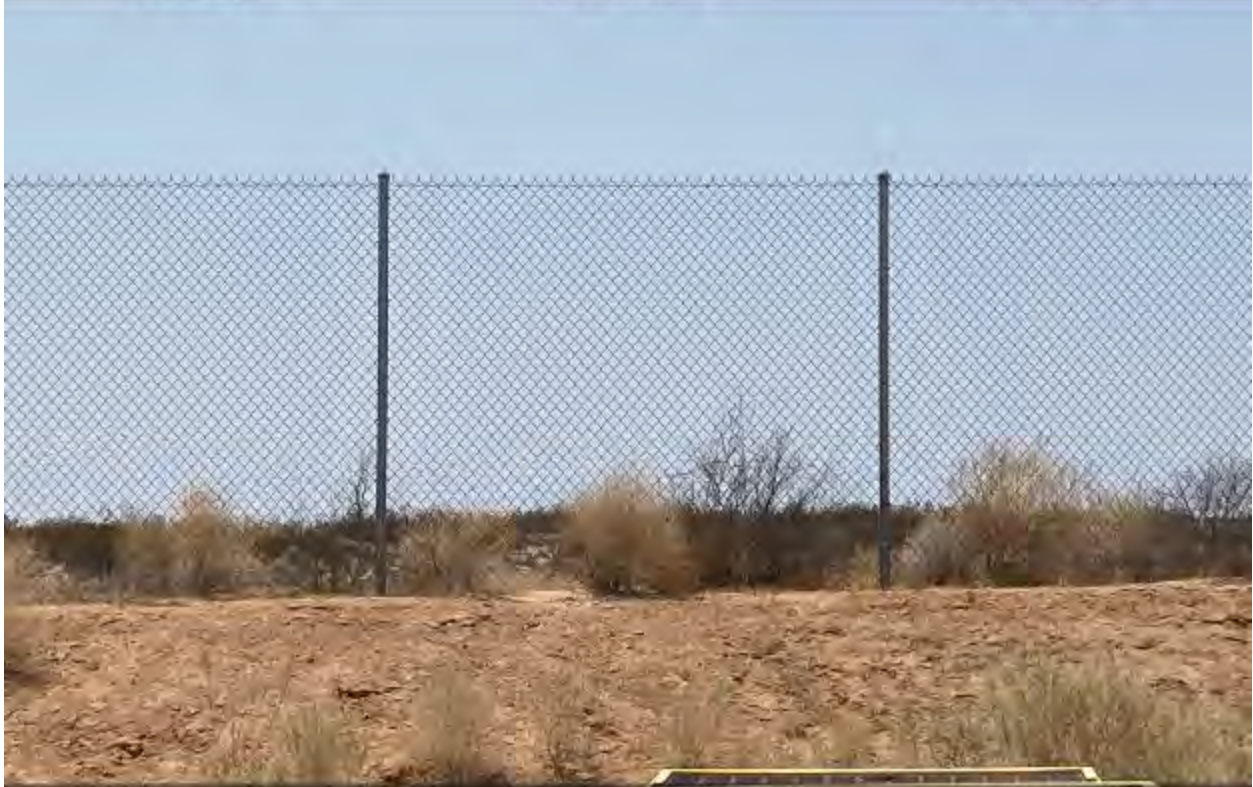
SEGSVI/VII fence gap

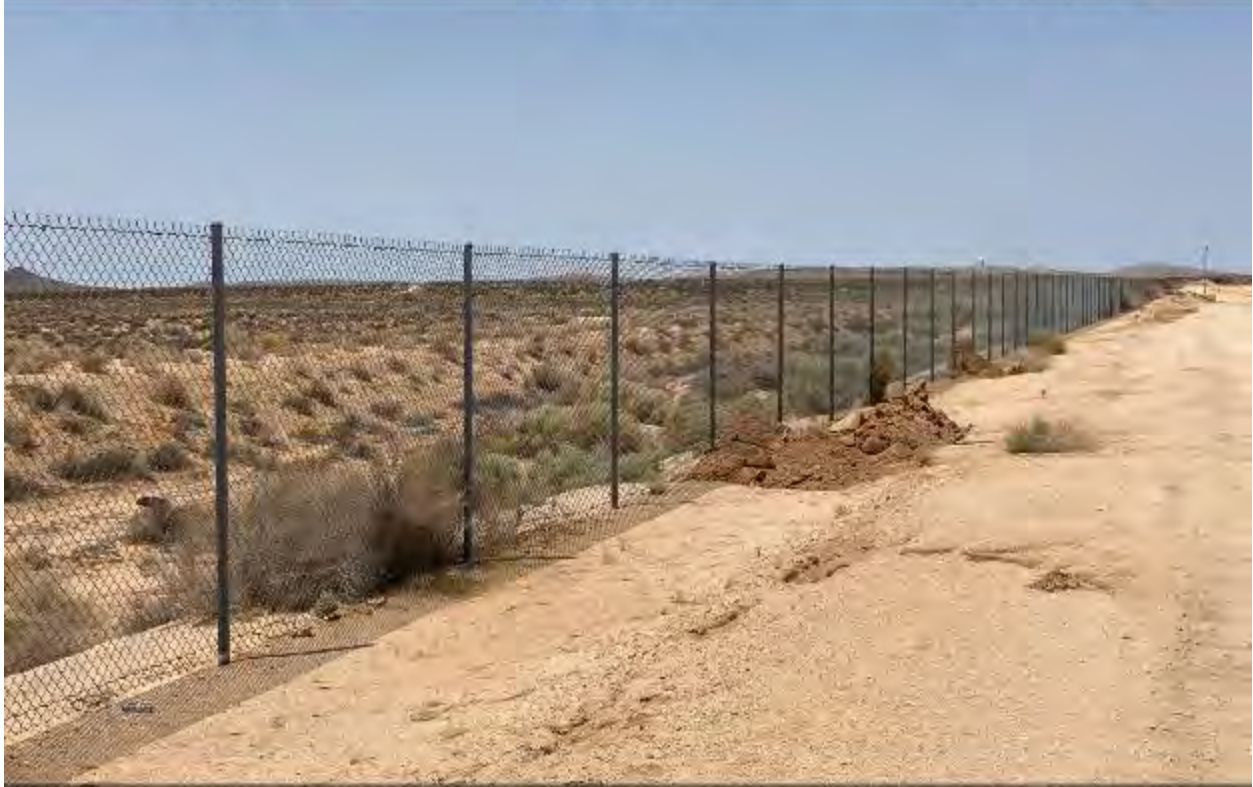
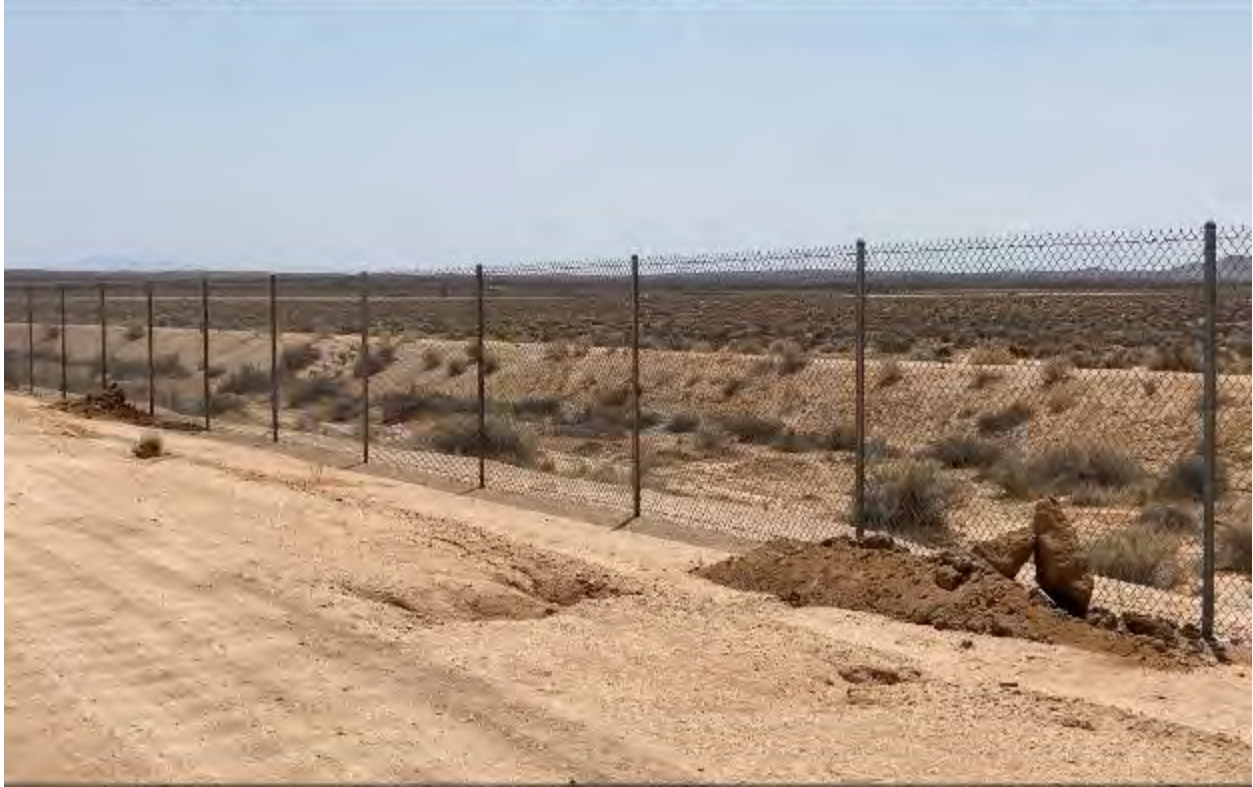
SEGSVII fence gap

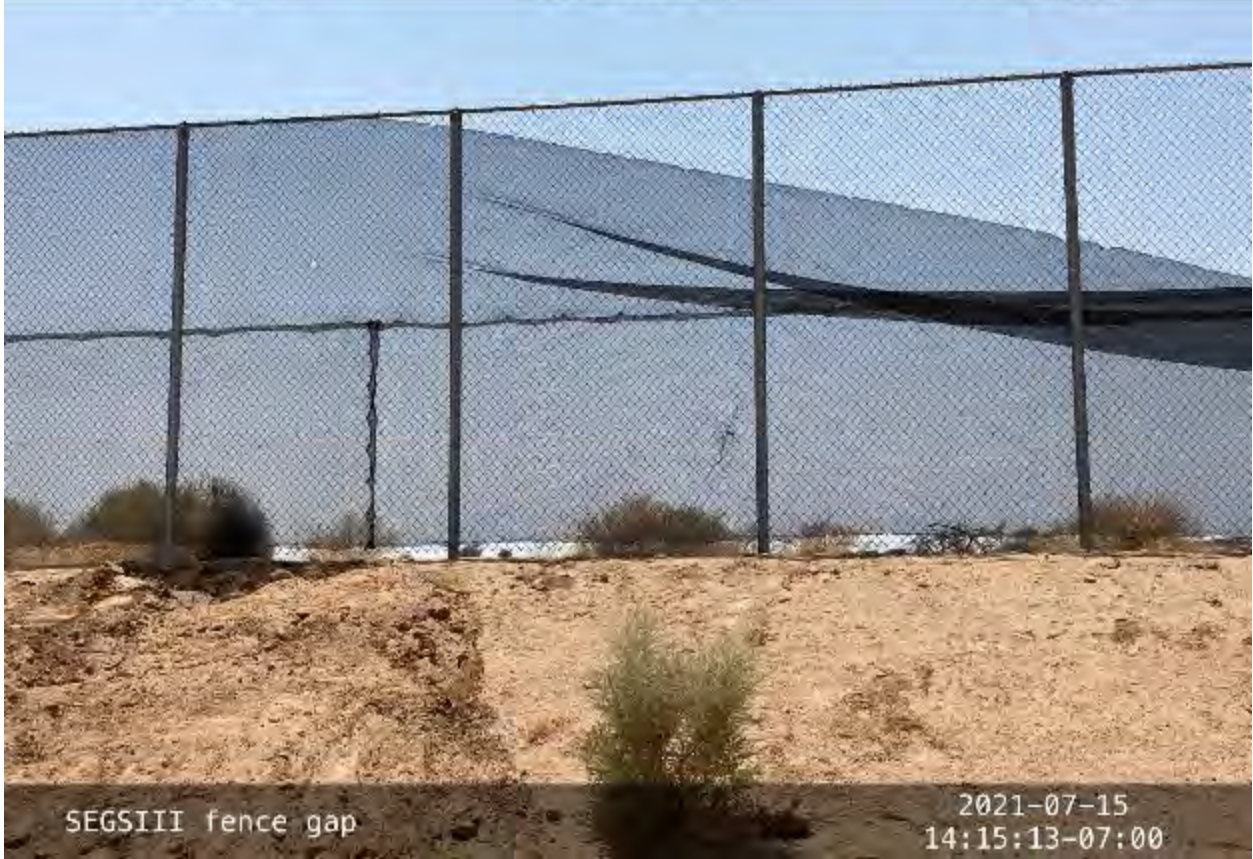
SEGSIII fence gap

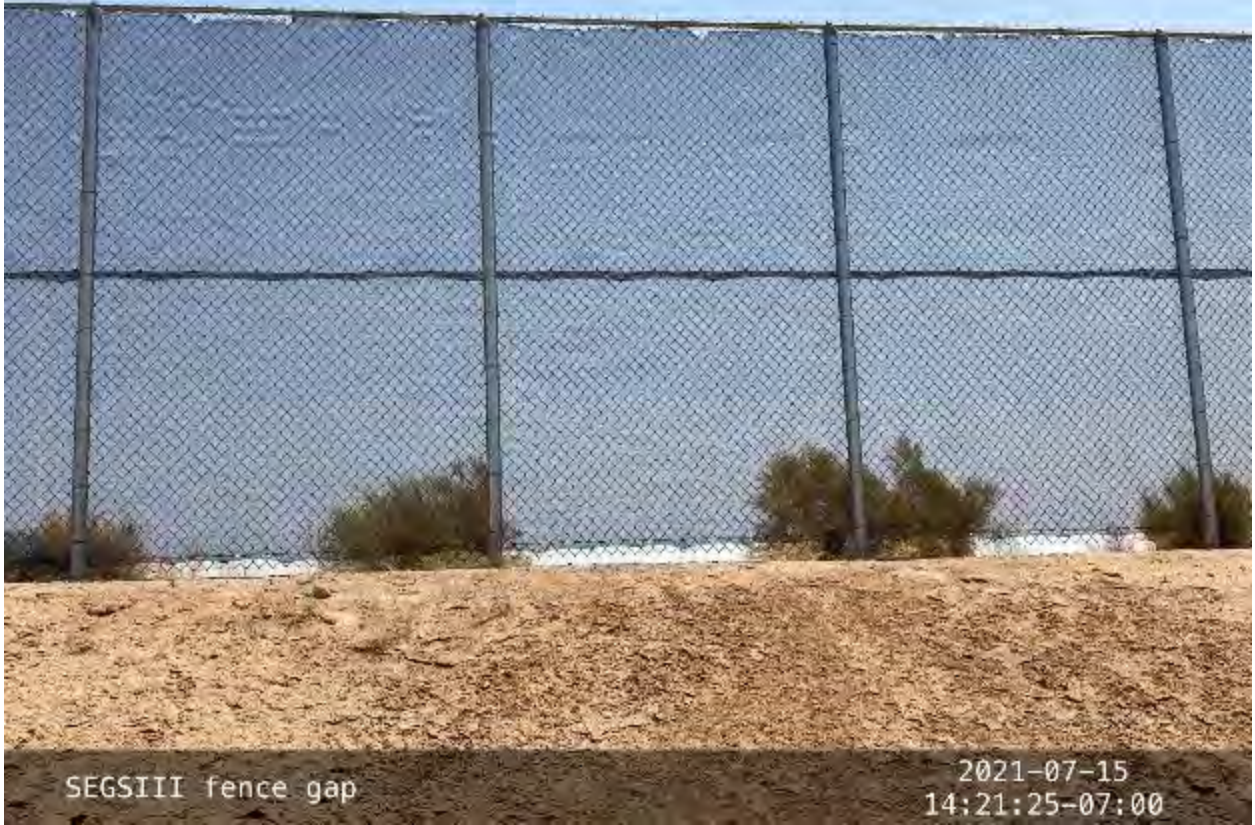
SEGSIII fence gap
